# Development Impact Report

## Assessment of Trees at 36 Sullivans Lane, Woodend

Friday, 8 May 2020

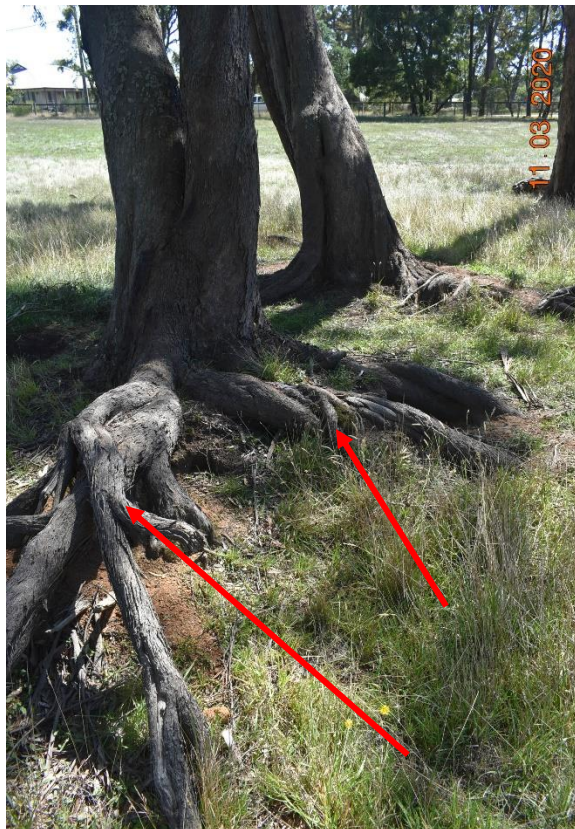
Examples of defects included Tree 7 which has failed at the roots in the past and is resting in the neighbouring tree (Figure 3). The roots are clearly out of the ground and erosion rabbit activity is visible. Complete tree failure is likely in the short to medium term. Tree 8 has had major failure stems failures, contains major decay throughout and contains codominant splitting stems (Figure 4). Large branch/stem failure is likely in the short term.

Figure 3 Tree 7 with exposed unstable roots and is resting on the neighbouring tree

- It is proposed to remove Trees 1, 2, 5-8, 11-16 and 27 (Group of Cypress). The trees include:
  - Paddock trees in poor condition with significant defects and high probability of branch and stem failure; or

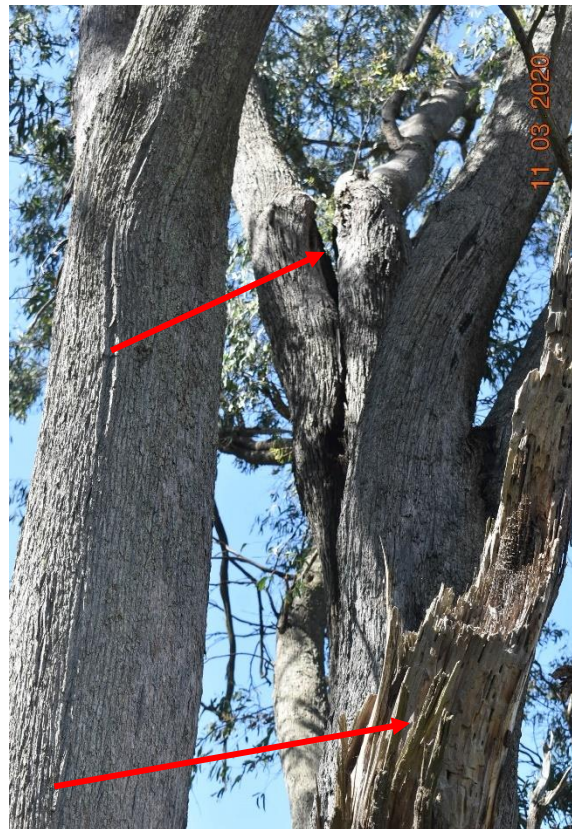
Figure 4 Tree 8 with splitting stems and recent failures following storm damage

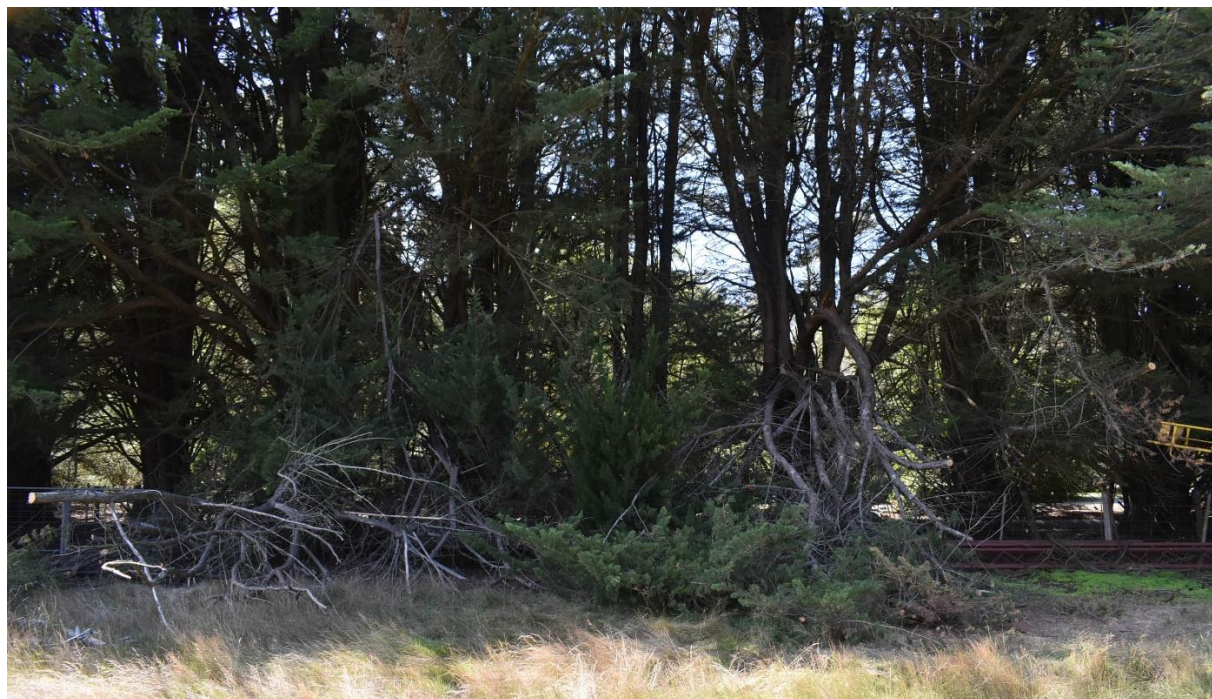
Tree group 27 is a row of predominately *Hesperocyparis macrocarpa* that are reaching the end of their useful life. The trees have reached their mature size and are experiencing major branch failure which is typical of the species of this age (Figure 5). Given the trees age, history of failure and likely future branch and stem failure, the trees have been assigned a ULE of 5-10 years.

Figure 5 Cypress windrow along the eastern boundary with large failed stems and branches throughout

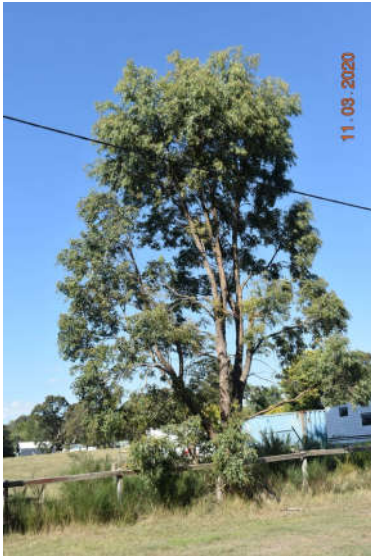
### Tree Number: 1

**Botanical Name:** *Eucalyptus radiata*  
**Common Name:** Narrow-leaved Peppermint  
**Origin:** Indigenous  
**Tree Age:** Semi mature  
**H x W:** 12m x 4m  
**Health:** Good  
**Structure:** Fair  
**ULE:** 20+ years  
**Retention Value:** Medium  
**Defects:** Codominant included stems with deadwood and lopped branches throughout the canopy  
**Comments:** Cleared from powerlines

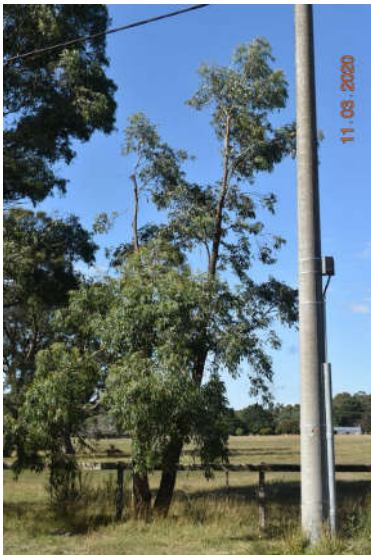
### Tree Number: 2

**Botanical Name:** *Eucalyptus radiata*  
**Common Name:** Narrow-leaved Peppermint  
**Origin:** Indigenous  
**Tree Age:** Semi mature  
**H x W:** 10m x 2m  
**Health:** Good  
**Structure:** Fair  
**ULE:** 20+ years  
**Retention Value:** Medium  
**Defects:** Included, codominant main stem and lopped canopy  
**Comments:** Cleared from powerlines

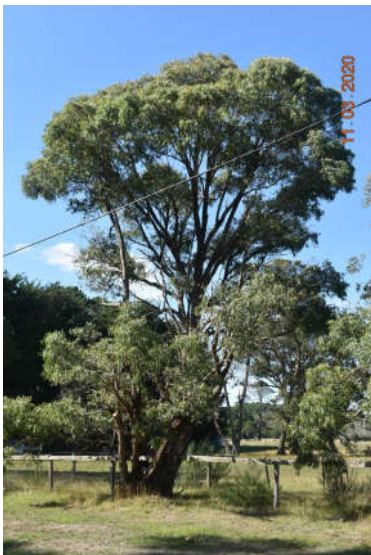
### Tree Number: 3

**Botanical Name:** *Eucalyptus radiata*  
**Common Name:** Narrow-leaved Peppermint  
**Origin:** Indigenous  
**Tree Age:** Mature  
**H x W:** 12m x 5m  
**Health:** Fair  
**Structure:** Fair  
**ULE:** 10-20 years  
**Retention Value:** Third party  
**Defects:** Damaged codominant main stems with decay and lopped canopy  
**Comments:**

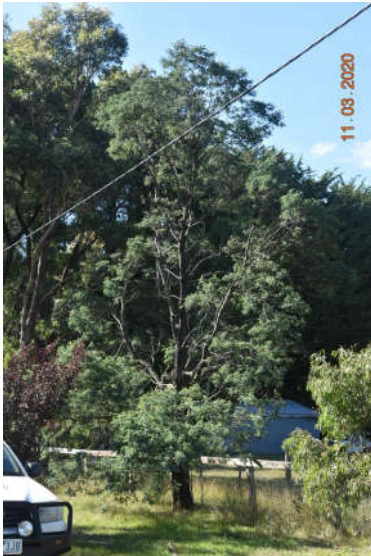
### Tree Number: 4

**Botanical Name:** *Acacia dealbata*  
**Common Name:** Silver Wattle  
**Origin:** Indigenous  
**Tree Age:** Mature  
**H x W:** 10m x 4m  
**Health:** Fair  
**Structure:** Fair  
**ULE:** 5-10 years  
**Retention Value:** Third party  
**Defects:** Lopped canopy

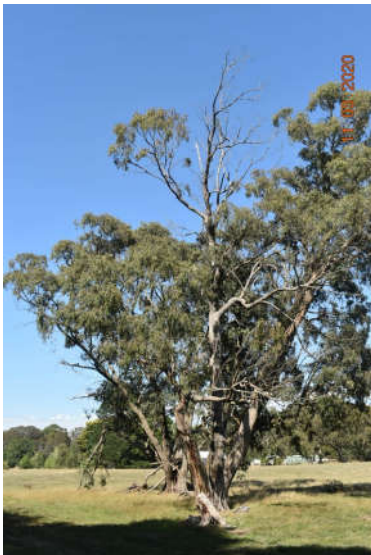
### Tree Number: 5

**Botanical Name:** *Eucalyptus radiata*  
**Common Name:** Narrow-leaved Peppermint  
**Origin:** Indigenous  
**Tree Age:** Mature  
**H x W:** 19m x 6m  
**Health:** Poor  
**Structure:** Poor  
**ULE:** 1-5 years  
**Retention Value:** Low  
**Defects:** Included, codominant main stems with extensive decay and cavities and dead branches throughout the canopy

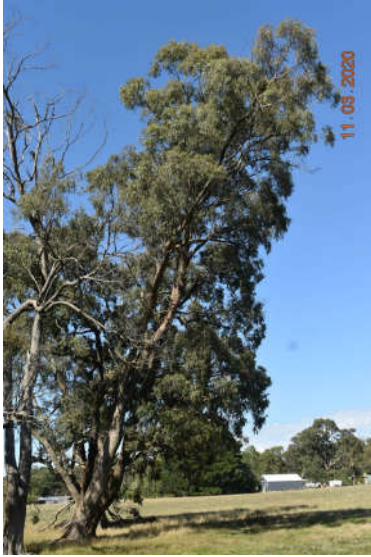
### Tree Number: 6

**Botanical Name:** *Eucalyptus radiata*  
**Common Name:** Narrow-leaved Peppermint  
**Origin:** Indigenous  
**Tree Age:** Mature  
**H x W:** 18m x 7m  
**Health:** Fair  
**Structure:** Poor  
**ULE:** 5-10 years  
**Retention Value:** Low

**Defects:** Exposed damaged roots, leaning main stem with extensive decay and extended branches throughout the canopy

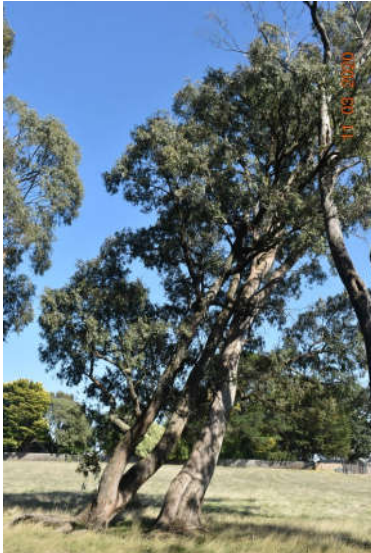
### Tree Number: 7

**Botanical Name:** *Eucalyptus radiata*  
**Common Name:** Narrow-leaved Peppermint  
**Origin:** Indigenous  
**Tree Age:** Mature  
**H x W:** 17m x 7m  
**Health:** Good  
**Structure:** Very poor  
**ULE:** 0 years  
**Retention Value:** Low

**Defects:** Exposed damaged unstable roots, leaning main stem

**Comments:** Tree failed in the ground and leaning on neighbouring trees

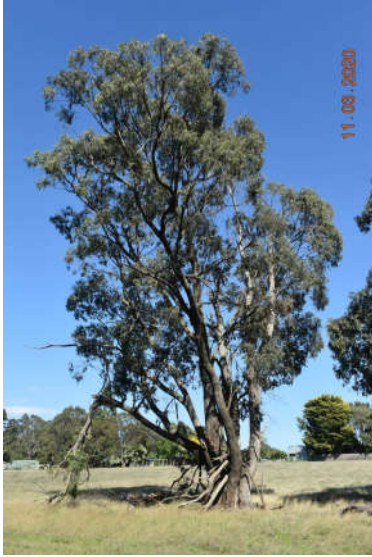
### Tree Number: 8

<b>Botanical Name:</b>	<i>Eucalyptus radiata</i>	
<b>Common Name:</b>	Narrow-leaved Peppermint	
<b>Origin:</b>	Indigenous	
<b>Tree Age:</b>	Mature	<b>DBH (cm):</b> 153
<b>H x W:</b>	18m x 12m	<b>TPZ (m):</b> 15
<b>Health:</b>	Fair	<b>SRZ (m):</b> 4.24
<b>Structure:</b>	Poor	
<b>ULE:</b>	5-10 years	
<b>Retention Value:</b>	Low	
<b>Defects:</b>	Included, codominant main stems with splitting, decay and cavities and dead branches throughout the canopy	
<b>Comments:</b>	Multiple recent failures

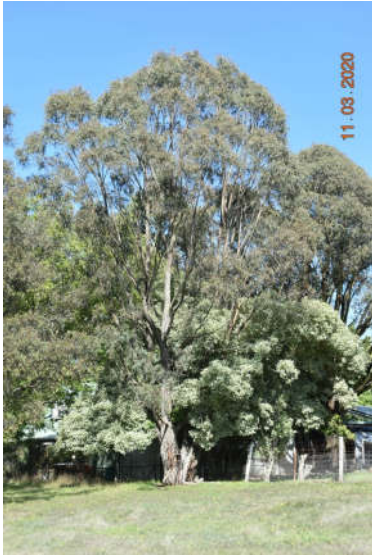
### Tree Number: 9

<b>Botanical Name:</b>	<i>Eucalyptus radiata</i>	
<b>Common Name:</b>	Narrow-leaved Peppermint	
<b>Origin:</b>	Indigenous	
<b>Tree Age:</b>	Mature	<b>DBH (cm):</b> 92
<b>H x W:</b>	16m x 7m	<b>TPZ (m):</b> 11.04
<b>Health:</b>	Fair	<b>SRZ (m):</b> 3.08
<b>Structure:</b>	Fair	
<b>ULE:</b>	5-10 years	
<b>Retention Value:</b>	Medium	
<b>Defects:</b>	Decay in codominant main stems and deadwood throughout the canopy	
<b>Comments:</b>

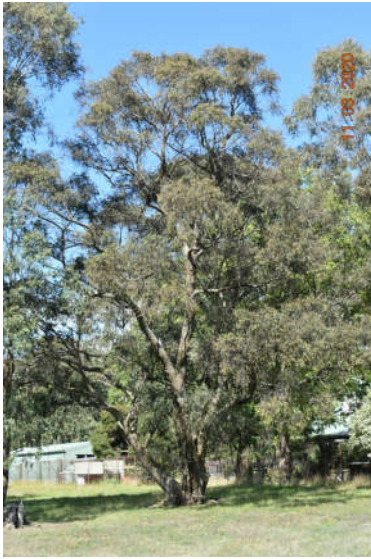
### Tree Number: 10

**Botanical Name:** *Eucalyptus radiata*  
**Common Name:** Narrow-leaved Peppermint  
**Origin:** Indigenous  
**Tree Age:** Mature  
**H x W:** 15m x 10m  
**Health:** Fair  
**Structure:** Fair  
**ULE:** 10-20 years  
**Retention Value:** Medium  
**Defects:** Exposed roots, codominant main stem and deadwood throughout the canopy  
**Comments:**

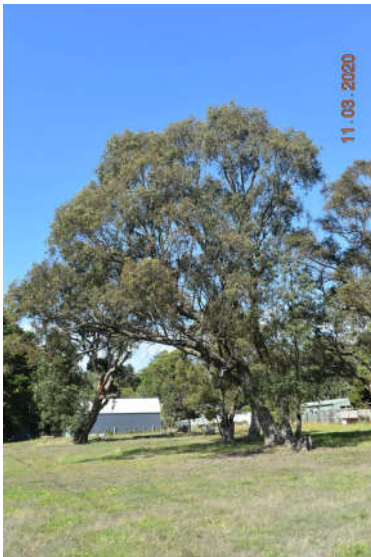
### Tree Number: 11

**Botanical Name:** *Eucalyptus radiata*  
**Common Name:** Narrow-leaved Peppermint  
**Origin:** Indigenous  
**Tree Age:** Mature  
**H x W:** 17m x 12m  
**Health:** Fair  
**Structure:** Fair  
**ULE:** 10-20 years  
**Retention Value:** Medium  
**Defects:** Leaning main stem with decay and deadwood throughout the canopy  
**Comments:**

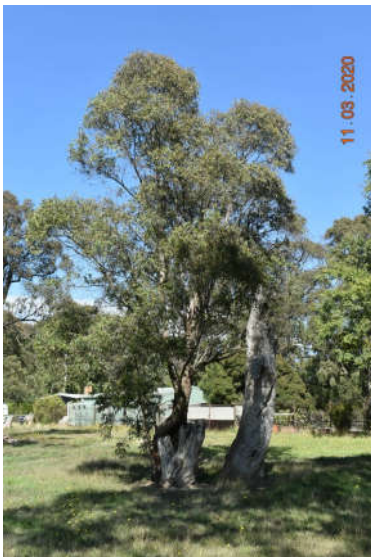
### Tree Number: 12

**Botanical Name:** *Eucalyptus radiata*  
**Common Name:** Narrow-leaved Peppermint  
**Origin:** Indigenous  
**Tree Age:** Semi mature  
**H x W:** 9m x 5m  
**Health:** Fair  
**Structure:** Poor  
**ULE:** 10-20 years  
**Retention Value:** Low  
**Defects:** Codominant decayed stems  
**Comments:** Regrowth from stump

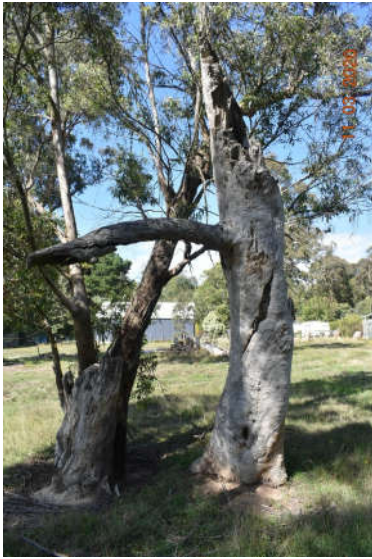
**Tree Number: 13**

**Botanical Name:** *Eucalyptus radiata*  
**Common Name:** Narrow-leaved Peppermint  
**Origin:** Indigenous  
**Tree Age:** Mature  
**H x W:** 4m x 1m  
**Health:** Dead  
**Structure:** Poor  
**ULE:** 0 years  
**Retention Value:** Low

**Defects:** Decay and cavities in main stem with deadwood throughout canopy

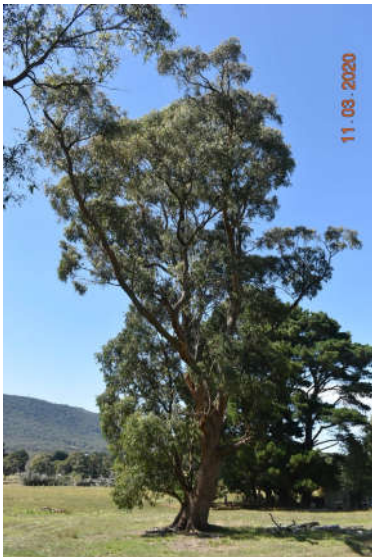
**Tree Number: 14**

**Botanical Name:** *Eucalyptus radiata*  
**Common Name:** Narrow-leaved Peppermint  
**Origin:** Indigenous  
**Tree Age:** Mature  
**H x W:** 20m x 14m  
**Health:** Good  
**Structure:** Very poor  
**ULE:** 5-10 years  
**Retention Value:** Medium

**Defects:** Exposed damaged unstable roots, leaning main stem with cavities and dead branches throughout the canopy

**Comments:** Major decay and cavity in main stem and exposed roots indicating partial failure

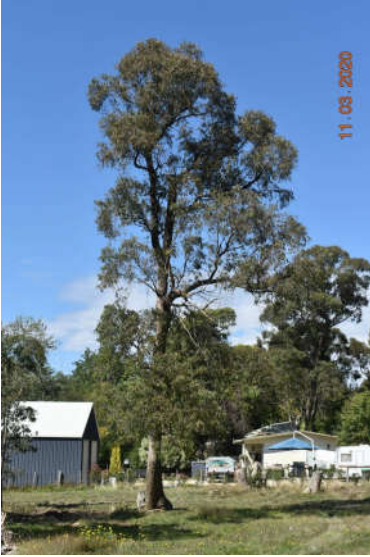
### Tree Number: 15

**Botanical Name:** *Eucalyptus radiata*  
**Common Name:** Narrow-leaved Peppermint  
**Origin:** Indigenous  
**Tree Age:** Semi mature  
**H x W:** 14m x 3m  
**Health:** Fair  
**Structure:** Very poor  
**ULE:** 1-5 years  
**Retention Value:** Low

**Defects:** Damaged roots, leaning main stem with extensive decay and dead branches throughout the canopy

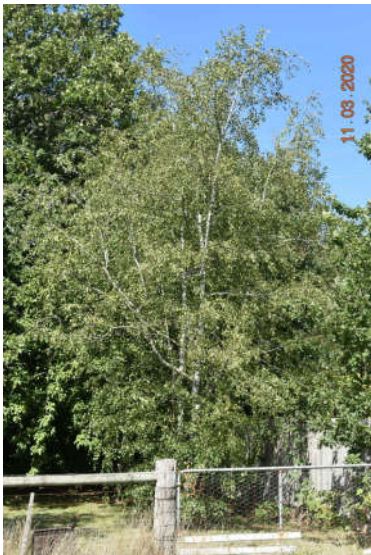
### Tree Number: 18

**Botanical Name:** *Betula pendula*  
**Common Name:** Silver Birch  
**Origin:** Exotic  
**Tree Age:** Semi mature  
**H x W:** 12m x 3m  
**Health:** Good  
**Structure:** Fair  
**ULE:** 10-20 years  
**Retention Value:** Low  
**Defects:** Codominant stems

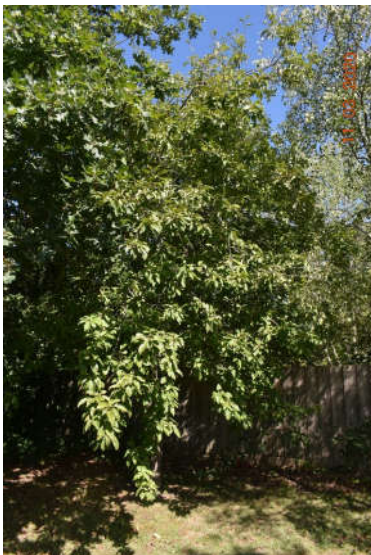
### Tree Number: 22

**Botanical Name:** *Malus domestica*  
**Common Name:** Apple  
**Origin:** Exotic  
**Tree Age:** Semi mature  
**H x W:** 6m x 3m  
**Health:** Good  
**Structure:** Good  
**ULE:** 20+ years  
**Retention Value:** Medium  
**Defects:** Codominant stems

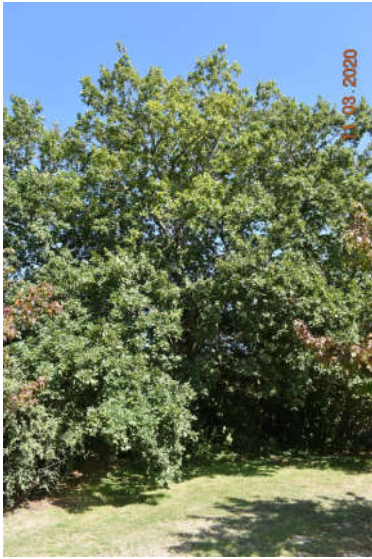
### Tree Number: 23

**Botanical Name:** *Quercus robur*  
**Common Name:** English Oak  
**Origin:** Exotic  
**Tree Age:** Mature  
**H x W:** 20m x 18m  
**Health:** Good  
**Structure:** Good  
**ULE:** 20+ years  
**Retention Value:** High

**Defects:** Extended branches in canopy

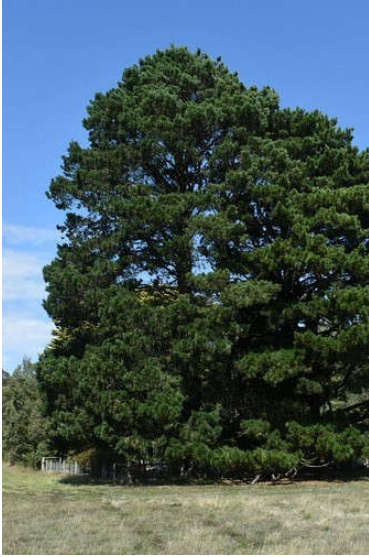
**Tree Number: 26**

**Botanical Name:** *Pinus radiata*  
**Common Name:** Monterey Pine  
**Origin:** Exotic  
**Tree Age:** Mature  
**H x W:** 30m x 10m  
**Health:** Good  
**Structure:** Good  
**ULE:** 20+ years  
**Retention Value:** Third party

**Defects:** Deadwood throughout the canopy

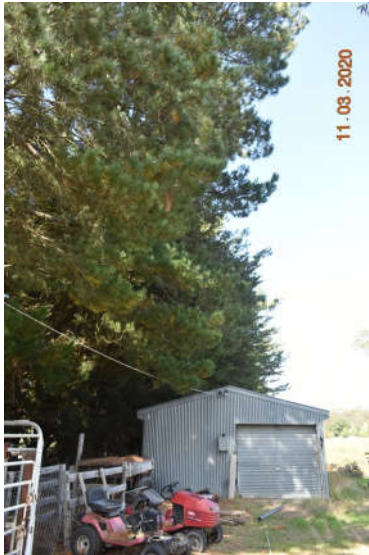
**Tree Number: 27**

**Botanical Name:** *Hesperocyparis macrocarpa*  
**Common Name:** Monterey Cypress  
**Origin:** Exotic  
**Tree Age:** Mature  
**H x W:** 22m x 8m  
**Health:** Fair  
**Structure:** Fair  
**ULE:** 5-10 years  
**Retention Value:** Third party

**Defects:** Broken branches and deadwood throughout the canopy
