Project No. 467

3 September 2020

**Final Letter Report: Vegetation Impact Assessment – Mount Gisborne Reserve, Woodlands Drive, Gisborne.**

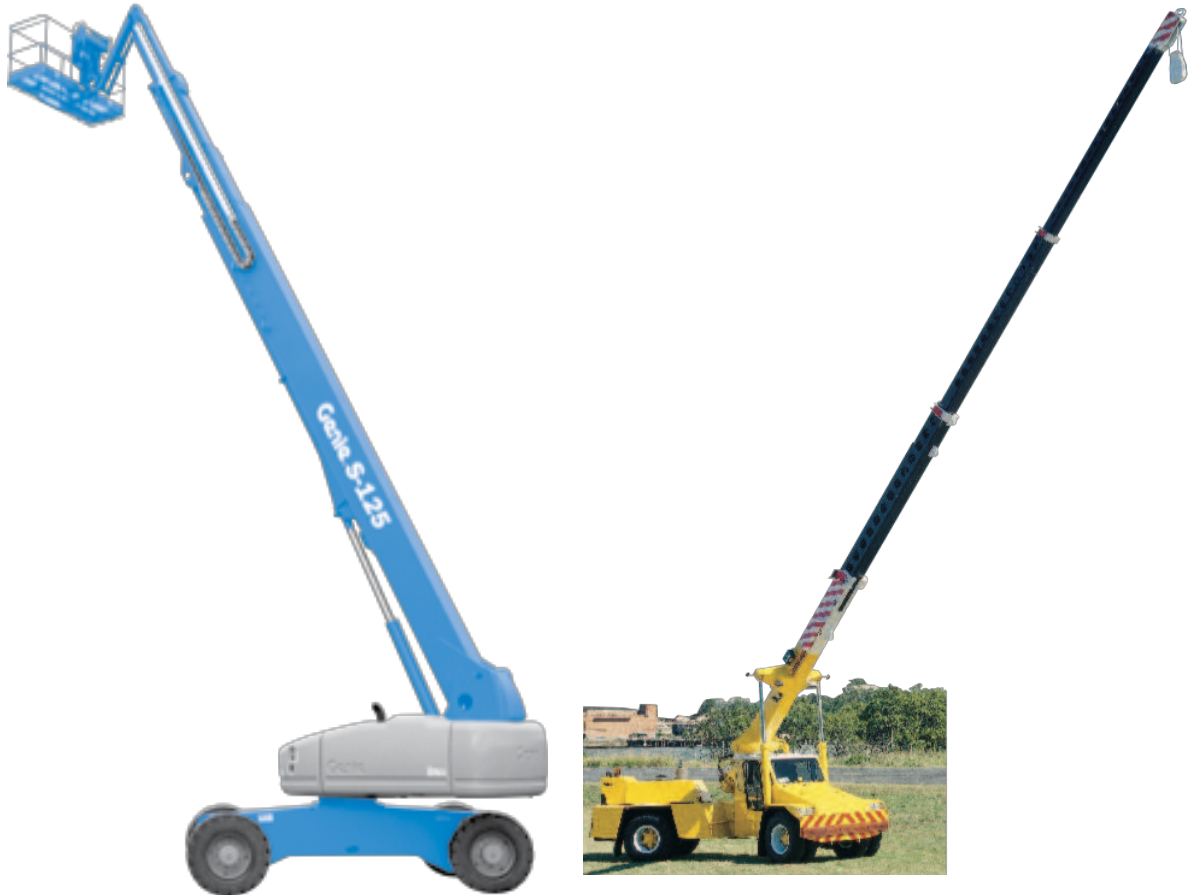
**Plate 1.** The two types of crane proposed to be used for the project

The access road leading up to the summit is approximately 2.5 metres wide. Both vehicles are 2.5 metres wide therefore there will be some impacts to native vegetation along the edges of the access road. These impacts include mainly temporary compaction of native grasses and herbs such as Tussock-grasses *Poa*, the loss of tree limbs (particularly Blackwoods *Acacia melanoxylon*) and some minor lopping of eucalyptus limbs (see Plate 2). Austral Bracken *Pteridium esculentum* will also be impacted. Several mitigation and management strategies can be employed on-site to minimise these impacts (see mitigation measures below).

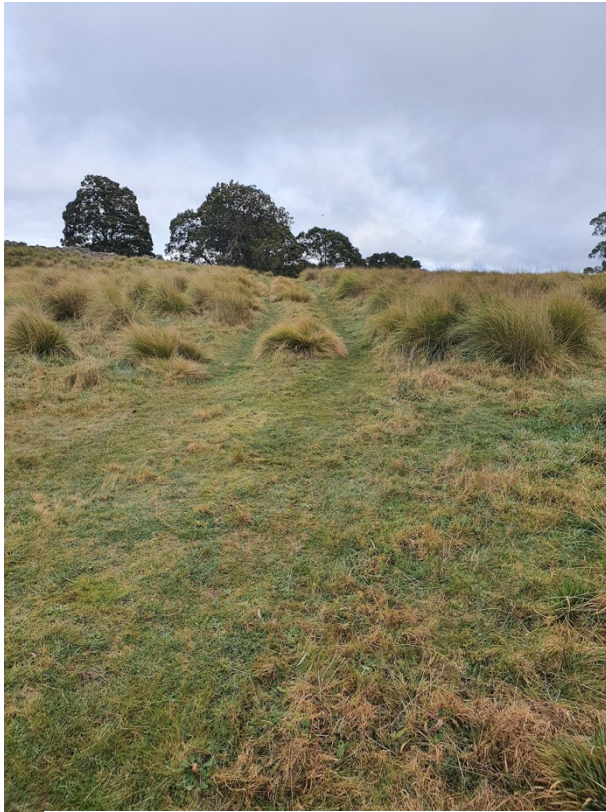
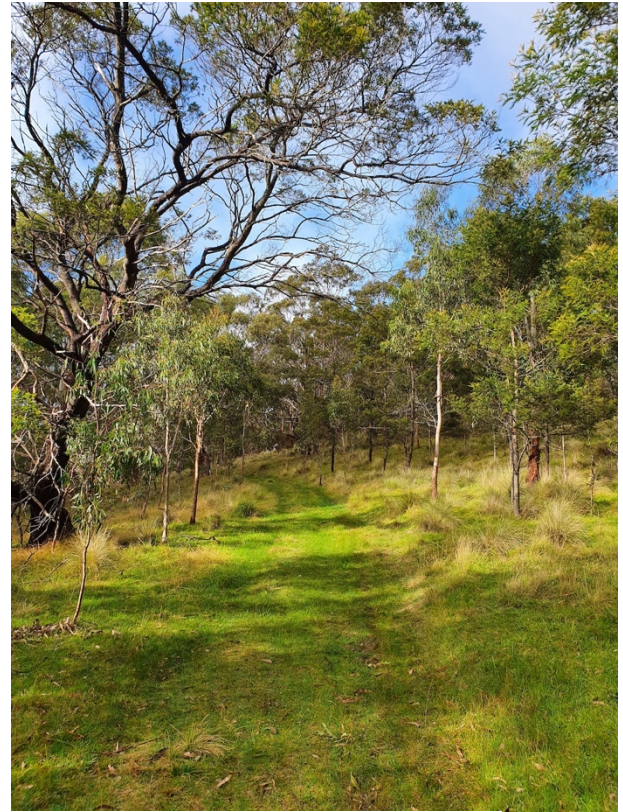
**Plate 2.** Left- indigenous Tussock-grasses near the summit; right- regenerating eucalypts, wattles and grasses lower down the mountain

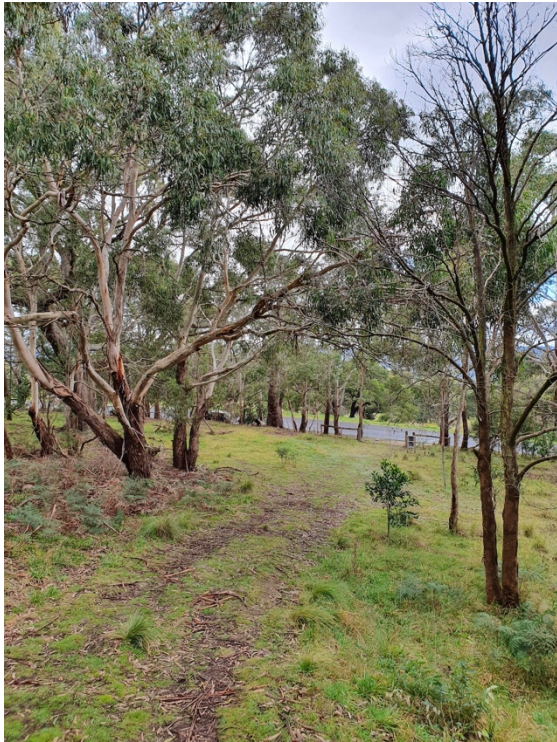
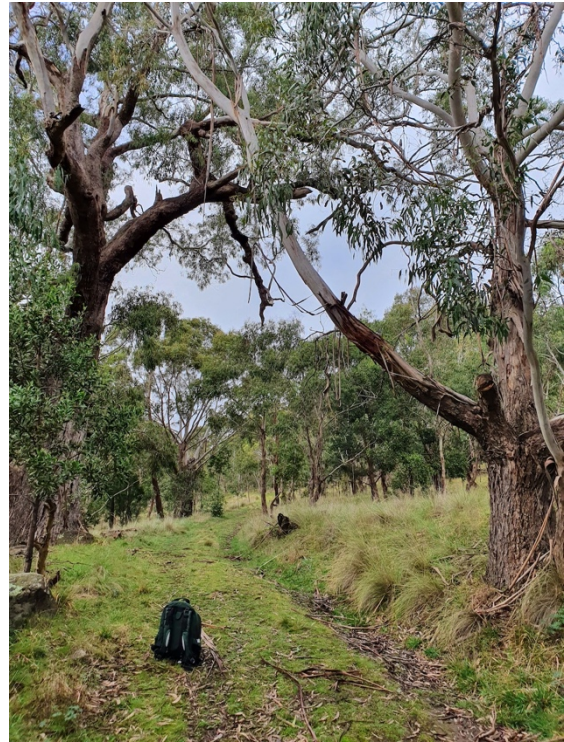
One area in particular at the base of the mountain approximately 30 metres from the entrance gate will require more intensive supervision and management. A low eucalypt limb here partially crosses over the access road. The limb crosses over the centre of the access road at a height of 4 metres, which is well clear of the height of the cranes; however the limb is 2.5 metres above the edge of the access road (see Plate 3). As the cranes' widths narrow higher up where their booms are stowed, it's been deemed that this limb can be cleared with micro-siting and careful management on the days of crane entry into the reserve (see mitigation measures below).

**Plate 3.** Left- eucalypt limb crossing over above access road, looking towards entrance gate; right- the same tree looking up towards summit

- It is recommended that a spotter and representative from Council be present when the cranes are ascending and descending the access track. Careful navigation of

the cranes will assist in reducing damage to soils and adjacent native vegetation. With instruction from a nearby spotter, the cranes can avoid some tree lopping and native grass compaction.

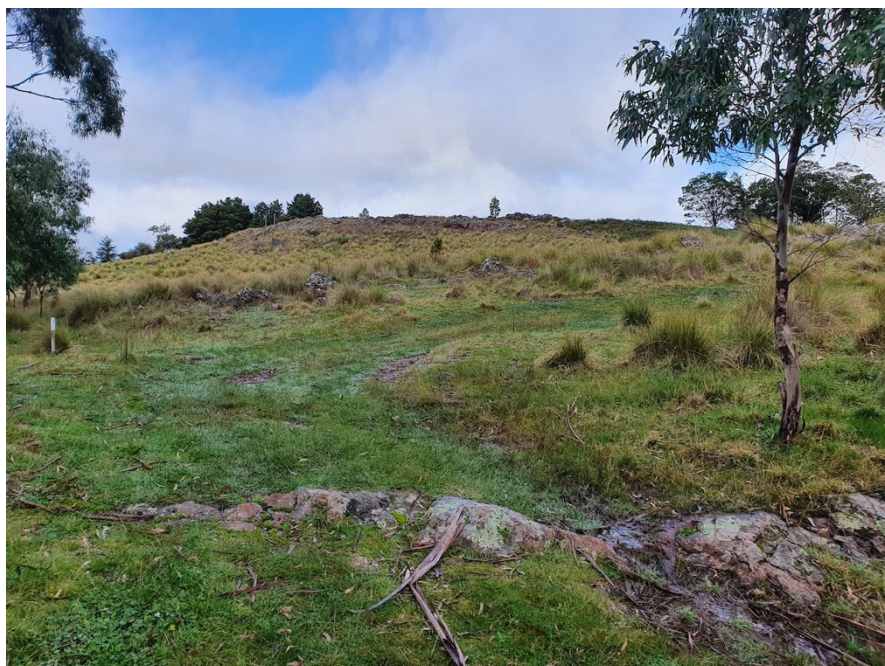
The second area of impact is the access track itself. The cranes weigh between 18-20 tonnes therefore there is likely to be impacts to the track, such as soil compaction, soil disturbance, vegetation compaction and damage and changes to water run-off patterns (see Plate 4).

**Plate 4.** A tight hairpin turn near the summit is likely to impact soil, vegetation on the track and native vegetation adjacent

- Planks of wood or similar are recommended to be used on the ground during the ascent and descent, to assist with traction where required. This may assist to minimise soil disturbance.

- Any compaction or damage to native vegetation should be rectified immediately after the works have been completed. This will involve some manual work and perhaps some shovel and rake work on the access track.

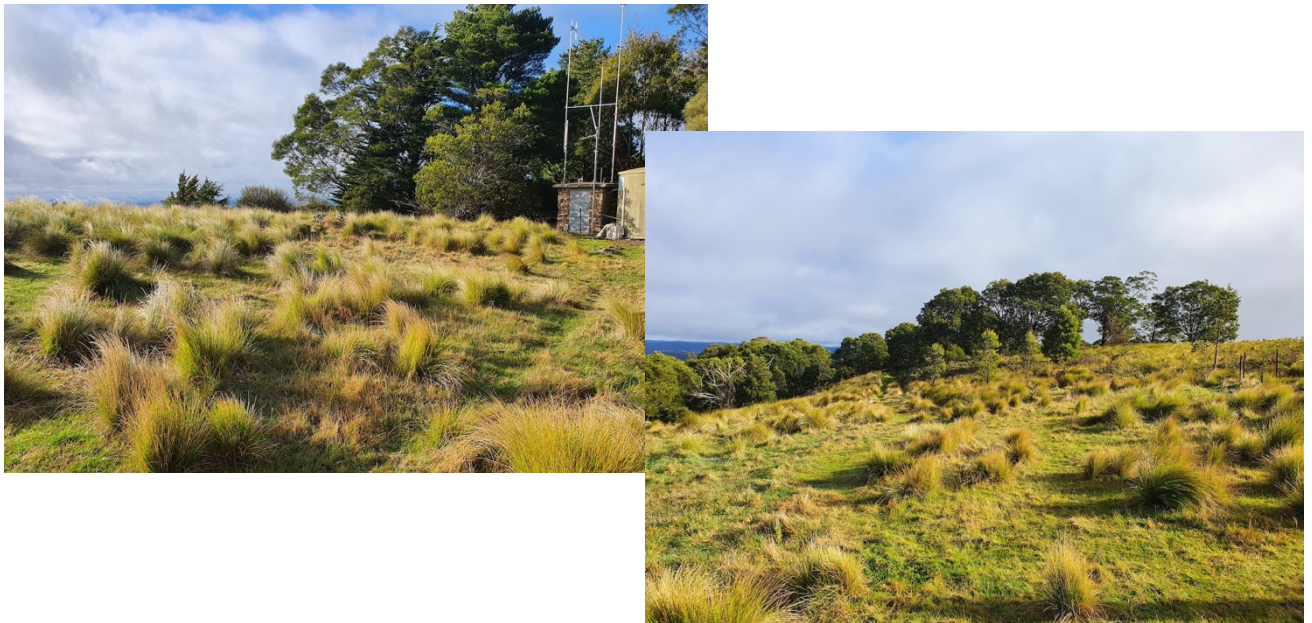
The third area of impact is the area near the summit surrounding the existing tower infrastructure. Native vegetation here will be temporarily impacted by equipment and machinery that need to use this area to install the tower. A turning circle of at least 8 metres is required at this site to allow for the movement of machinery. Tussock-grasses and some native herbs will be the main species impacted in this area (see Plate 5).

**Plate 5.** Left- View of existing infrastructure and cable route from tower site; right- marked out tower site on right with access track on the left. Proposed turning circle in foreground

- Any damaged areas, such as the edges of the access track or turning circle, are to be re-assessed after any permitted works to address possible rehabilitation measures. These may include: cordoning off more damaged areas to avoid further disturbance from people and vehicles and to allow natural recovery, manual work within specific areas where damage has occurred (such as stabilisation of plant roots by hand, movement of soil to original location etc.), and possible re-seeding of indigenous species such as grasses where damage has occurred and where natural recovery and establishment may not be successful. These measures should be established post works through a site assessment with council or an ecologist.

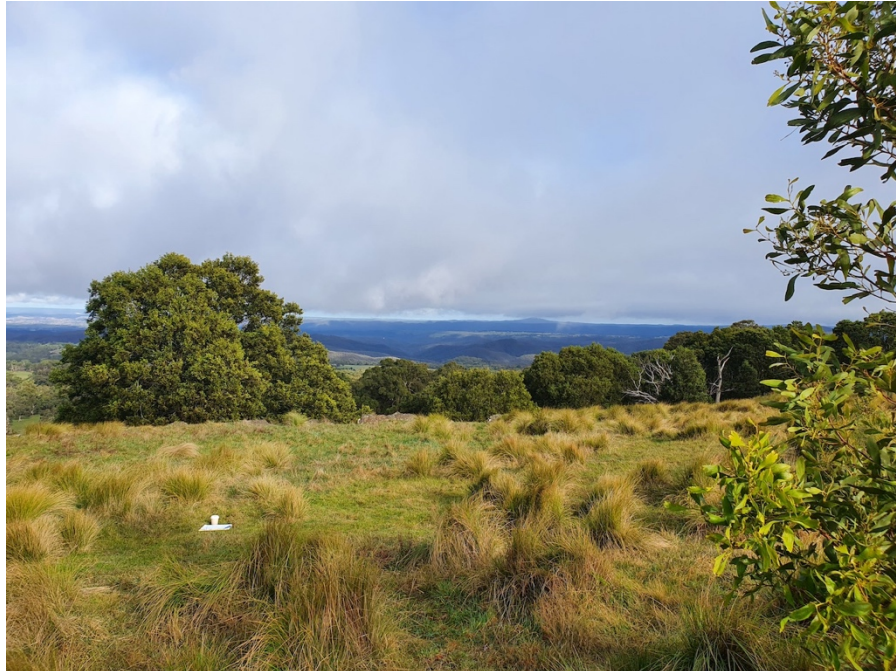
**Plate 6.** A more cleared area occurs to the south of the tower location where materials and equipment can be stored (however some *Poa* will be impacted).

- Materials and equipment storage must only be located within cordoned off areas near the tower location. To the south of the tower location there is an area more cleared of native vegetation (*Poa*) which is the best location for materials and equipment storage (Plate 6). This area should be used as much as practicable. The works area and turning circle should ideally also be delineated near the summit in order to provide a clear boundary as to where machinery and equipment can go. Temporary fencing such as orange para-webbing is recommended.
