Project No. 467

3 September 2020

### **Final Letter Report: Vegetation Impact Assessment – Mount Gisborne Reserve, Woodlands Drive, Gisborne.**

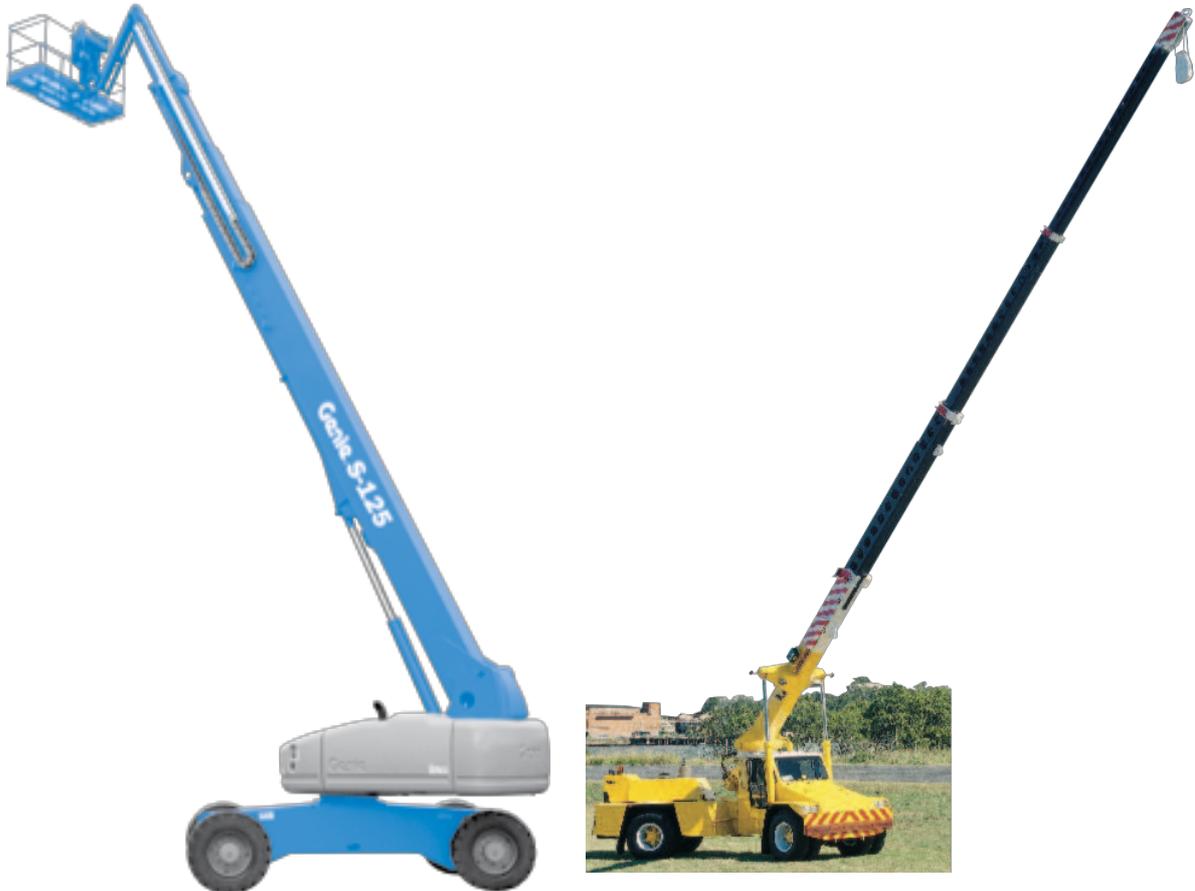
**Plate 1.** The two types of crane proposed to be used for the project

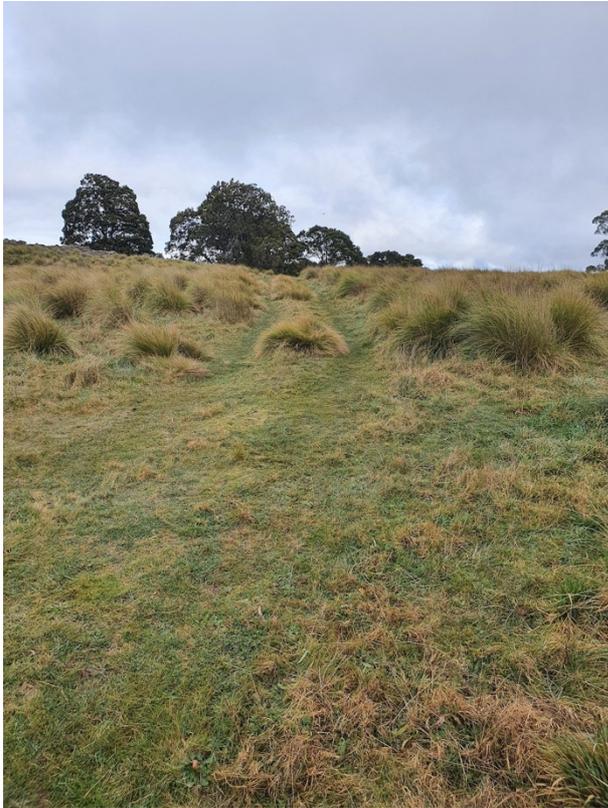
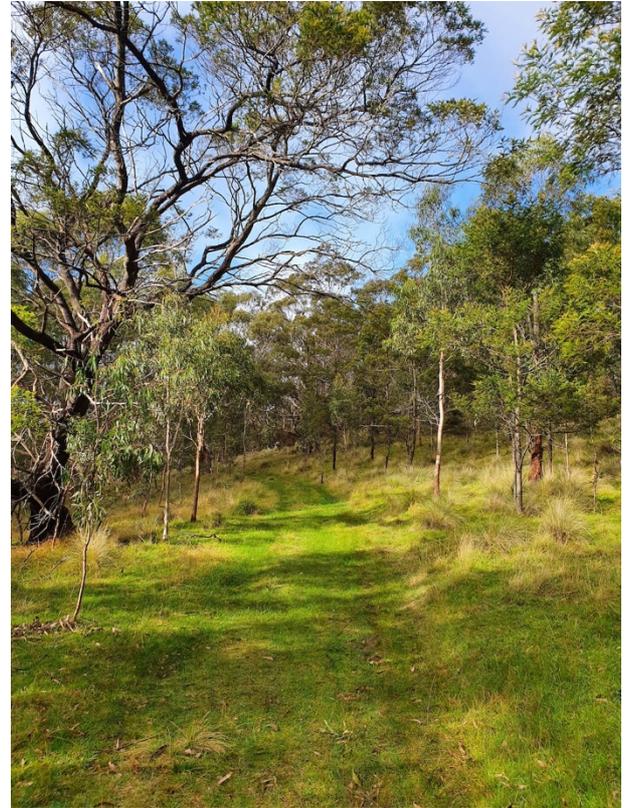
The access road leading up to the summit is approximately 2.5 metres wide. Both vehicles are 2.5 metres wide therefore there will be some impacts to native vegetation along the edges of the access road. These impacts include mainly temporary compaction of native grasses and herbs such as Tussock-grasses *Poa*, the loss of tree limbs (particularly Blackwoods *Acacia melanoxylon*) and some minor lopping of eucalyptus limbs (see Plate 2). Austral Bracken *Pteridium esculentum* will also be impacted. Several mitigation and management strategies can be employed on-site to minimise these impacts (see mitigation measures below).

**Plate 2.** Left- indigenous Tussock-grasses near the summit; right- regenerating eucalypts, wattles and grasses lower down the mountain

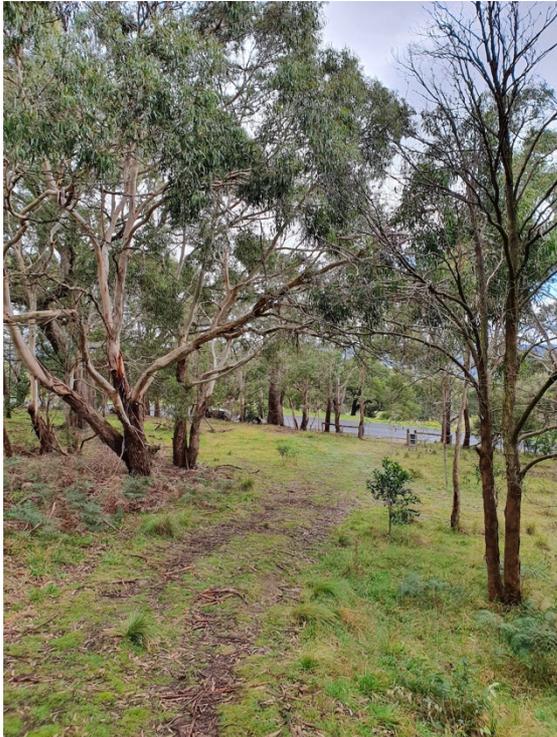
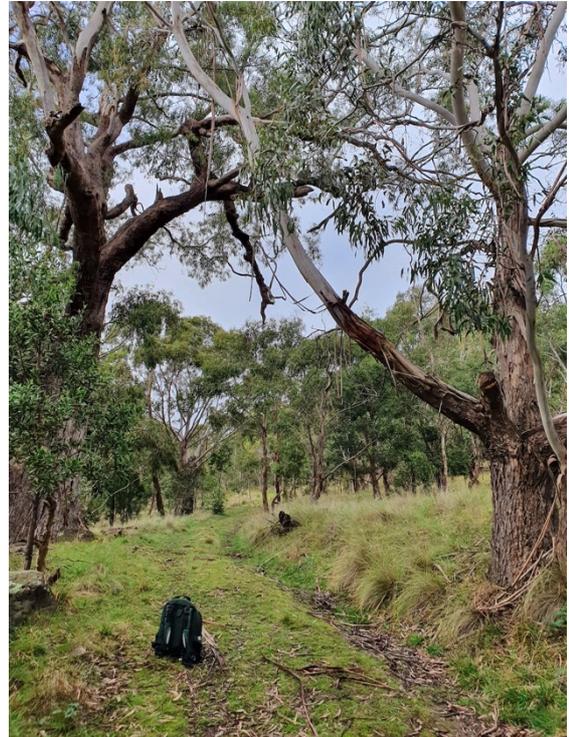
One area in particular at the base of the mountain approximately 30 metres from the entrance gate will require more intensive supervision and management. A low eucalypt limb here partially crosses over the access road. The limb crosses over the centre of the access road at a height of 4 metres, which is well clear of the height of the cranes; however the limb is 2.5 metres above the edge of the access road (see Plate 3). As the cranes' widths narrow higher up where their booms are stowed, it's been deemed that this limb can be cleared with micro-siting and careful management on the days of crane entry into the reserve (see mitigation measures below).

**Plate 3.** Left- eucalypt limb crossing over above access road, looking towards entrance gate; right- the same tree looking up towards summit

- It is recommended that a spotter and representative from Council be present when the cranes are ascending and descending the access track. Careful navigation of

the cranes will assist in reducing damage to soils and adjacent native vegetation. With instruction from a nearby spotter, the cranes can avoid some tree lopping and native grass compaction.

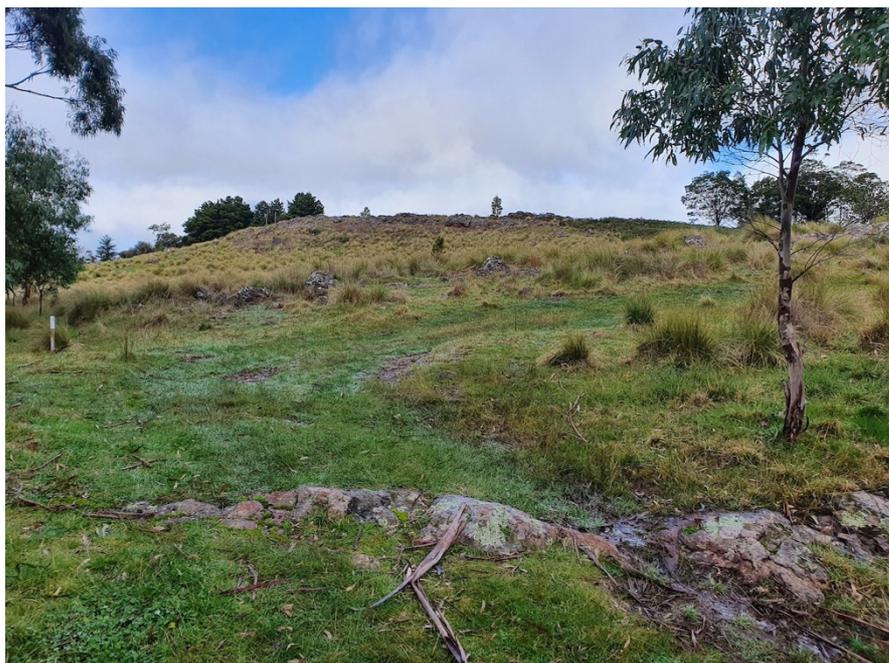
The second area of impact is the access track itself. The cranes weigh between 18-20 tonnes therefore there is likely to be impacts to the track, such as soil compaction, soil disturbance, vegetation compaction and damage and changes to water run-off patterns (see Plate 4).

**Plate 4.** A tight hairpin turn near the summit is likely to impact soil, vegetation on the track and native vegetation adjacent

- Planks of wood or similar are recommended to be used on the ground during the ascent and descent, to assist with traction where required. This may assist to minimise soil disturbance.

- Any compaction or damage to native vegetation should be rectified immediately after the works have been completed. This will involve some manual work and perhaps some shovel and rake work on the access track.

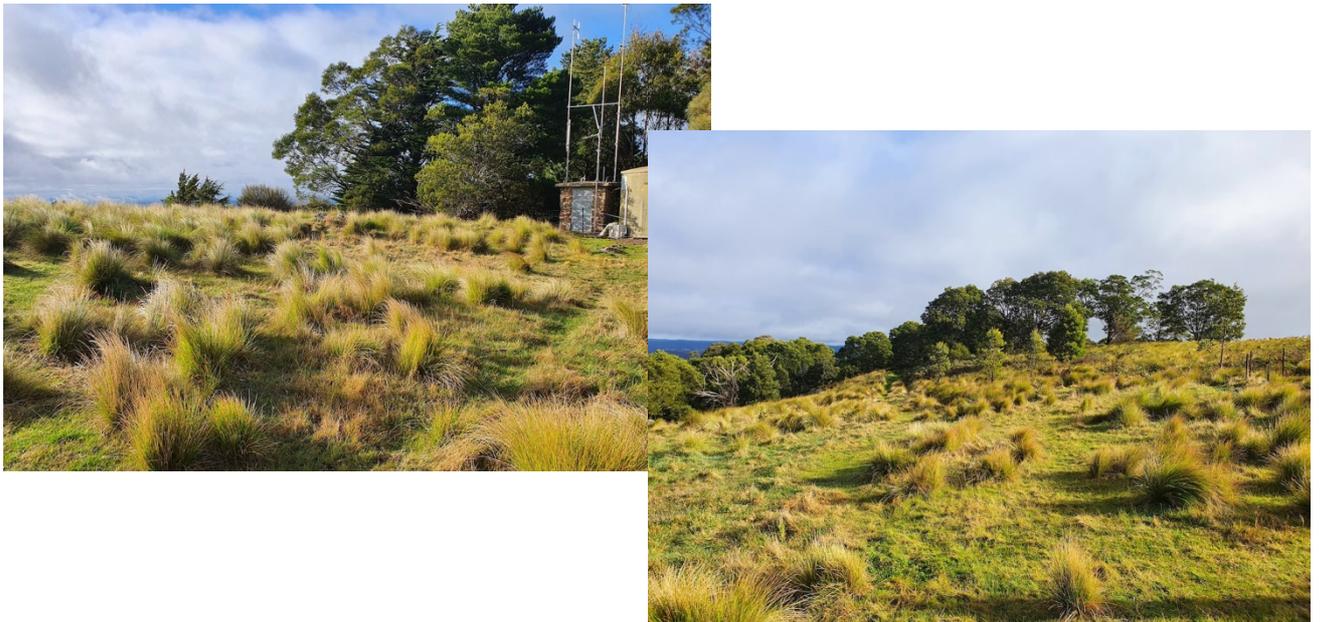
The third area of impact is the area near the summit surrounding the existing tower infrastructure. Native vegetation here will be temporarily impacted by equipment and machinery that need to use this area to install the tower. A turning circle of at least 8 metres is required at this site to allow for the movement of machinery. Tussock-grasses and some native herbs will be the main species impacted in this area (see Plate 5).

**Plate 5.** Left- View of existing infrastructure and cable route from tower site; right- marked out tower site on right with access track on the left. Proposed turning circle in foreground

- Any damaged areas, such as the edges of the access track or turning circle, are to be re-assessed after any permitted works to address possible rehabilitation measures. These may include: cordoning off more damaged areas to avoid further disturbance from people and vehicles and to allow natural recovery, manual work within specific areas where damage has occurred (such as stabilisation of plant roots by hand, movement of soil to original location etc.), and possible re-seeding of indigenous species such as grasses where damage has occurred and where natural recovery and establishment may not be successful. These measures should be established post works through a site assessment with council or an ecologist.

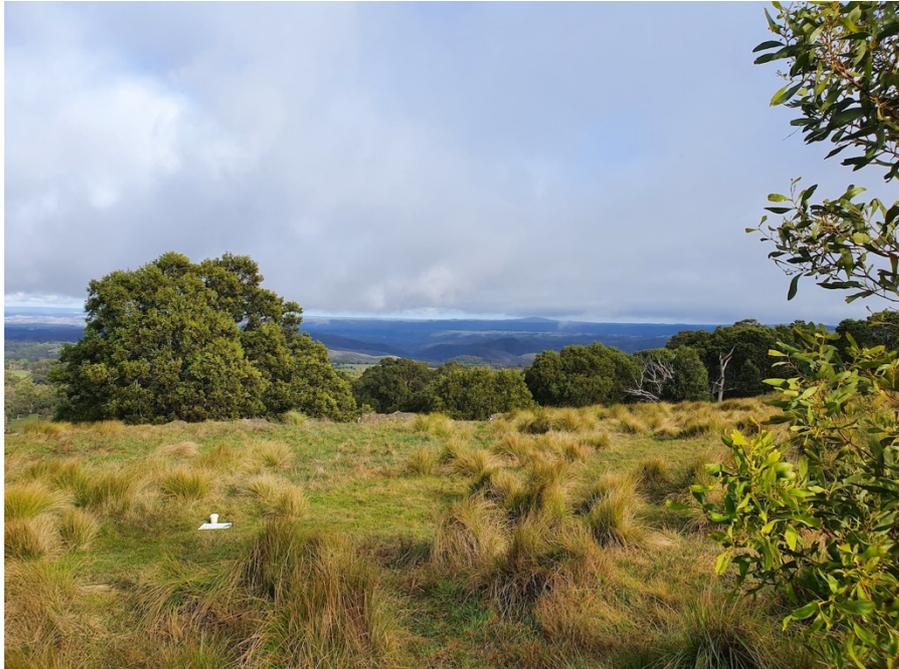
**Plate 6.** A more cleared area occurs to the south of the tower location where materials and equipment can be stored (however some *Poa* will be impacted).

- Materials and equipment storage must only be located within cordoned off areas near the tower location. To the south of the tower location there is an area more cleared of native vegetation (*Poa*) which is the best location for materials and equipment storage (Plate 6). This area should be used as much as practicable. The works area and turning circle should ideally also be delineated near the summit in order to provide a clear boundary as to where machinery and equipment can go. Temporary fencing such as orange para-webbing is recommended.
