**Sustainability Report**  
**Bennett Road Development Plan**  
**Gisborne South**

**Rev 5 Dec 4 2021**

# **LAND CAPABILITY AND STORM WATER REPORT**

## **Bennett Road Development Plan, Gisborne South**

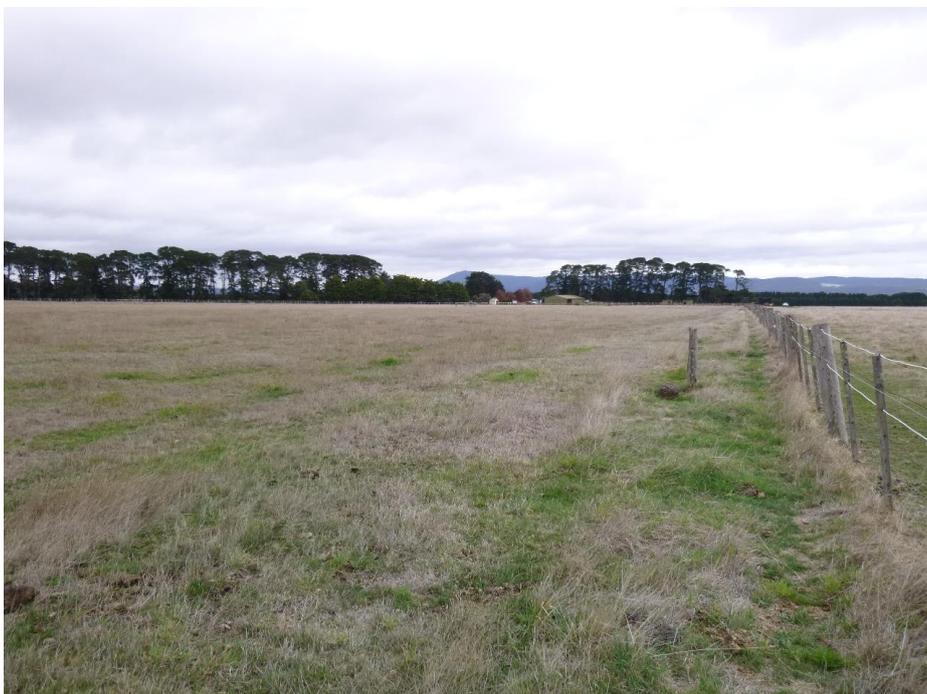
Plate 1 View to north toward example of introduced vegetation/windbelt within the study area.

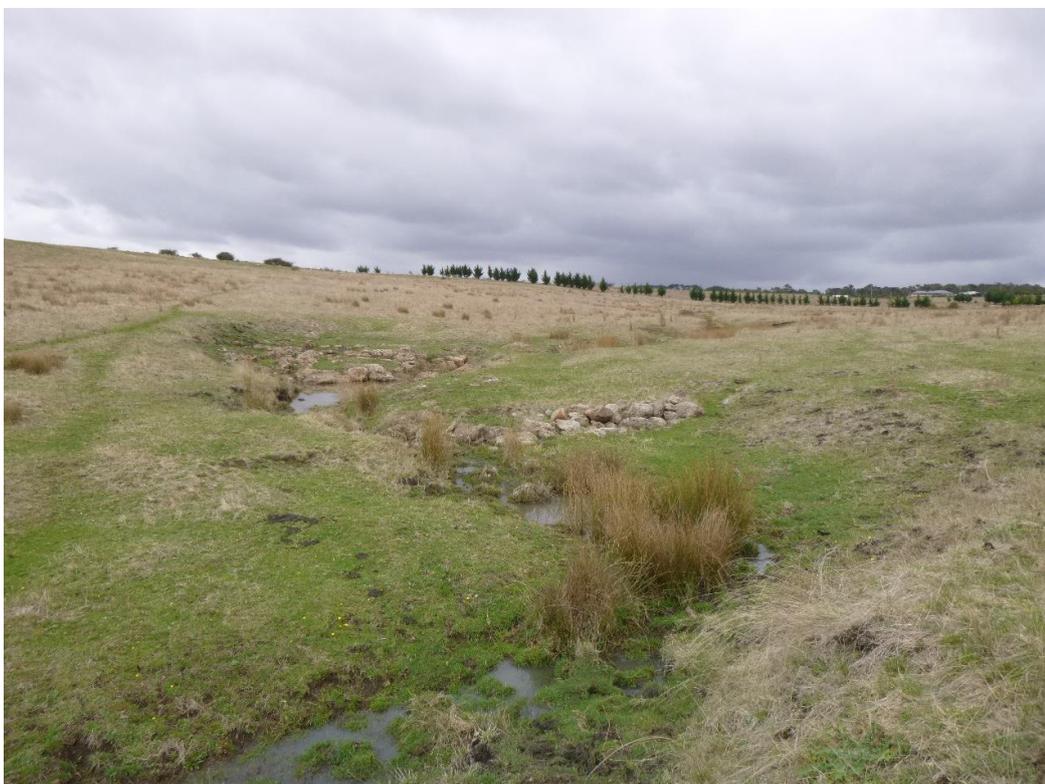
Plate 2 View to south across Djirri Djirri Creek planned for revegetation

A program of revegetation of Djirri Djirri Creek will provide habitat, erosion and flood mitigation as well as an area of passive recreation (Plate 2). In addition the wider Development Area will retain original vegetation where possible and establish a program of buffer/corridor planting, road reserve and habitat planting (Fig 3) with the aim of retaining existing assets and improving shelter, screening, microclimate, fauna habitat and general amenity.
