Black Hill Reserve
Environmental Management Plan
(Part 1 – Background Report)
(Part 2 – Actions and Implementation)

Black Hill Reserve
Environmental Management Plan– Parts 1 and 2
Adopted by Council 24th May 2017

Prepared for:	Macedon Ranges Shire Council	PE project number:	MAC 2032
Contact:	Michelle Wyatt Macedon Ranges Shire Council PO Box 151 Kyneton Victoria 3444 Phone 03 5421 9678 Fax 03 5422 3623 MWyatt@mrsc.vic.gov.au	PE file location:	R:\Macedon Ranges\Black Hill Reserve JUL 2016

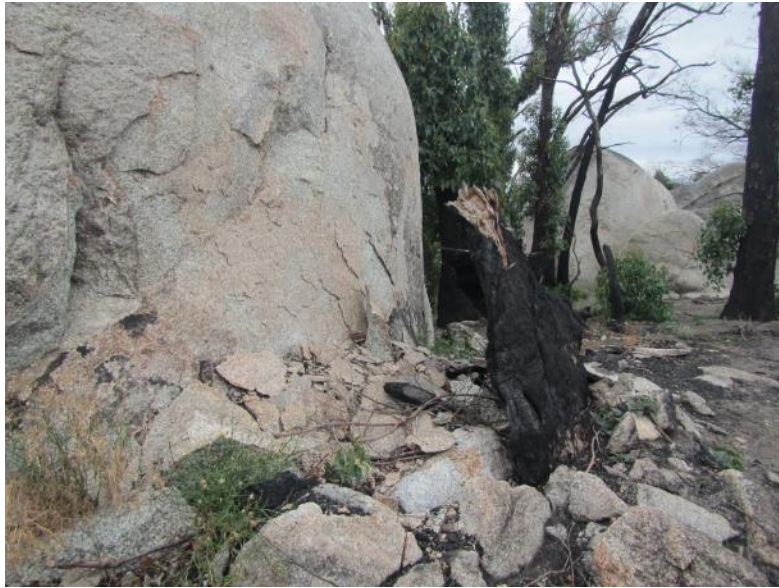
Interestingly after the January 2015 bushfire, granite is flaking off some of the boulders in sheets. It was observed that this has mostly occurred where large trees were growing close to the boulders. The heat from these trees, many of which would have burnt/smouldered for days, has probably caused prolonged heat exposure to some sections of granite, which has resulted in sections of the boulders flaking off. These flaked boulders now provide habitat for wildlife.

Granite flaking off the boulders

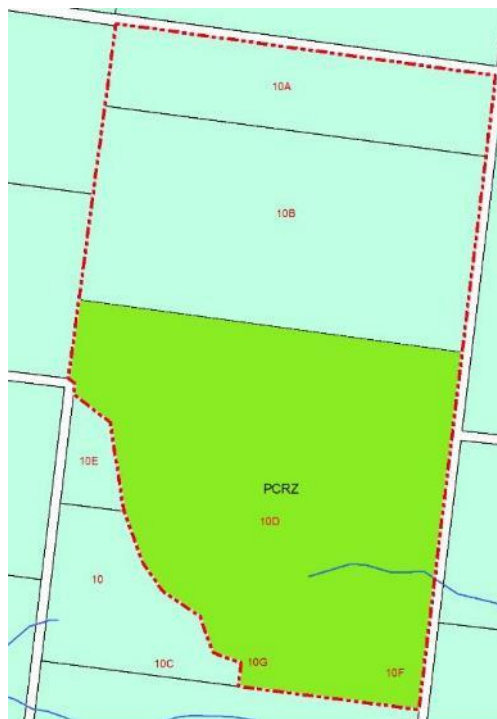
Figure 1. Land Tenure at Black Hill Reserve

Black Hill consists of both Crown allotments and freehold land. Lots 10A and 10B are freehold land which is owned by Macedon Ranges Shire Council, whilst Lots 10D, 10E, 10F and 10G are Crown allotments, managed by Parks Victoria. The locations of the Lots are depicted in Figure 1 below (source: Macedon Ranges Planning Scheme on-line).

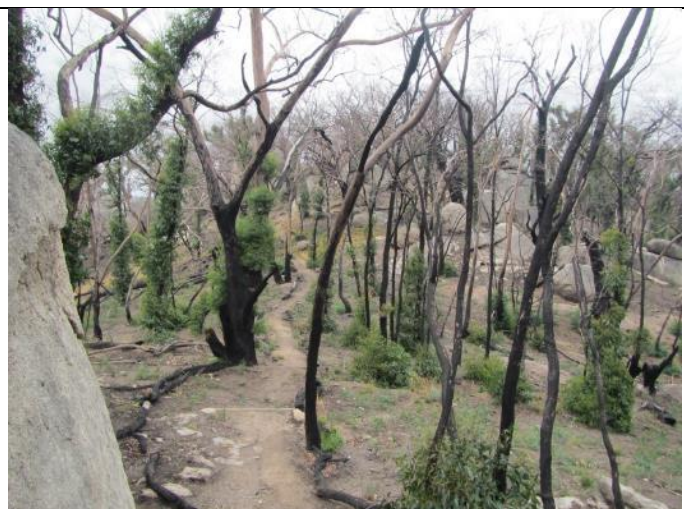
Some log replacement alongside the tracks has occurred utilising burnt logs

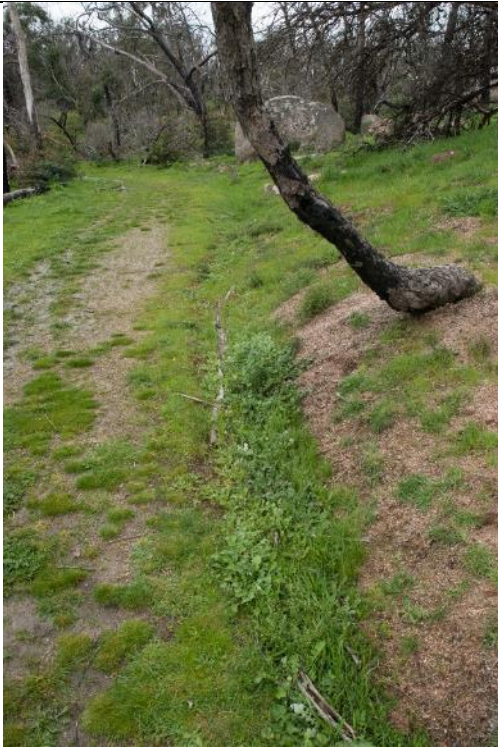
Weed infested drainage ditch (Sep 2016)

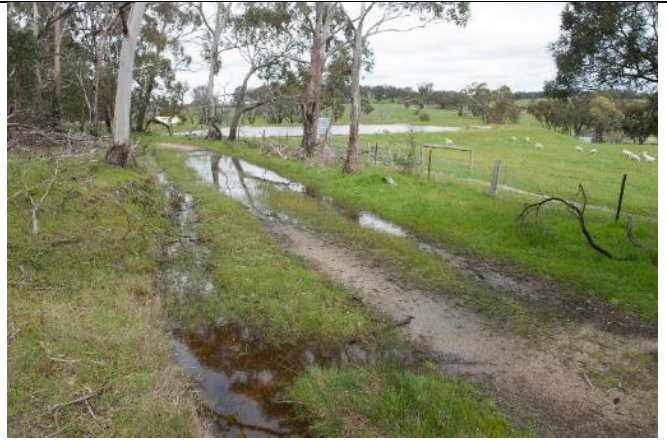
Water pooled along the Circuit Track at the south end of the reserve following high rainfall (Sep 2016)

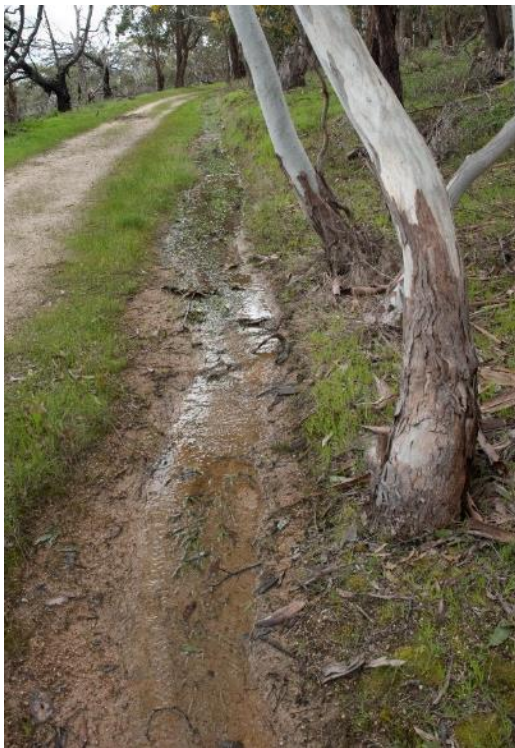
Modified drainage ditch along the Circuit Track at the south end of the reserve (Sep 2016)

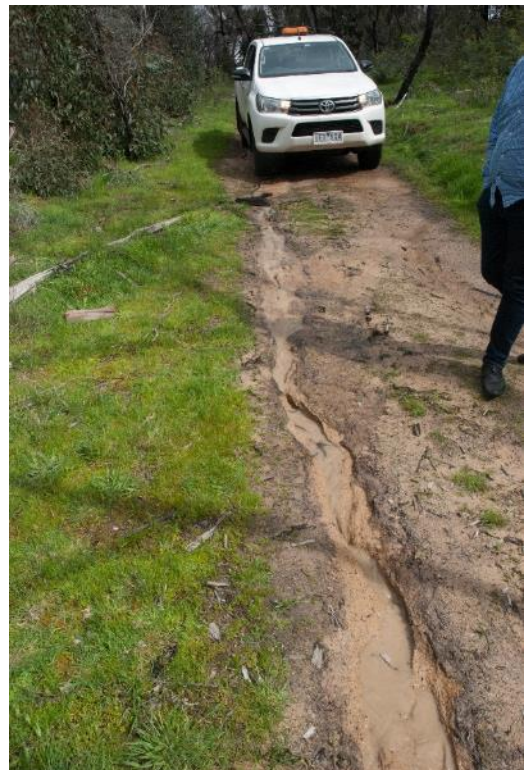
Concentrated water flows along the Circuit Track (Sep 2016)

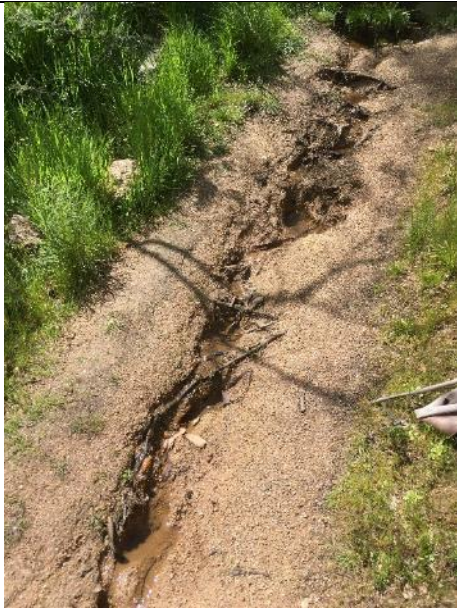
Erosion along Ridge Track, near the intersection with the Revegetation Track

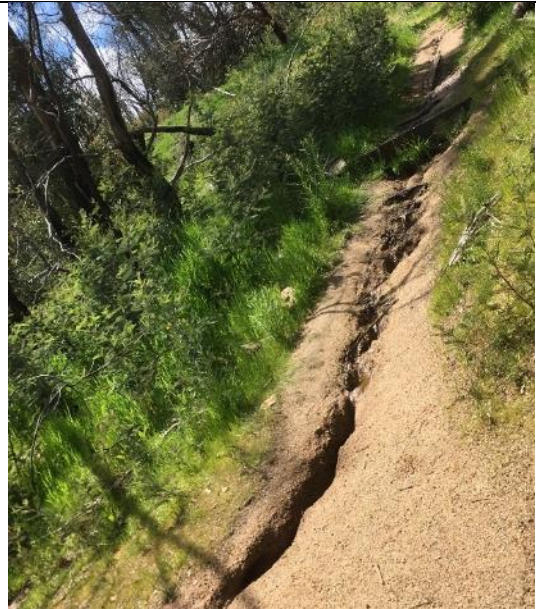
Erosion along Ridge Track, near the intersection with the Revegetation Track

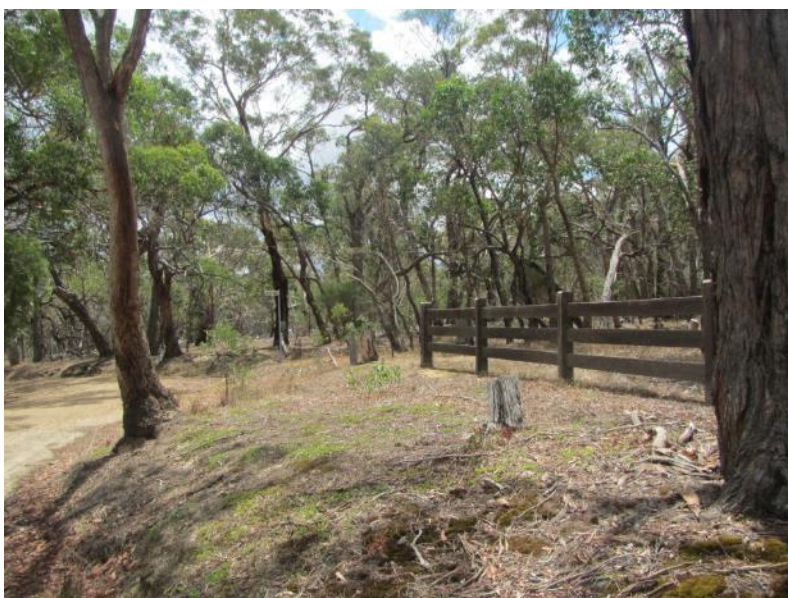
Post and rail fence could be continued to the road sign, for fencing consistency at the entrance to the reserve

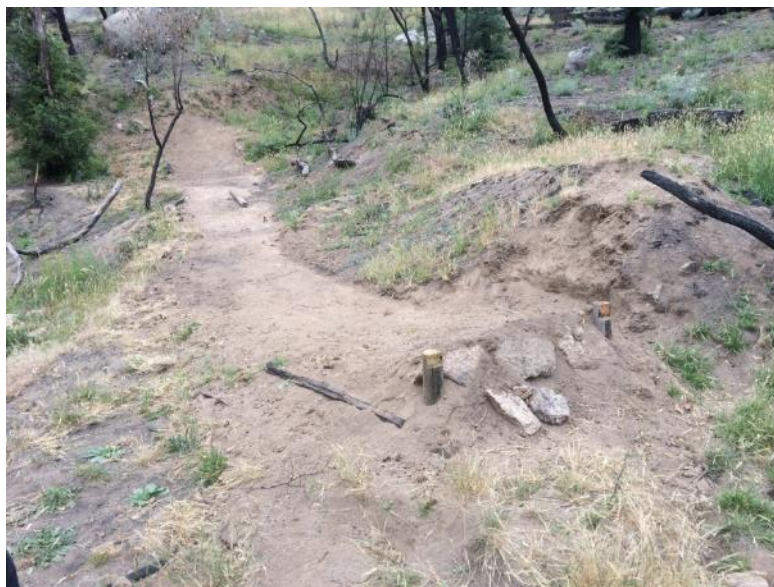
Section of mountain bike track (Provided by W Terry)

Mountain bike riding does damage bushland, especially when tracks and jumps are created. Mountain bike riders sharing tracks is also dangerous for the other users. As mountain bike riders can go off track, they would cause damage to ground storey vegetation and the fragile soils of Black Hill. It is recommended that mountain bike riding be prohibited at Black Hill reserve.

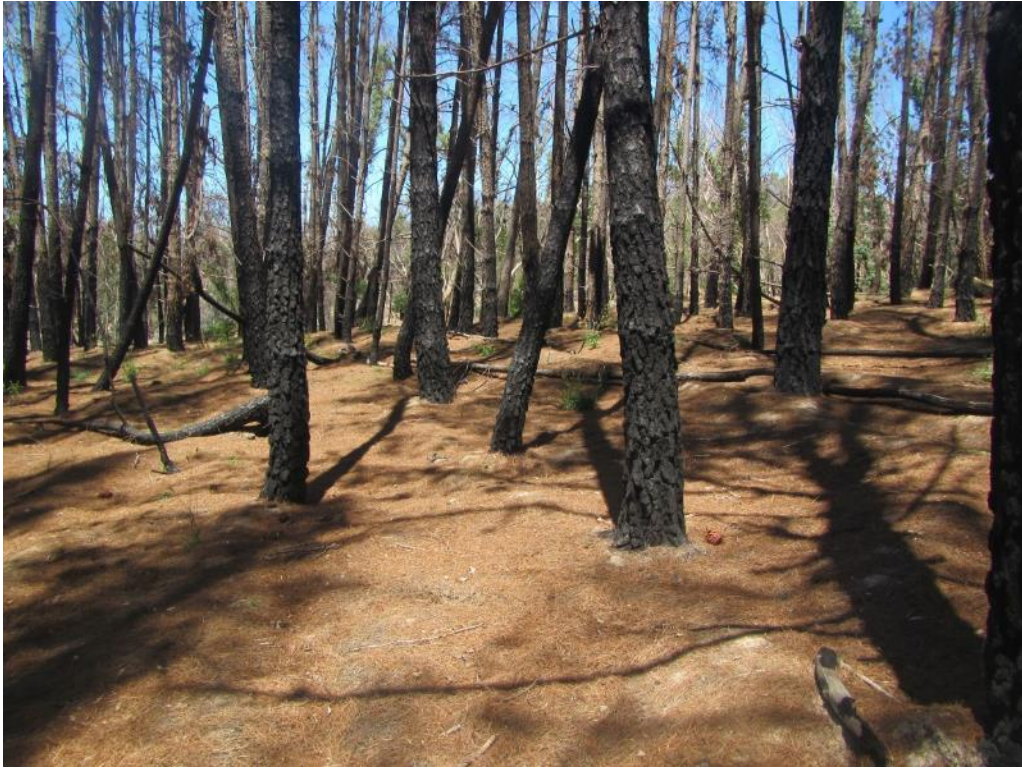
There is currently a conundrum regarding how to manage the plantation. Since the bushfire many logs within the plantation have fallen over, and it is likely all the burnt trees will fall in the next 10 or so years. After the burnt trees have fallen over, it is probable that the remaining trees will decline (there is evidence some are already declining) and also fall.

The pine plantation

The main issue with the pine plantation is whether to leave the trees to naturally fall over in the next 5–20 years, or whether to intervene and remove the hazards. The latter option is resource intensive and would require a plan to be prepared for the area. As there are some remnant larger eucalypts and smaller trees/shrubs growing around the plantation, these also need to be considered in any future plans for the area.

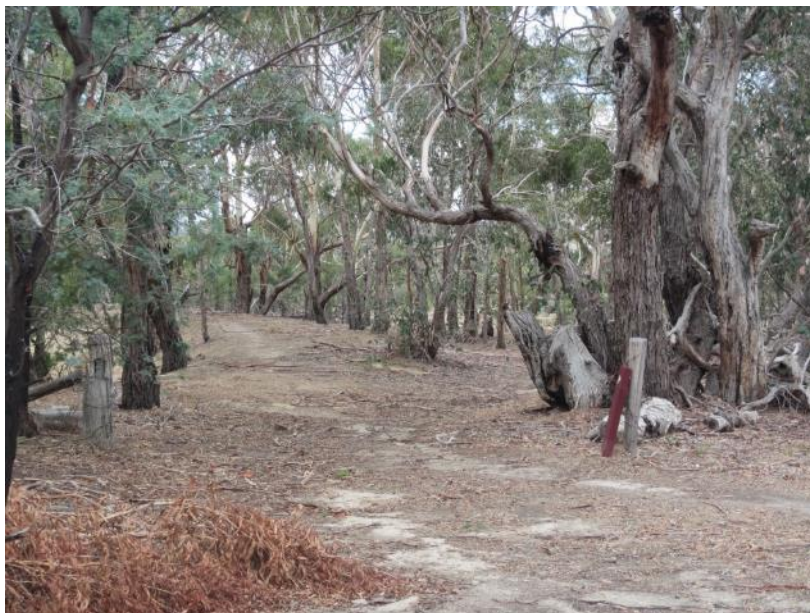
Opening along western perimeter fence between the reserve and an adjacent property

There should be no private access into the reserve, unless for fire track maintenance purposes.
