**Response to Objector Concerns - PLN/2020/165 Replacement Telecommunications Tower at 1/198 Mount Gisborne Road, Gisborne**

**Final Letter Report: Vegetation Impact Assessment – Mount Gisborne Reserve,  
Woodlands Drive, Gisborne.**

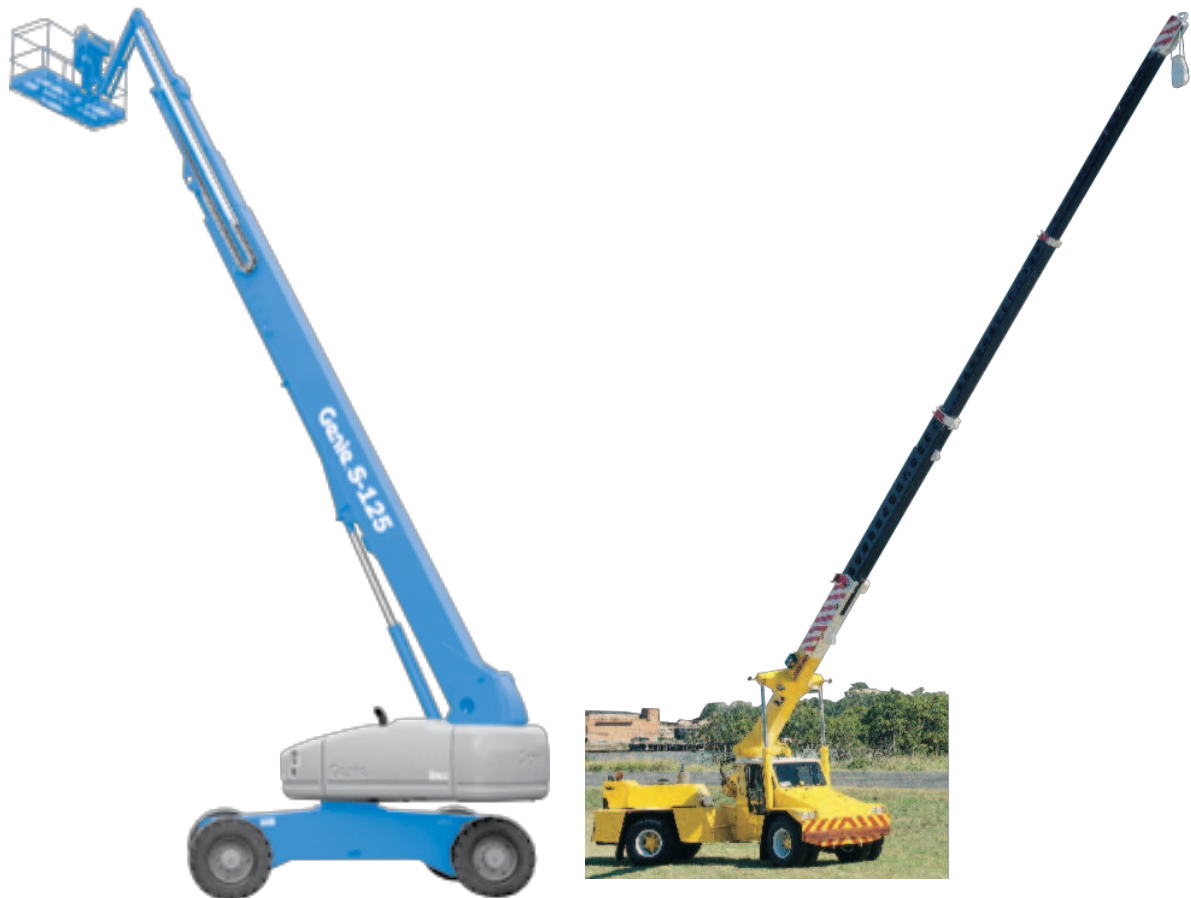
**Plate 1.** The two types of crane proposed to be used for the project

There are three key areas during the implementation of this project where there are likely to be some impacts to native vegetation. The first area is along the access track leading from Woodlands Drive to the telecommunications tower site near the summit. Two types of telescopic crane will be employed to carry out the required works. The first is a 'Self-propelled telescopic boom' (see Plate 1, below left). The length of this vehicle is 12.17 metres with the boom lowered and jib tucked under, the width is 2.49 metres when in transit with the axles retracted, and the height when in transit is 3.1 metres. The second crane is an 18 tonne crane (see Plate 1, below right) where the length of the vehicle is 9.7 metres, the width is 2.5 metres and the height in transit is 3.1 metres. Both vehicles were selected based on their compact nature as well their ability to carry out the works on this type of terrain (Western Water, pers.comm.).

- The 18 tonne crane used to transport equipment and materials to the summit will ascend and descend the mountain twice, as the monopole (part of the new tower) is in two pieces. The telescopic boom crane will ascend and descend only once to carry out the tower installation. Only the minimum number of trips to carry out the works required will be undertaken.

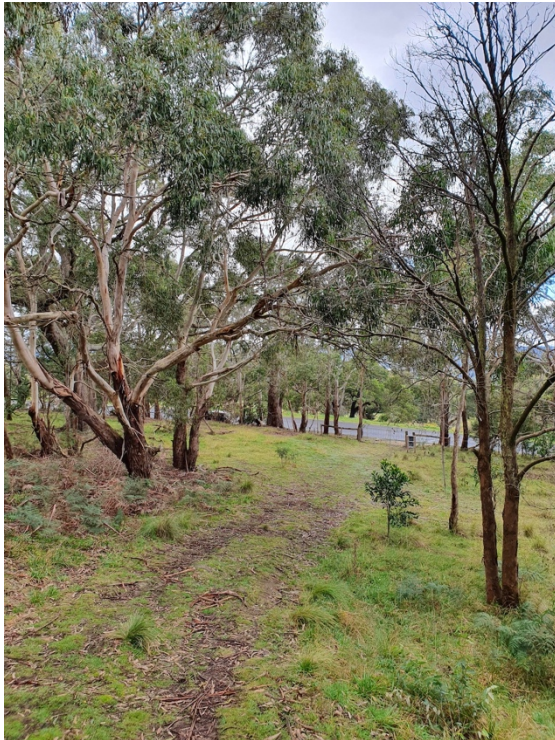
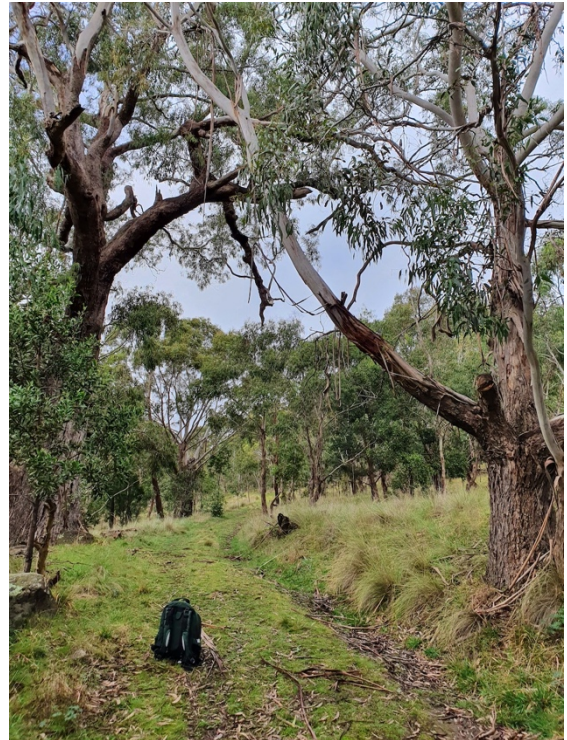
**Plate 3.** Left- eucalypt limb crossing over above access road, looking towards entrance gate; right- the same tree looking up towards summit

One area in particular at the base of the mountain approximately 30 metres from the entrance gate will require more intensive supervision and management. A low eucalypt limb here partially crosses over the access road. The limb crosses over the centre of the access road at a height of 4 metres, which is well clear of the height of the cranes; however the limb is 2.5 metres above the edge of the access road (see Plate 3). As the cranes' widths narrow higher up where their booms are stowed, it's been deemed that this limb can be cleared with micro-siting and careful management on the days of crane entry into the reserve (see mitigation measures below).

- It is recommended that a spotter and representative from Council be present when the cranes are ascending and descending the access track. Careful navigation of

the cranes will assist in reducing damage to soils and adjacent native vegetation. With instruction from a nearby spotter, the cranes can avoid some tree lopping and native grass compaction.

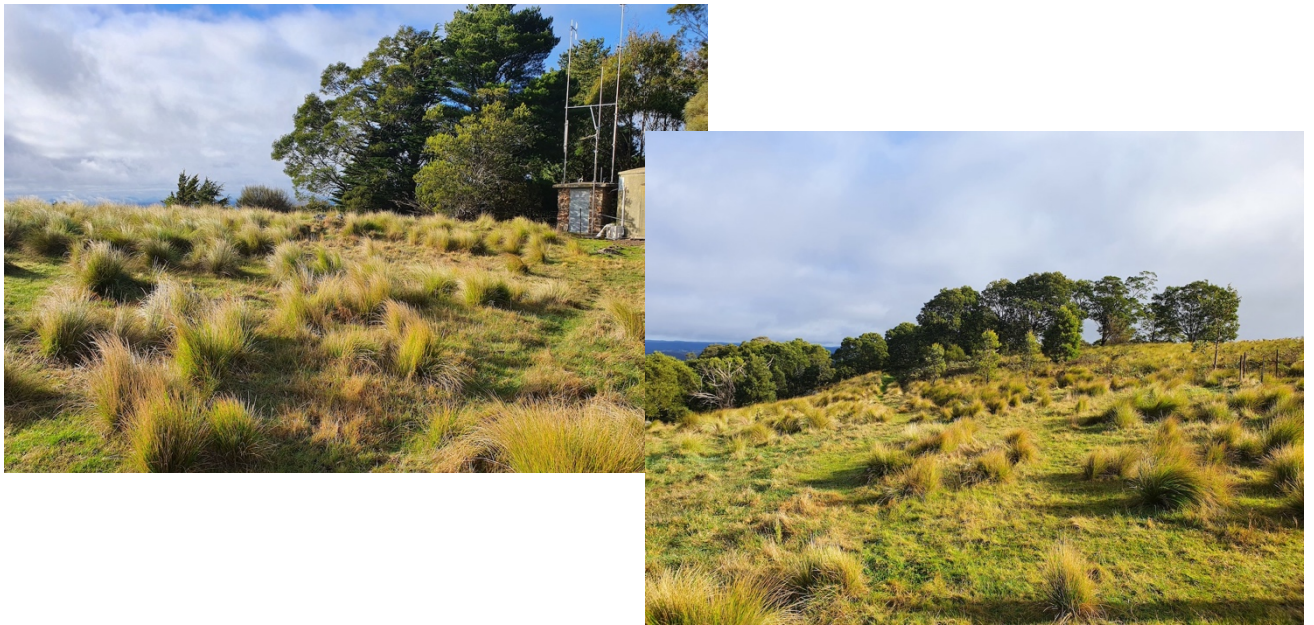
**Plate 5.** Left- View of existing infrastructure and cable route from tower site; right- marked out tower site on right with access track on the left. Proposed turning circle in foreground

The third area of impact is the area near the summit surrounding the existing tower infrastructure. Native vegetation here will be temporarily impacted by equipment and machinery that need to use this area to install the tower. A turning circle of at least 8 metres is required at this site to allow for the movement of machinery. Tussock-grasses and some native herbs will be the main species impacted in this area (see Plate 5).

- Any damaged areas, such as the edges of the access track or turning circle, are to be re-assessed after any permitted works to address possible rehabilitation measures. These may include: cordoning off more damaged areas to avoid further disturbance from people and vehicles and to allow natural recovery, manual work within specific areas where damage has occurred (such as stabilisation of plant roots by hand, movement of soil to original location etc.), and possible re-seeding of indigenous species such as grasses where damage has occurred and where natural recovery and establishment may not be successful. These measures should be established post works through a site assessment with council or an ecologist.

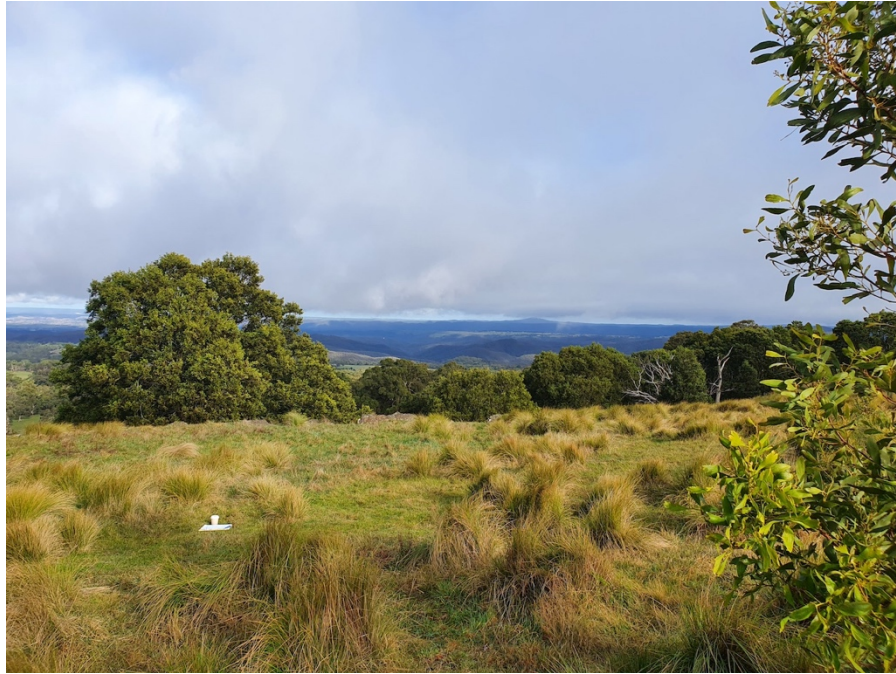
**Plate 6.** A more cleared area occurs to the south of the tower location where materials and equipment can be stored (however some *Poa* will be impacted).

- Materials and equipment storage must only be located within cordoned off areas near the tower location. To the south of the tower location there is an area more cleared of native vegetation (*Poa*) which is the best location for materials and equipment storage (Plate 6). This area should be used as much as practicable. The works area and turning circle should ideally also be delineated near the summit in order to provide a clear boundary as to where machinery and equipment can go. Temporary fencing such as orange para-webbing is recommended.
