**Planning Delegated Committee
Meeting
Under Separate Cover**

DEVELOPMENT PLAN

88A-90 Wedge Street, Kyneton

Prepared for ADTS P/L for Jasper Family Trust | July 2022 | Ref: 13263

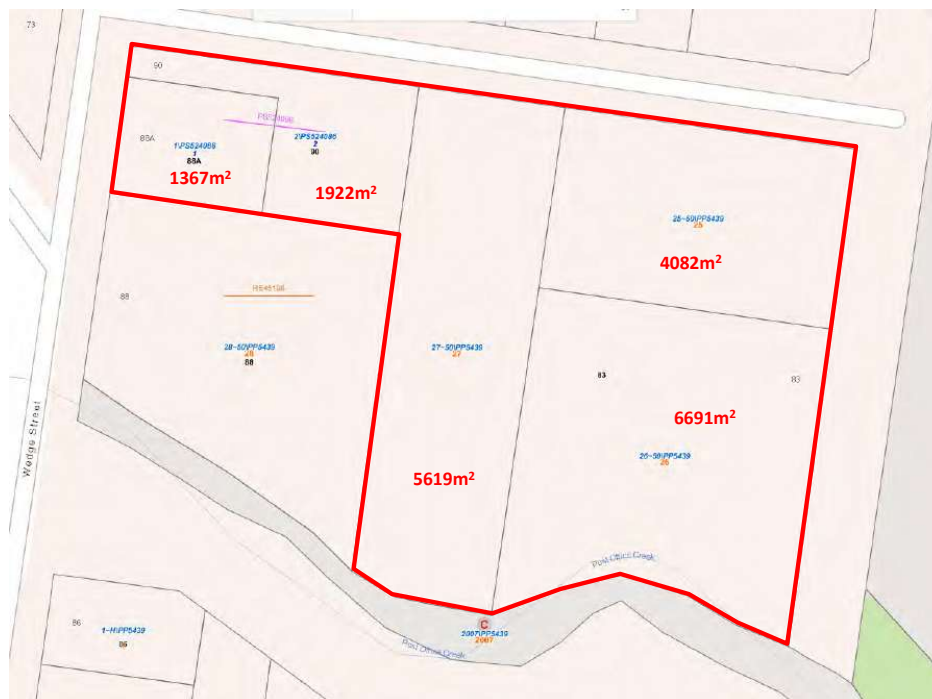
Figure 1 – Subject site and title parcels.

The site comprises of five (5) parcels measuring a total of approximately 1.97ha – See Figure 1.

The subject land is bounded by Wedge Street to the West, an unnamed road reserve to the North, an undeveloped portion of the Powlett Street road reserve adjoins the site's Eastern frontage, Post Office Creek bounds the southernmost portion of the site.

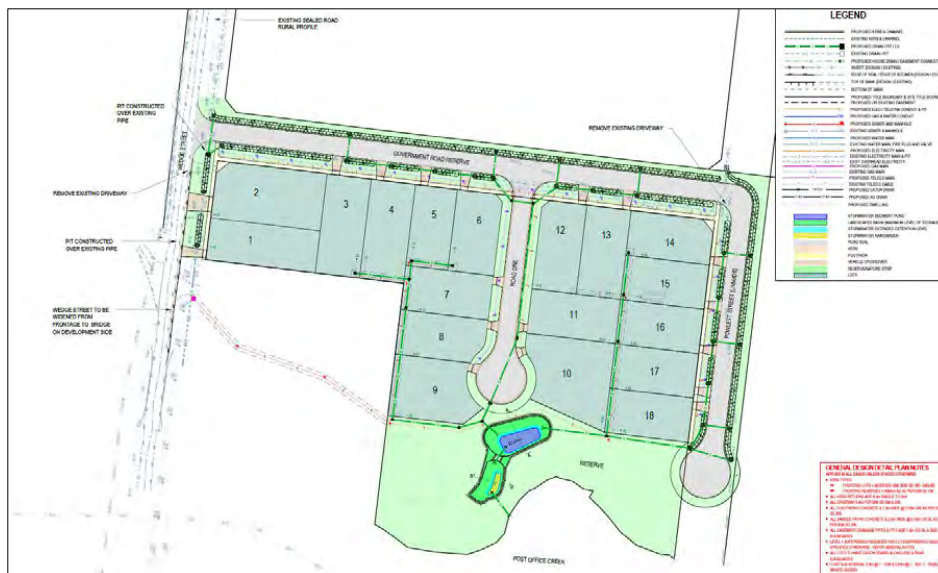
Figure 4: Proposed Layout and access design.

This Development Plan has been prepared to enable an application for the future subdivision of the subject land into Eighteen (18) lots and includes all of the associated requirements of DP017 for approval of a Development Plan. The Development Plan depicts and informs the future lot layout for a future planning application. See Appendix 6 for proposed layout.

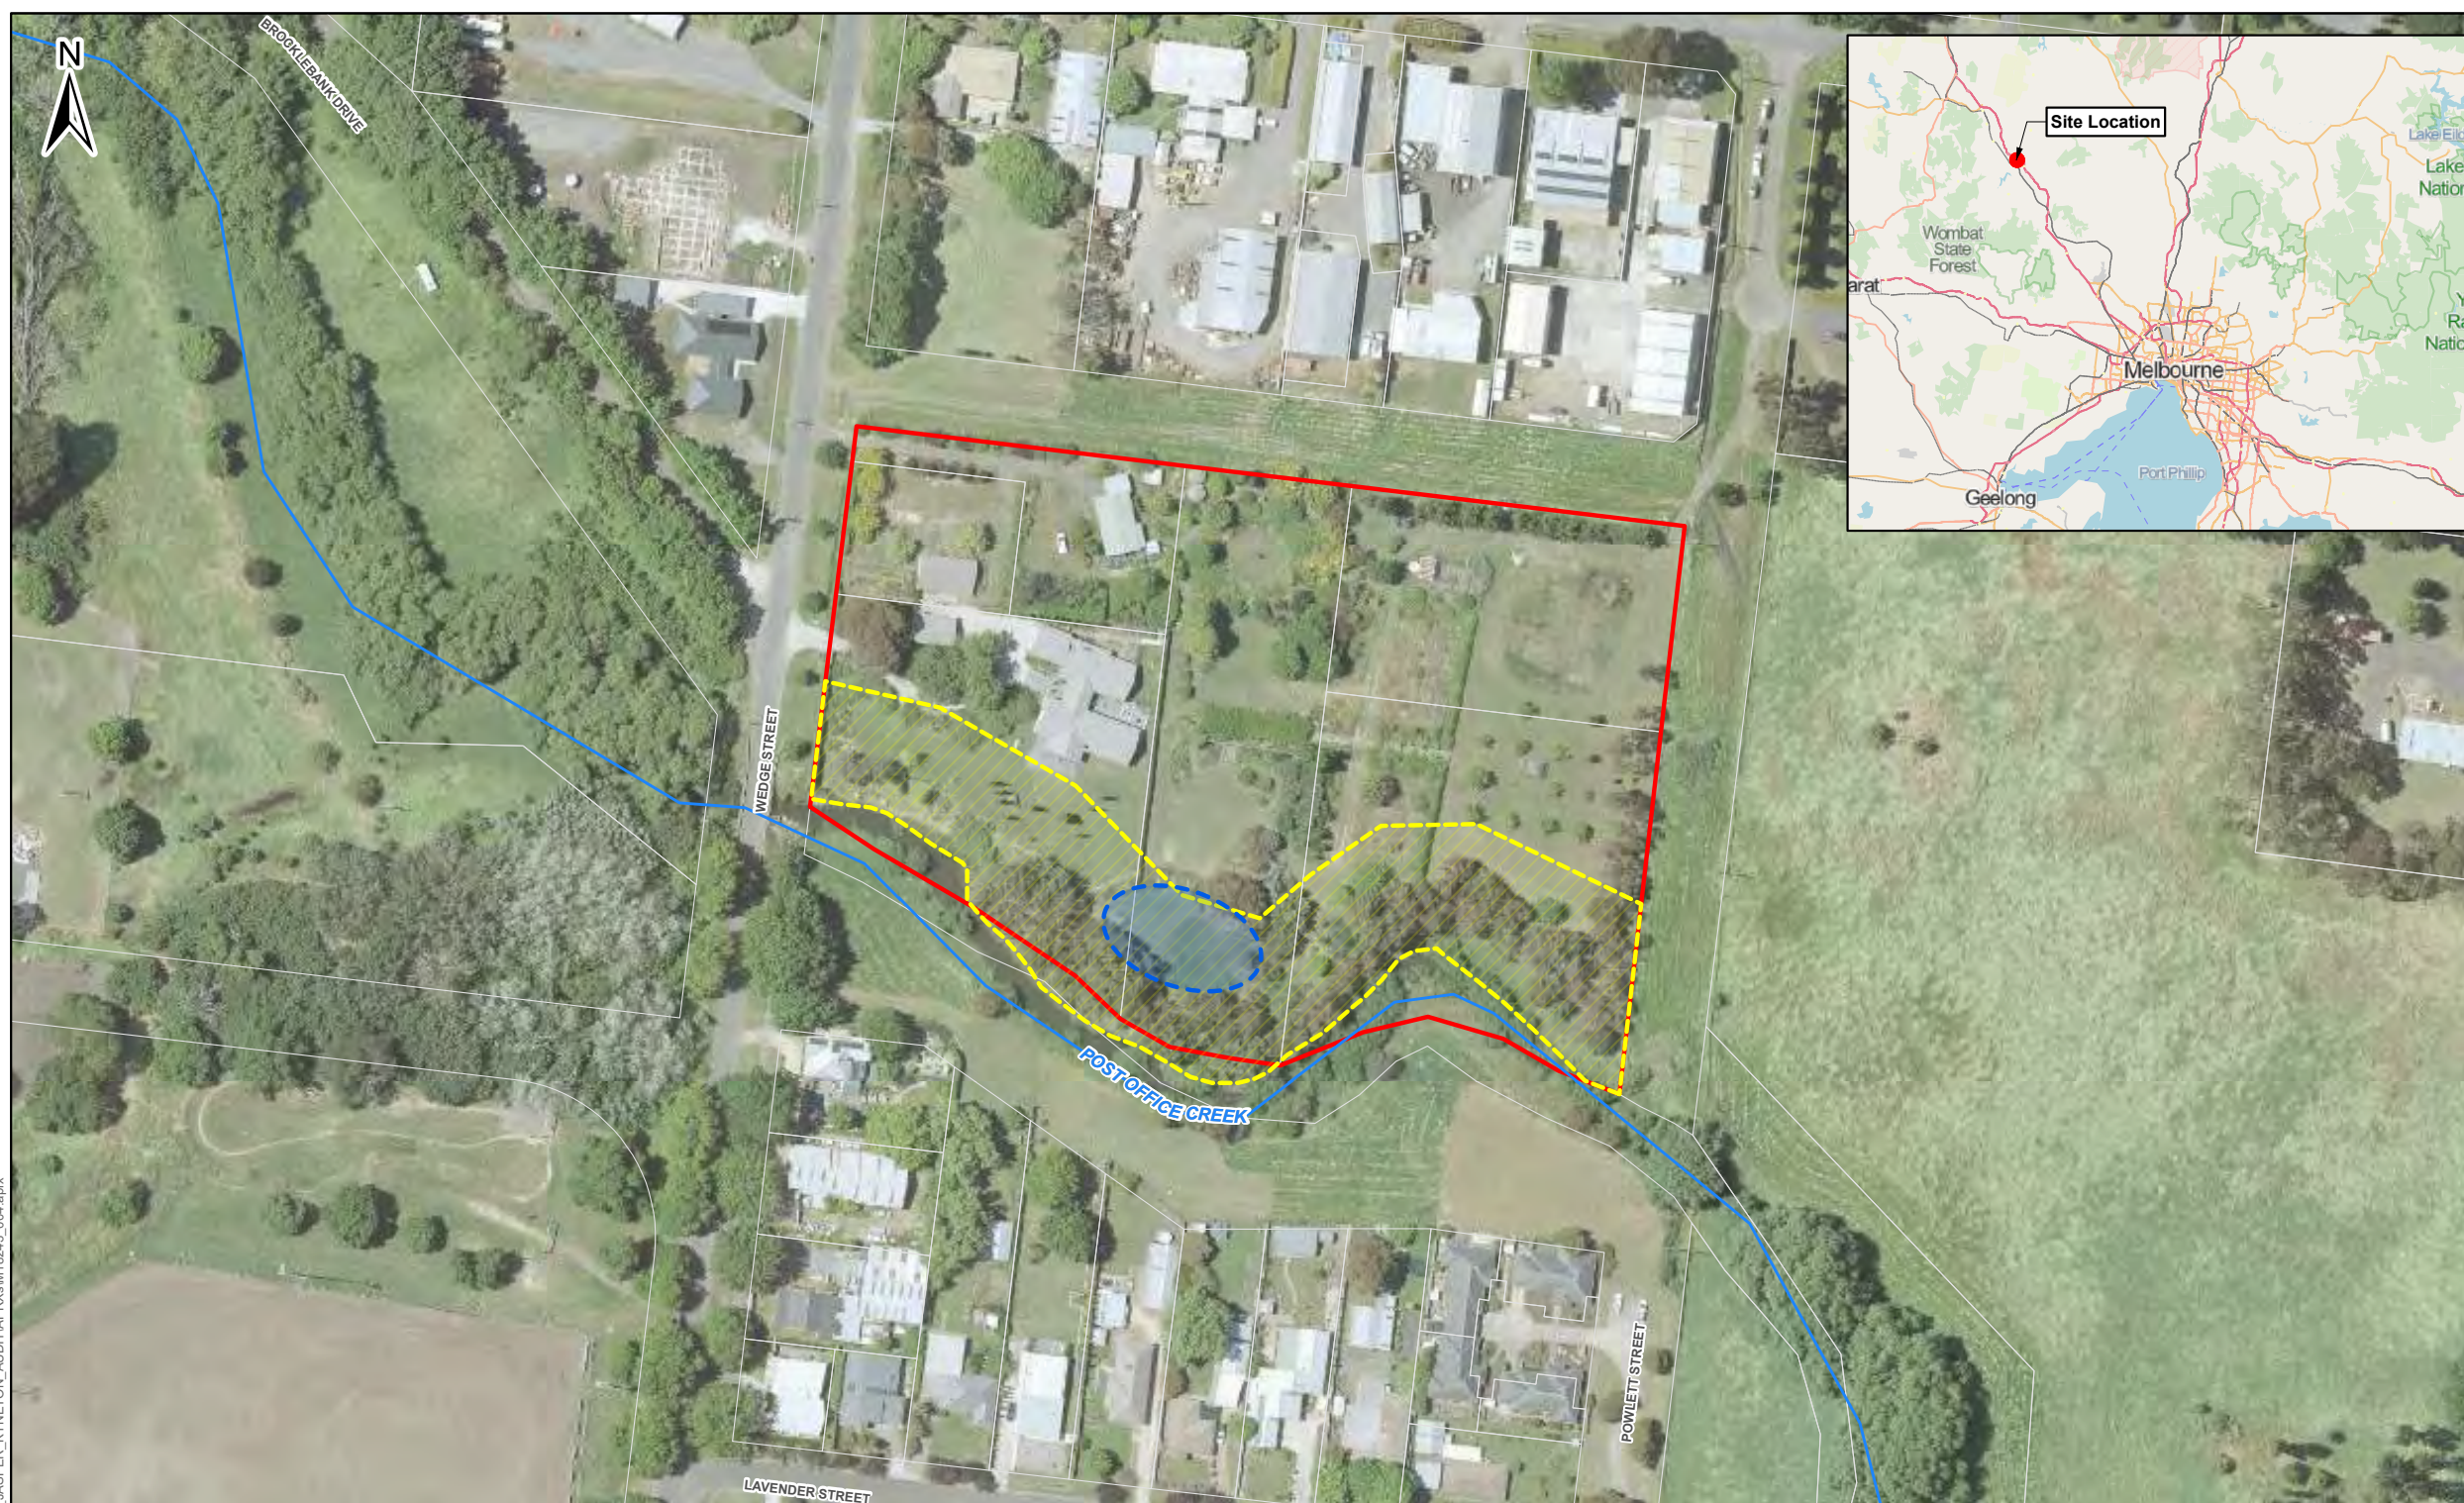
Figure 4: Groundwater Contamination

Table 5-7 and **Figure 4** summarise groundwater indicators reported at concentrations exceeding adopted objectives (screening levels) for relevant environmental values of groundwater, based on the groundwater sampling event (October 2021). The data and adopted objectives are also detailed in **Table 3** (within 'Tables' section at end of this report).

Table 5-12 and **Figure 4** summarise surface water indicators reported at concentrations exceeding adopted objectives (screening levels) for relevant environmental values of surface water, based on the surface water sampling events (November 2020 (C1, C2) and March 2021 (CR03, CR04)). The data and adopted objectives are also detailed in **Table 3** (within the 'Tables' section at end of this report).

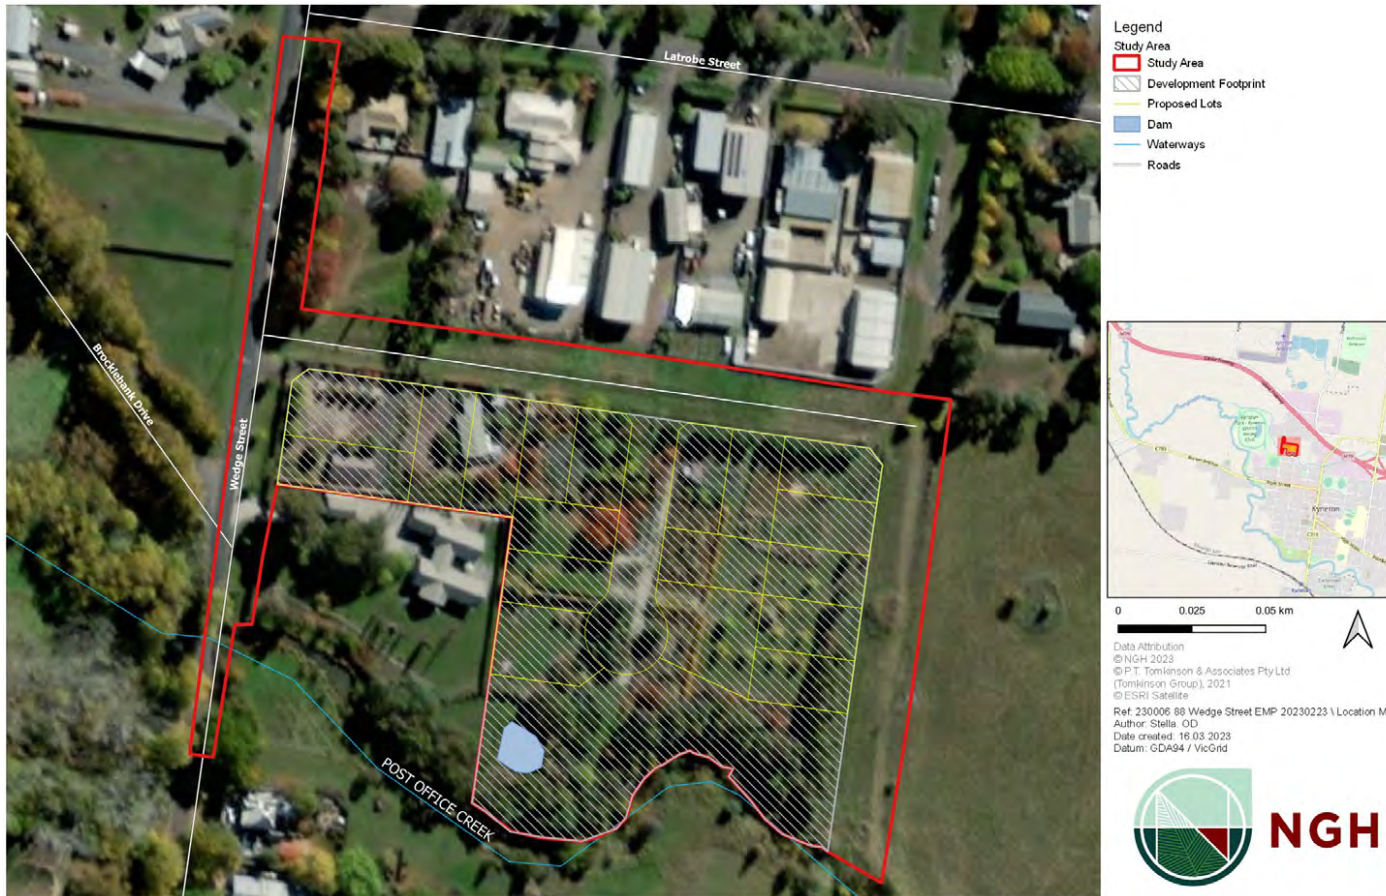
Figure 1-1 Locality Map

The Post Office Creek Reserve is located within the Campaspe River basin of the North Central Catchment Management Area (NCCMA) (North Central Catchment Management Authority, 2023). Post Office Creek joins Campaspe River to the northwest of the site. There is also a dam on site that covers 0.19 ha (Figure 1-1). The dam will be removed and reshaped as part of the subdivision stormwater management.

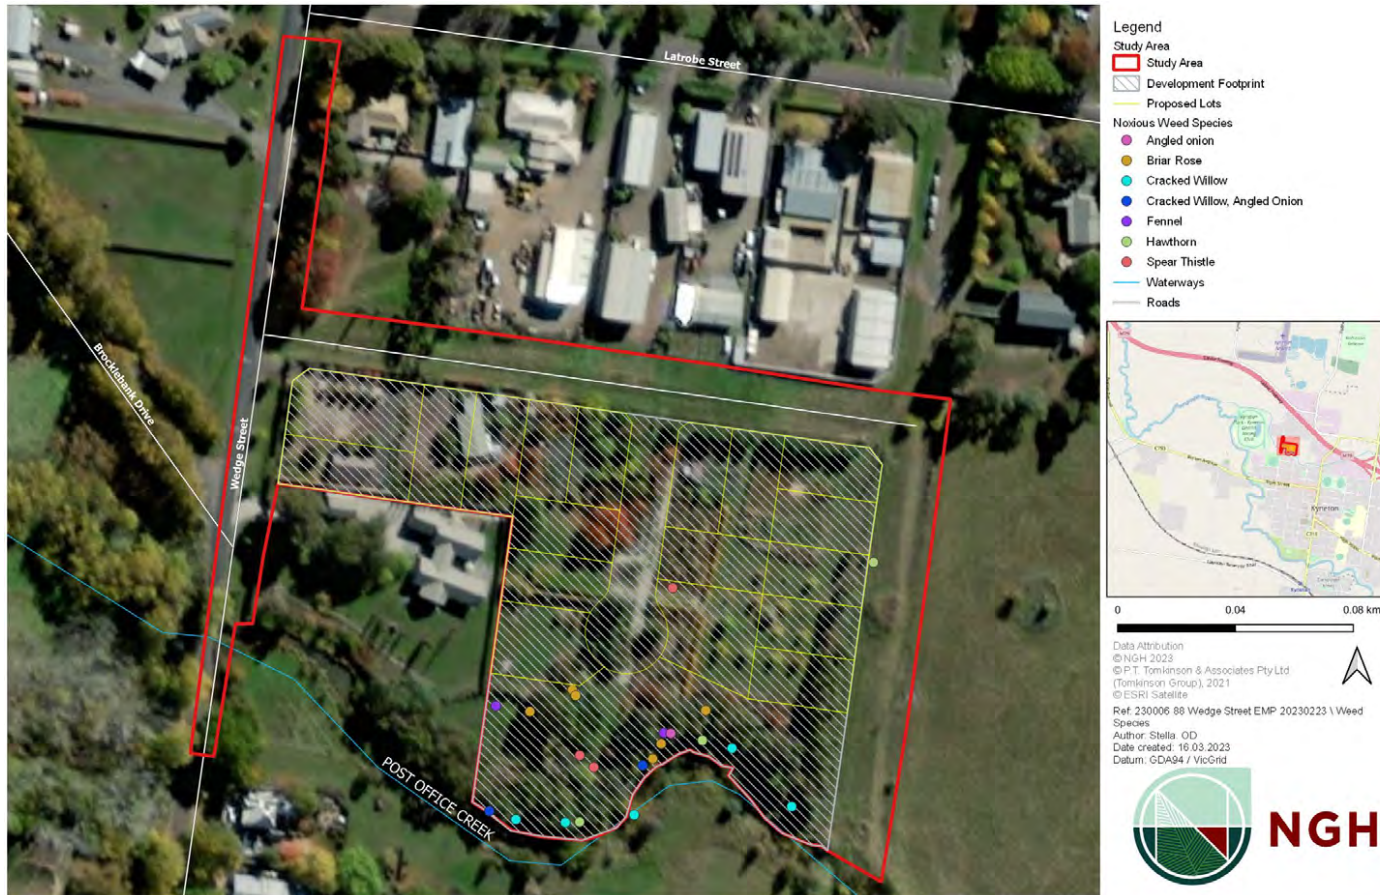
Figure 2-2 Noxious weed species in Post Office Creek Reserve

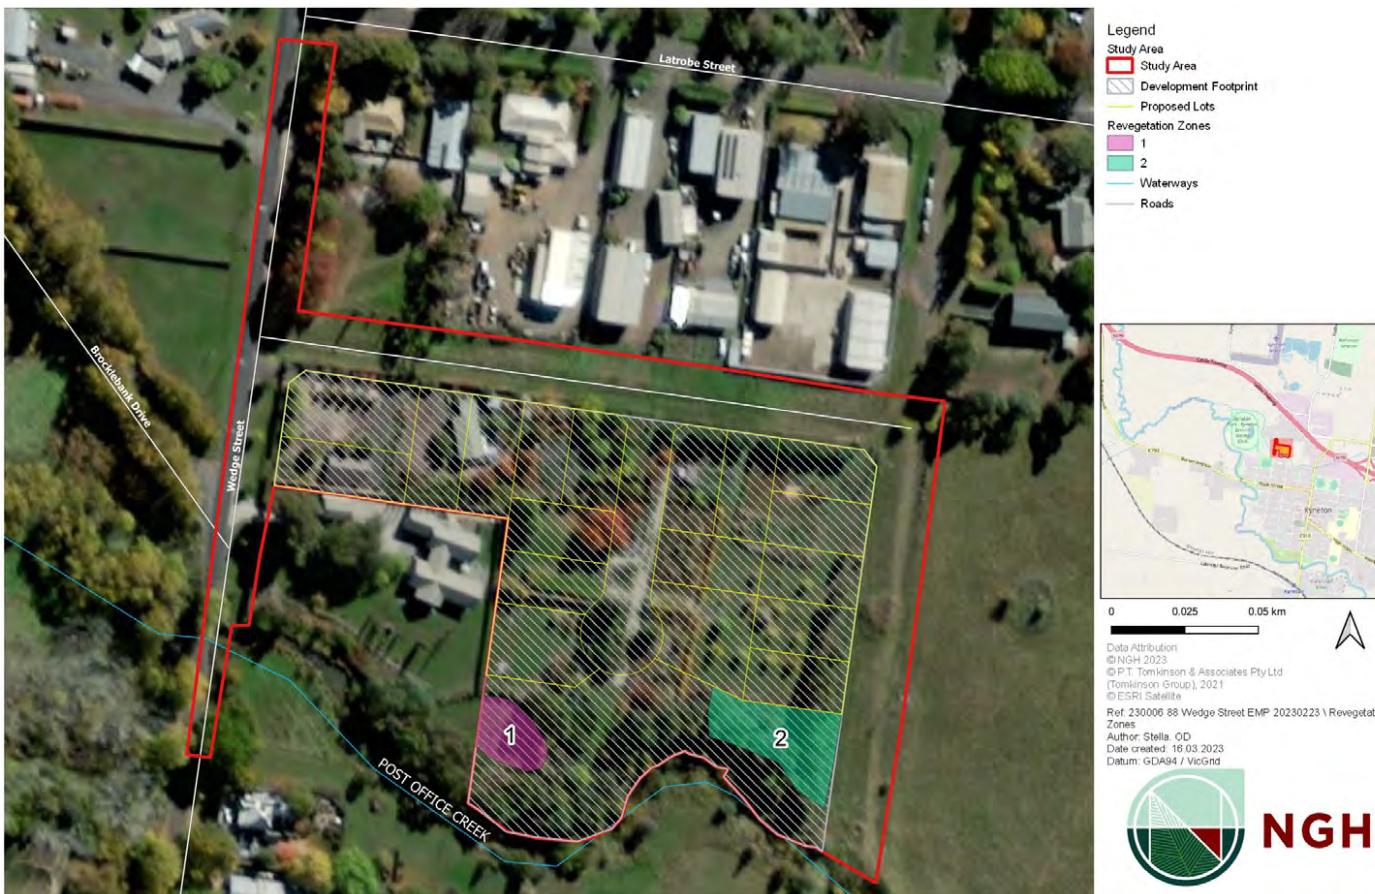
Figure 4-1 Revegetation planting zones for tree and shrub species

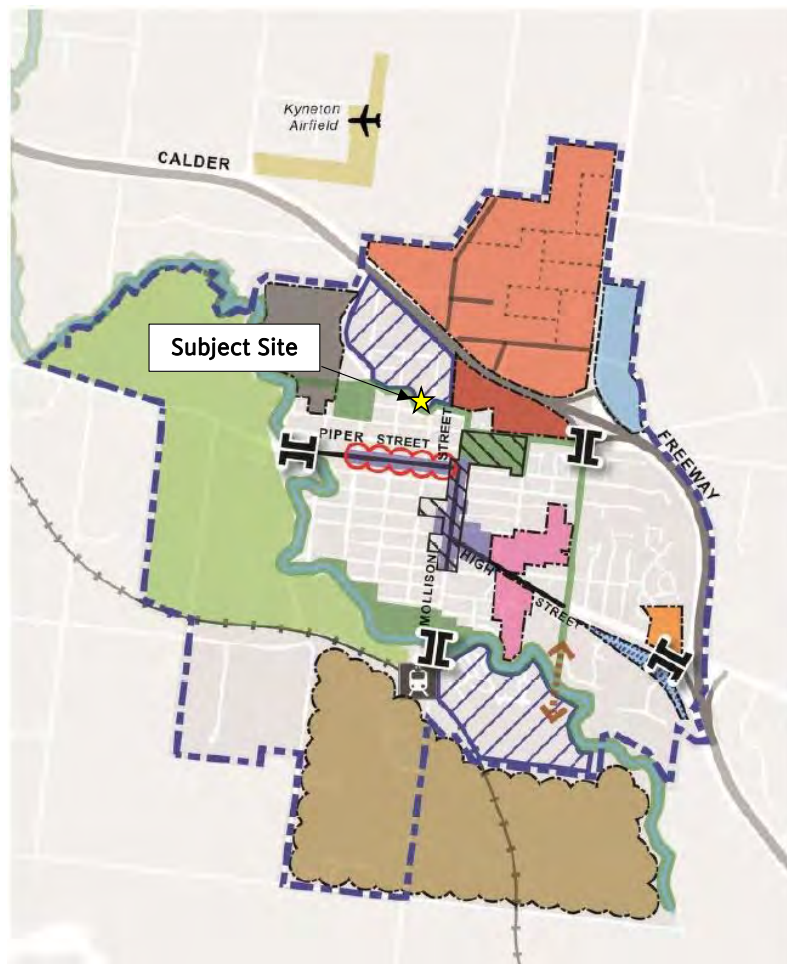
FIGURE 6: OVERALL KYNETON STRUCTURE PLAN

The Structure Plan for the precinct is provided in **Figure 6**. The subject site, which is highlighted on the plan, sits within an area earmarked for residential development, which extends north to the boundary of the Calder Freeway reserve.

The Structure Plan shows a pedestrian and bicycle link along Post Office Creek connecting to a trail along the Campaspe River to the west, and to Mollison Street and the Showgrounds to the east. While the Structure Plan does not nominate which side of Post Office Creek the trail would be provided, it would be appropriate to construct the path on the southern side given there is an existing road reserve on that side.

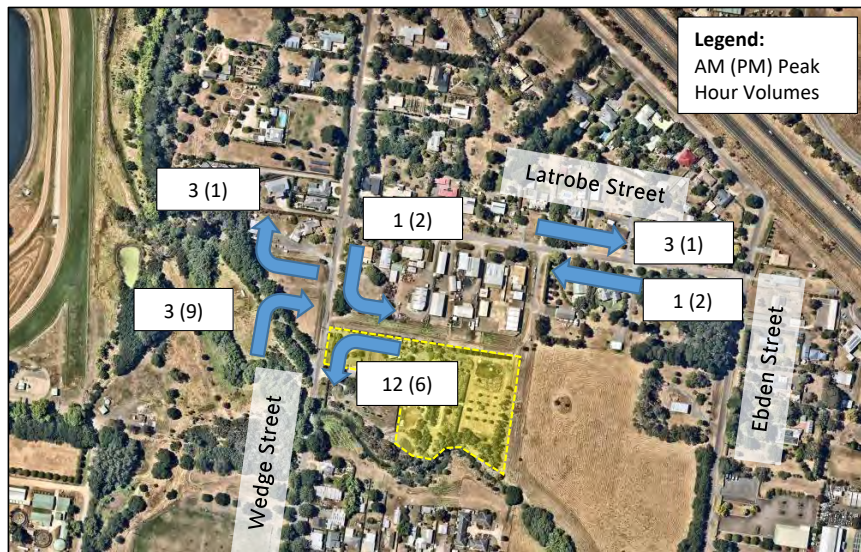
FIGURE 7: PEAK HOUR TRAFFIC DISTRIBUTION

Based on the above, the AM and PM peak hour traffic distribution to/from the proposed subdivision is shown in **Figure 7**.

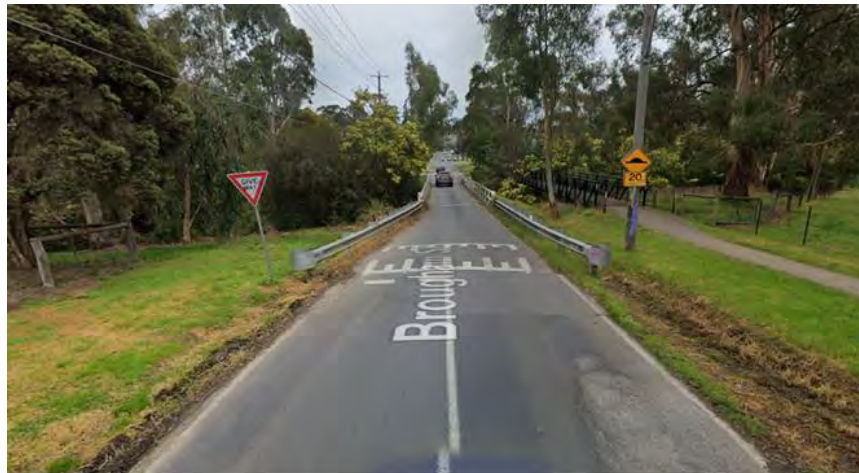
FIGURE 8: GIVE WAY ARRANGEMENT AT ONE-LANE BRIDGE – BROUGHAM STREET, ELTHAM

formalise priority. A similar arrangement is shown in **Figure 8**. Speed humps could also be provided at each end of the bridge to reduce vehicle speeds, if desired.

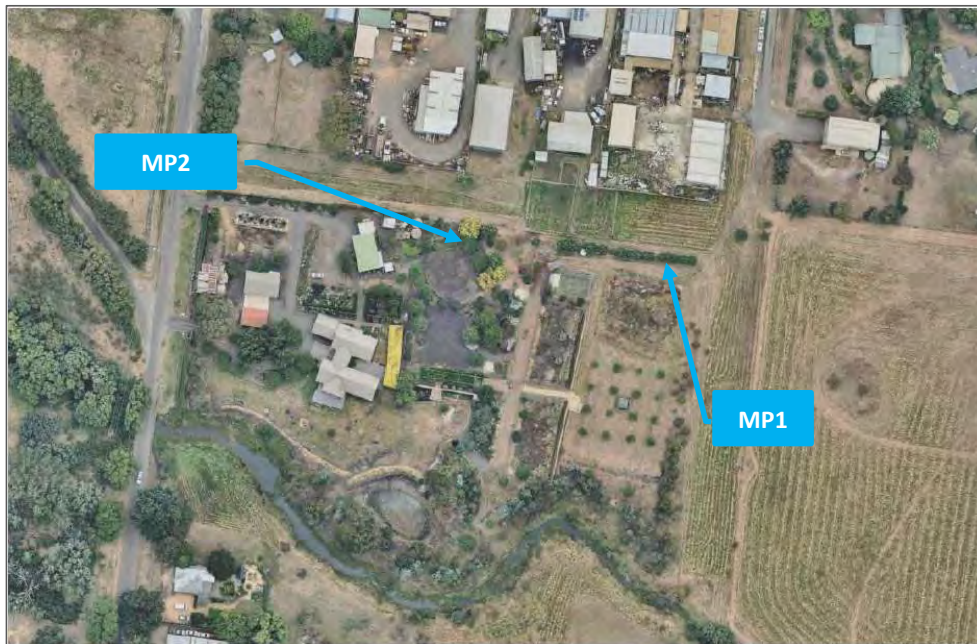
Figure 2 Location of Noise Loggers

The loggers were not within 2 m of an acoustically reflective surface and therefore require a facade adjustment of +2.5 dB as per AS 1055 - 2018 Acoustics - Description and measurement of environmental noise. The raw data is presented in the subsections below.

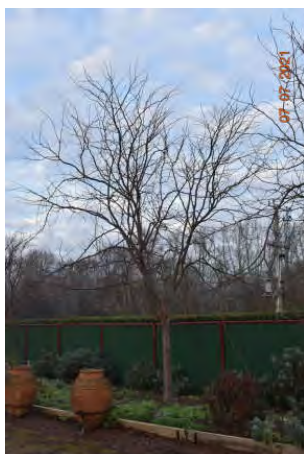
Botanical Name: *Gleditsia triacanthos*
Common Name: Honey Locust
Origin: Exotic
Tree Age: Semi mature
H x W: 6m x 4m
Health: Good
Structure: Fair
ULE: 20+ years
Retention Value: Medium
Defects: Decay in main stem
Comments: Evidence of previous branch failure

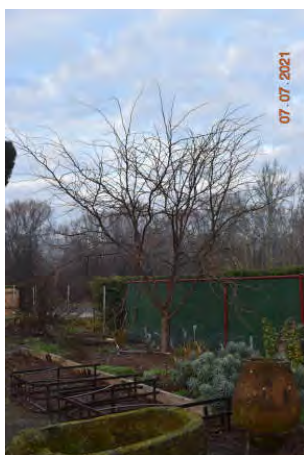
Botanical Name: *Gleditsia triacanthos*
Common Name: Honey Locust
Origin: Exotic
Tree Age: Semi mature
H x W: 6m x 4m
Health: Good
Structure: Fair
ULE: 20+ years
Retention Value: Medium
Defects: None
Comments: Evidence of previous branch failure

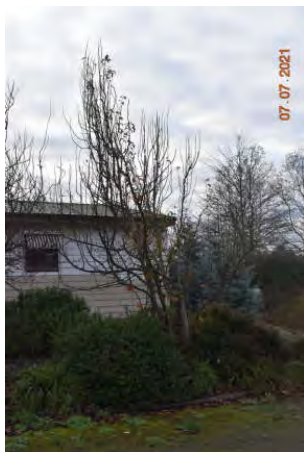
Tree Number: 13

Botanical Name: *Pyrus calleryana*
Common Name: Callery Pear
Origin: Exotic
Tree Age: Semi mature
H x W: 6m x 5m
Health: Fair
Structure: Very poor
ULE: 1-5 years
Retention Value: Low
Defects: Lopped, decayed main stem

DBH (cm):	9
TPZ (m):	2
SRZ (m):	1.65

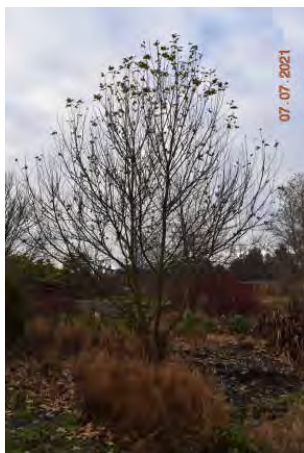
Tree Number: 21

Botanical Name: *Platanus Xacerifolia*
Common Name: London Plane
Origin: Exotic
Tree Age: Semi mature
H x W: 6m x 4m
Health: Good
Structure: Fair
ULE: 20+ years
Retention Value: Medium
Defects: Codominant stems with included union

DBH (cm): 13
TPZ (m): 2
SRZ (m): 1.75

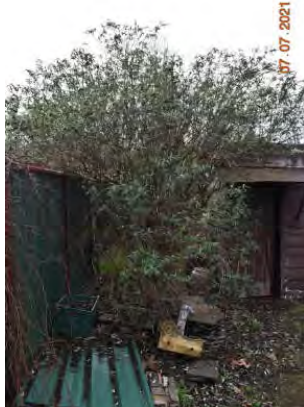
Tree Number: 22

Botanical Name: *Buddleja davidii*
Common Name: Butterfly Bush
Origin: Exotic
Tree Age: Semi mature
H x W: 4m x 4m
Health: Good
Structure: Fair
ULE: 10-20 years
Retention Value: Low
Defects: None

DBH (cm): 10
TPZ (m): 2
SRZ (m): 1.94

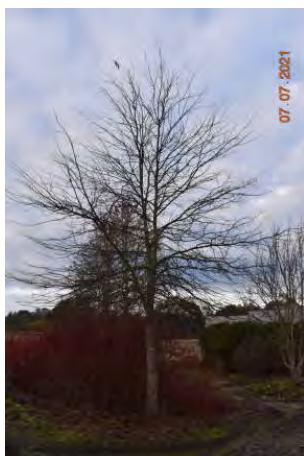
Botanical Name: *Quercus palustris*
Common Name: Pin Oak
Origin: Exotic
Tree Age: Semi mature
H x W: 11m x 5m
Health: Good
Structure: Fair
ULE: 20+ years
Retention Value: Medium
Defects: Codominant stems with included union

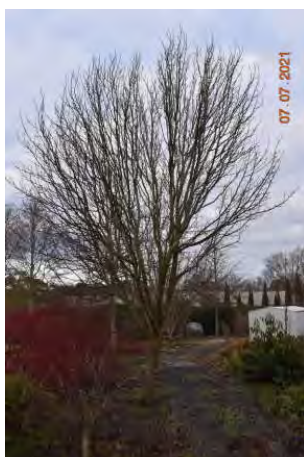
Botanical Name: *Pyrus calleryana*
Common Name: Callery Pear
Origin: Exotic
Tree Age: Semi mature
H x W: 7m x 5m
Health: Good
Structure: Fair
ULE: 20+ years
Retention Value: Medium
Defects: Leaning main stem

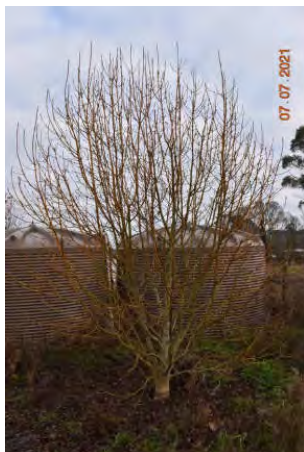
Tree Number: 25

Botanical Name: *Fraxinus excelsior 'Aurea'*
Common Name: Golden Ash
Origin: Exotic
Tree Age: Semi mature
H x W: 5m x 3m
Health: Good
Structure: Good
ULE: 20+ years
Retention Value: Low
Defects: None

DBH (cm): 7
TPZ (m): 2
SRZ (m): 1.53

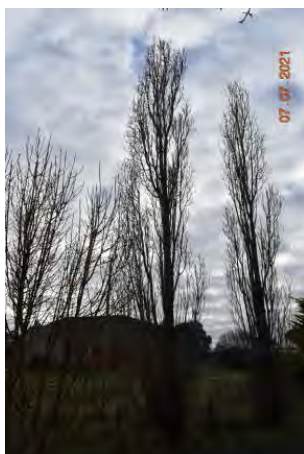
Tree Number: 26

Botanical Name: *Populus nigra 'Italica'*
Common Name: Lombardy Poplar
Origin: Exotic
Tree Age: Semi mature
H x W: 11m x 2m
Health: Good
Structure: Fair
ULE: 20+ years
Retention Value: Medium
Defects: None

DBH (cm): 21
TPZ (m): 2.52
SRZ (m): 2.39

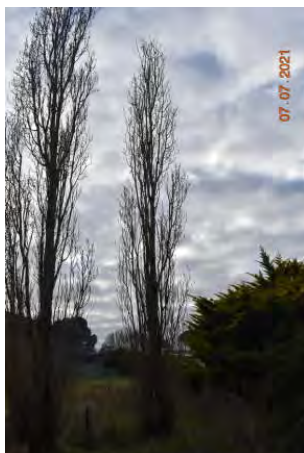
Tree Number: 27

Botanical Name: *Populus nigra 'Italica'*
Common Name: Lombardy Poplar
Origin: Exotic
Tree Age: Semi mature
H x W: 10m x 2m
Health: Good
Structure: Fair
ULE: 20+ years
Retention Value: Medium
Defects: None

DBH (cm): 21
TPZ (m): 2.52
SRZ (m): 2.34

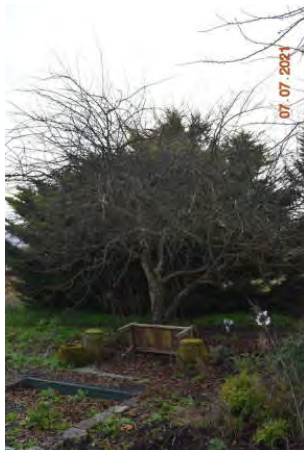
Tree Number: 28

Botanical Name: *Malus domestica*
Common Name: Apple
Origin: Exotic
Tree Age: Semi mature
H x W: 5m x 6m
Health: Good
Structure: Fair
ULE: 20+ years
Retention Value: Low
Defects: None

DBH (cm): 20
TPZ (m): 2.4
SRZ (m): 1.75

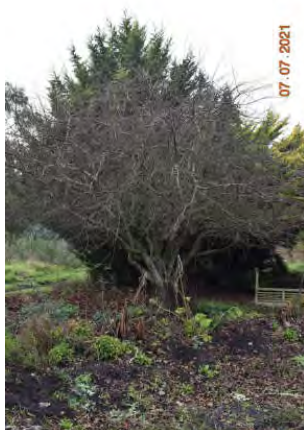
Tree Number: 29

Botanical Name: *Malus domestica*
Common Name: Apple
Origin: Exotic
Tree Age: Semi mature
H x W: 5m x 6m
Health: Good
Structure: Fair
ULE: 20+ years
Retention Value: Low
Defects: None

DBH (cm): 21
TPZ (m): 2.52
SRZ (m): 1.88

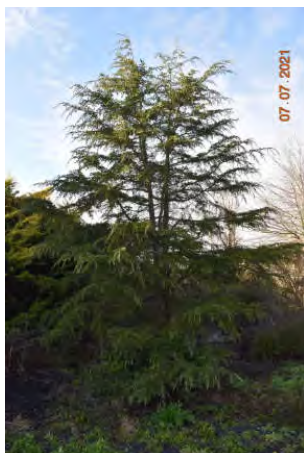
Tree Number: 30

Botanical Name: *Cedrus deodara*
Common Name: Deodar Cedar
Origin: Exotic
Tree Age: Semi mature
H x W: 6m x 3m
Health: Good
Structure: Fair
ULE: 20+ years
Retention Value: Low
Defects: Codominant stems with included union

DBH (cm): 18
TPZ (m): 2.16
SRZ (m): 1.79

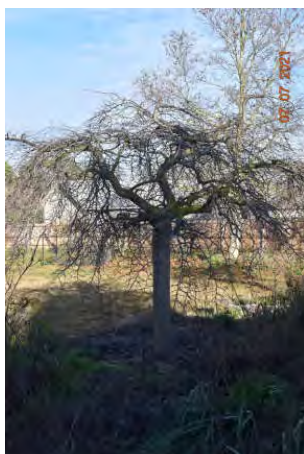
Tree Number: 32

Botanical Name: *Malus ioensis 'Plena'*
Common Name: Prairie Crabapple
Origin: Exotic
Tree Age: Semi mature
H x W: 4m x 3m
Health: Good
Structure: Good
ULE: 20+ years
Retention Value: Medium
Defects: None

DBH (cm):	21
TPZ (m):	2.52
SRZ (m):	1.91

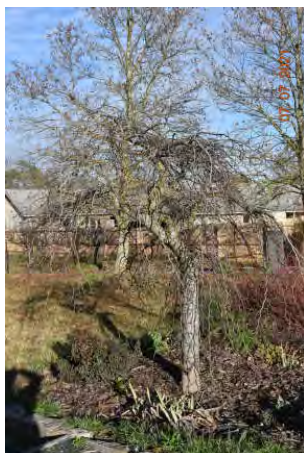
Tree Number: 33

Botanical Name: *Malus ioensis 'Plena'*
Common Name: Prairie Crabapple
Origin: Exotic
Tree Age: Semi mature
H x W: 3m x 3m
Health: Good
Structure: Good
ULE: 20+ years
Retention Value: Low
Defects: None

DBH (cm):	20
TPZ (m):	2.4
SRZ (m):	1.68

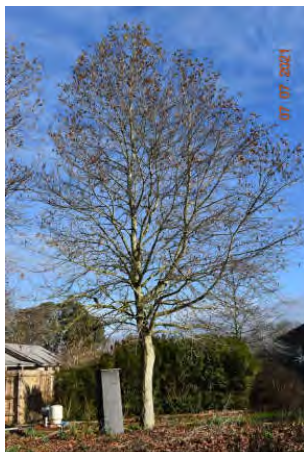
Tree Number: 34

Botanical Name: *Platanus orientalis 'Digitata'*
Common Name: Cut-leaf Plane
Origin: Exotic
Tree Age: Semi mature
H x W: 12m x 6m
Health: Good
Structure: Good
ULE: 20+ years
Retention Value: Medium
Defects: None

DBH (cm): 31
TPZ (m): 3.72
SRZ (m): 2.28

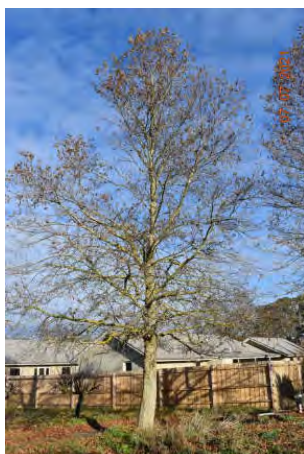
Tree Number: 35

Botanical Name: *Platanus orientalis 'Digitata'*
Common Name: Cut-leaf Plane
Origin: Exotic
Tree Age: Semi mature
H x W: 12m x 6m
Health: Good
Structure: Good
ULE: 20+ years
Retention Value: Medium
Defects: None

DBH (cm): 34
TPZ (m): 4.08
SRZ (m): 2.34

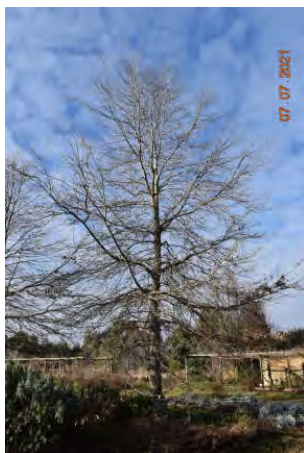
Tree Number: 36

Botanical Name: *Quercus palustris*
Common Name: Pin Oak
Origin: Exotic
Tree Age: Semi mature
H x W: 12m x 6m
Health: Good
Structure: Good
ULE: 20+ years
Retention Value: Medium
Defects: None

DBH (cm): 32
TPZ (m): 3.84
SRZ (m): 2.34

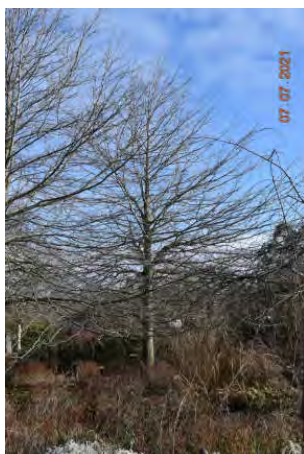
Tree Number: 38

Botanical Name: *Quercus palustris*
Common Name: Pin Oak
Origin: Exotic
Tree Age: Semi mature
H x W: 12m x 6m
Health: Good
Structure: Good
ULE: 20+ years
Retention Value: Medium
Defects: None

DBH (cm): 32
TPZ (m): 3.84
SRZ (m): 2.37

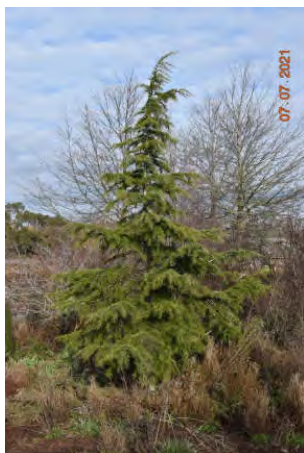
Tree Number: 39

Botanical Name: *Cedrus deodara*
Common Name: Deodar Cedar
Origin: Exotic
Tree Age: Semi mature
H x W: 4m x 1m
Health: Good
Structure: Good
ULE: 20+ years
Retention Value: Low
Defects: None

DBH (cm): 9
TPZ (m): 2
SRZ (m): 1.50

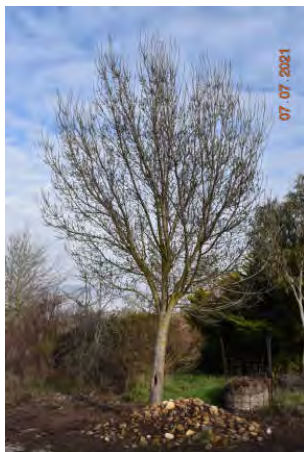
Tree Number: 40

Botanical Name: *Fraxinus oxycarpa*
Common Name: Desert Ash
Origin: Exotic
Tree Age: Semi mature
H x W: 7m x 5m
Health: Good
Structure: Good
ULE: 20+ years
Retention Value: Medium
Defects: None

DBH (cm):	21
TPZ (m):	2.52
SRZ (m):	1.82

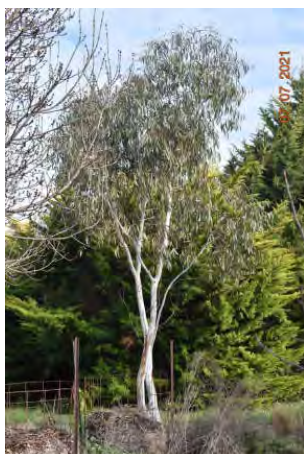
Botanical Name: *Eucalyptus pauciflora*
Common Name: Snow Gum
Origin: Indigenous
Tree Age: Semi mature
H x W: 6m x 3m
Health: Good
Structure: Fair
ULE: 20+ years
Retention Value: Medium
Defects: Codominant stems

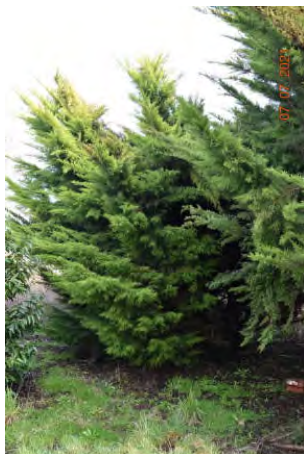
Tree Number: 43

Botanical Name: *Hesperocyparis macrocarpa*
Common Name: Monterey Cypress
Origin: Exotic
Tree Age: Semi mature
H x W: 5m x 4m
Health: Good
Structure: Fair
ULE: 20+ years
Retention Value: Medium
Defects: None

DBH (cm):	22
TPZ (m):	2.64
SRZ (m):	2.05

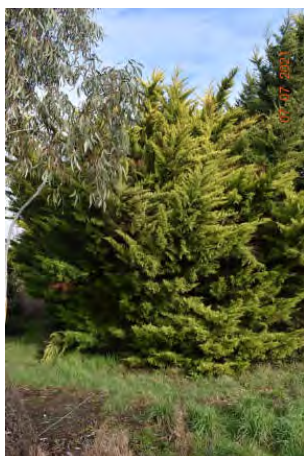
Tree Number: 44

Botanical Name: *Hesperocyparis macrocarpa*
Common Name: Monterey Cypress
Origin: Exotic
Tree Age: Semi mature
H x W: 5m x 4m
Health: Good
Structure: Fair
ULE: 20+ years
Retention Value: Medium
Defects: None

DBH (cm):	23
TPZ (m):	2.76
SRZ (m):	2.30

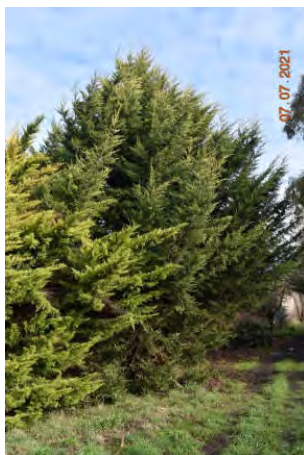
Tree Number: 45

Botanical Name: *Hesperocyparis macrocarpa*
Common Name: Monterey Cypress
Origin: Exotic
Tree Age: Semi mature
H x W: 8m x 5m
Health: Good
Structure: Fair
ULE: 20+ years
Retention Value: Medium
Defects: None

DBH (cm):	26
TPZ (m):	3.12
SRZ (m):	2.32

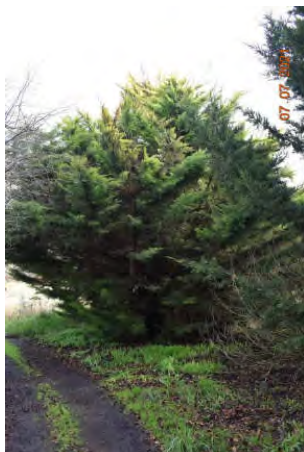
Tree Number: 46

Botanical Name: *Hesperocyparis macrocarpa*
Common Name: Monterey Cypress
Origin: Exotic
Tree Age: Semi mature
H x W: 5m x 6m
Health: Good
Structure: Fair
ULE: 20+ years
Retention Value: Medium
Defects: None

DBH (cm):	30
TPZ (m):	3.6
SRZ (m):	2.30

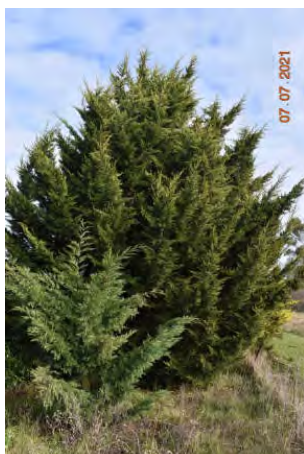
Tree Number: 47

Botanical Name: *Hesperocyparis macrocarpa*
Common Name: Monterey Cypress
Origin: Exotic
Tree Age: Semi mature
H x W: 8m x 5m
Health: Good
Structure: Fair
ULE: 20+ years
Retention Value: Medium
Defects: None

DBH (cm):	30
TPZ (m):	3.6
SRZ (m):	2.43

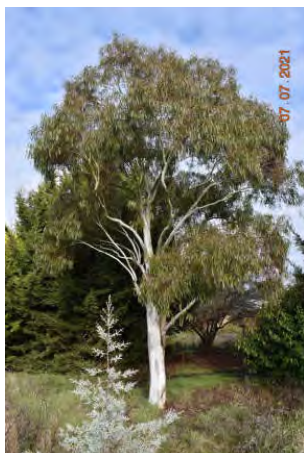
Tree Number: 48

Botanical Name: *Eucalyptus camaldulensis*
Common Name: River Red Gum
Origin: Indigenous
Tree Age: Semi mature
H x W: 7m x 4m
Health: Good
Structure: Fair
ULE: 20+ years
Retention Value: Medium
Defects: None

DBH (cm):	31
TPZ (m):	3.72
SRZ (m):	2.10

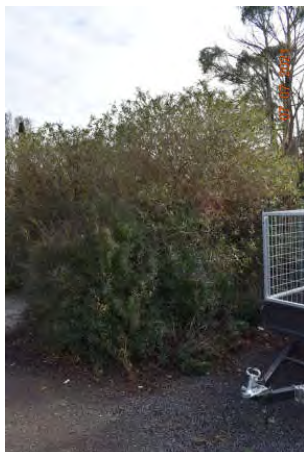
Tree Number: 49

Botanical Name: *Buddleja davidii*
Common Name: Butterfly Bush
Origin: Exotic
Tree Age: Semi mature
H x W: 3m x 3m
Health: Good
Structure: Good
ULE: 10-20 years
Retention Value: Low
Defects: None

DBH (cm): 10
TPZ (m): 2
SRZ (m): 1.50

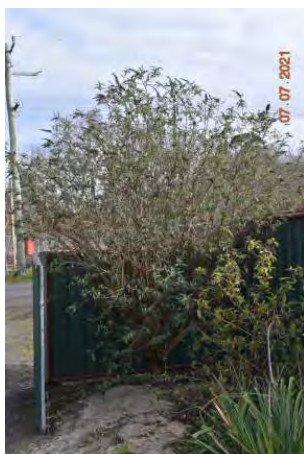
Tree Number: 50

Botanical Name: *Buddleja davidii*
Common Name: Butterfly Bush
Origin: Exotic
Tree Age: Semi mature
H x W: 2m x 2m
Health: Fair
Structure: Fair
ULE: 10-20 years
Retention Value: Low
Defects: None

DBH (cm): 3
TPZ (m): 2
SRZ (m): 1.50

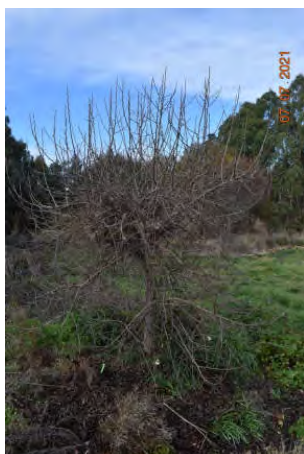
Botanical Name: *Pyrus calleryana*
Common Name: Callery Pear
Origin: Exotic
Tree Age: Semi mature
H x W: 3m x 2m
Health: Fair
Structure: Poor
ULE: 5-10 years
Retention Value: Low
Defects: Lopped main stem

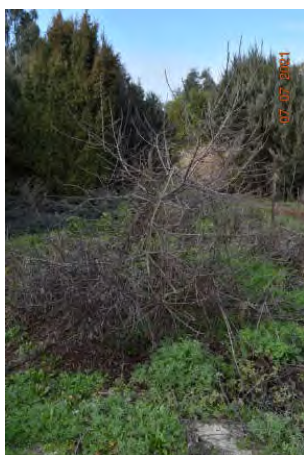
Tree Number: 54

Botanical Name: *Pyrus calleryana*
Common Name: Callery Pear
Origin: Exotic
Tree Age: Young
H x W: 2m x 2m
Health: Fair
Structure: Fair
ULE: 10-20 years
Retention Value: Low
Defects: None

DBH (cm):	3
TPZ (m):	2
SRZ (m):	1.50

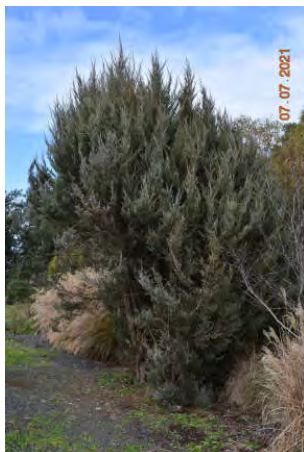
Tree Number: 55

Botanical Name: *xCupressocyparis leylandii*
Common Name: Leyland Cypress
Origin: Exotic
Tree Age: Semi mature
H x W: 5m x 3m
Health: Good
Structure: Fair
ULE: 10-20 years
Retention Value: Low
Defects: None

DBH (cm):	14
TPZ (m):	2
SRZ (m):	1.75

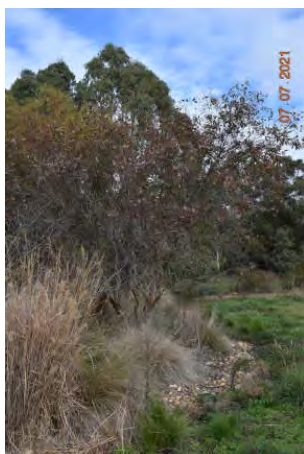
Botanical Name: *Eucalyptus leucoxylon*
Common Name: Yellow Gum
Origin: Indigenous
Tree Age: Semi mature
H x W: 5m x 4m
Health: Very Poor
Structure: Fair
ULE: 1-5 years
Retention Value: Low
Defects: None

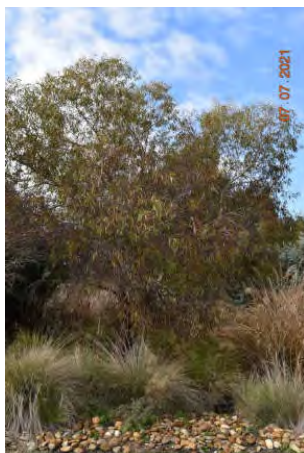
Tree Number: 57

Botanical Name: *Eucalyptus leucoxylon*
Common Name: Yellow Gum
Origin: Indigenous
Tree Age: Semi mature
H x W: 5m x 5m
Health: Good
Structure: Fair
ULE: 20+ years
Retention Value: Medium
Defects: None

DBH (cm):	22
TPZ (m):	2.64
SRZ (m):	1.94

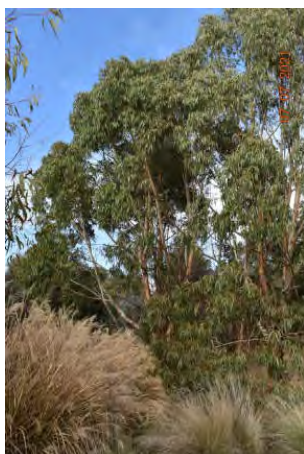
Tree Number: 59

Botanical Name: *Eucalyptus viminalis*
Common Name: Manna Gum
Origin: Indigenous
Tree Age: Semi mature
H x W: 10m x 6m
Health: Good
Structure: Good
ULE: 20+ years
Retention Value: Medium
Defects: None

DBH (cm): 38
TPZ (m): 4.56
SRZ (m): 2.34

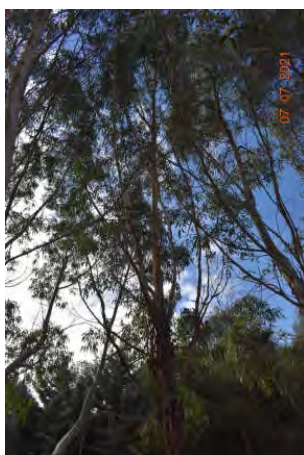
Tree Number: 60

Botanical Name: *Eucalyptus viminalis*
Common Name: Manna Gum
Origin: Indigenous
Tree Age: Semi mature
H x W: 10m x 2m
Health: Good
Structure: Fair
ULE: 20+ years
Retention Value: Medium
Defects: None

DBH (cm): 24
TPZ (m): 2.88
SRZ (m): 2.10

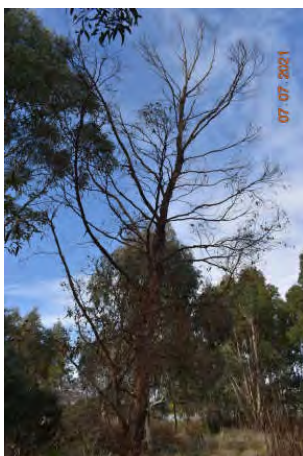
Botanical Name: *Eucalyptus viminalis*
Common Name: Manna Gum
Origin: Indigenous
Tree Age: Semi mature
H x W: 10m x 3m
Health: Dead
Structure: Poor
ULE: 0 years
Retention Value: Low
Defects: None

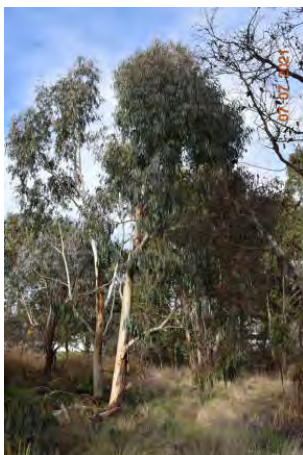
Tree Number: 63

Botanical Name: *Eucalyptus viminalis*
Common Name: Manna Gum
Origin: Indigenous
Tree Age: Semi mature
H x W: 9m x 4m
Health: Good
Structure: Good
ULE: 20+ years
Retention Value: Medium
Defects: None

DBH (cm):	23
TPZ (m):	2.76
SRZ (m):	2.05

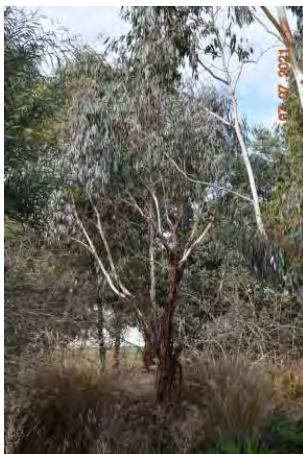
Tree Number: 65

Botanical Name: *Eucalyptus viminalis*
Common Name: Manna Gum
Origin: Indigenous
Tree Age: Semi mature
H x W: 5m x 3m
Health: Good
Structure: Fair
ULE: 10-20 years
Retention Value: Low
Defects: None

DBH (cm):	18
TPZ (m):	2.16
SRZ (m):	1.82

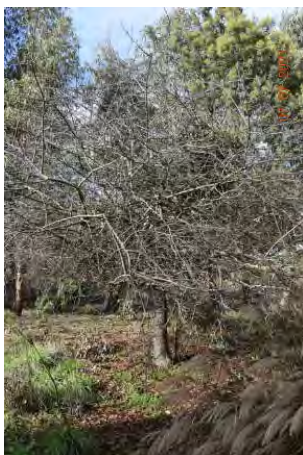
Tree Number: 66

Botanical Name: *Malus domestica*
Common Name: Apple
Origin: Exotic
Tree Age: Semi mature
H x W: 5m x 5m
Health: Good
Structure: Fair
ULE: 10-20 years
Retention Value: Low
Defects: None

DBH (cm):	19
TPZ (m):	2.28
SRZ (m):	1.79

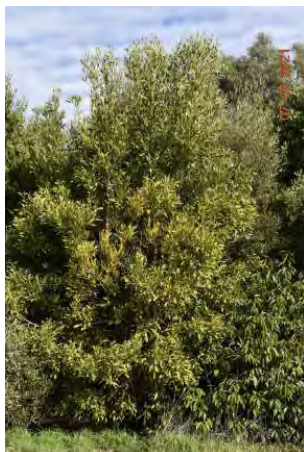
Tree Number: 67

Botanical Name: *Acacia melanoxylon*
Common Name: Blackwood
Origin: Indigenous
Tree Age: Young
H x W: 4m x 2m
Health: Good
Structure: Fair
ULE: 20+ years
Retention Value: Low
Defects: None

DBH (cm): 9
TPZ (m): 2
SRZ (m): 1.50

Comments: Group of approximately 14 individuals, Blackwood and mixed exotic species

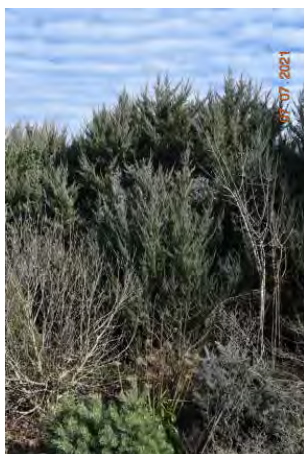
Tree Number: 68

Botanical Name: *Hesperocyparis macrocarpa*
Common Name: Monterey Cypress
Origin: Exotic
Tree Age: Semi mature
H x W: 5m x 2m
Health: Good
Structure: Good
ULE: 20+ years
Retention Value: Low
Defects: None

DBH (cm): 10
TPZ (m): 2
SRZ (m): 1.50

Comments: Group of approximately 14 individuals

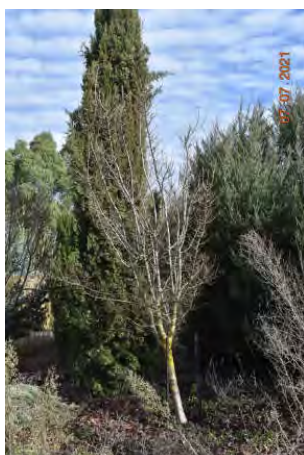
Tree Number: 69

Botanical Name: *Pyrus calleryana*
Common Name: Callery Pear
Origin: Exotic
Tree Age: Semi mature
H x W: 4m x 2m
Health: Good
Structure: Good
ULE: 20+ years
Retention Value: Low
Defects: None

DBH (cm): 9
TPZ (m): 2
SRZ (m): 1.50

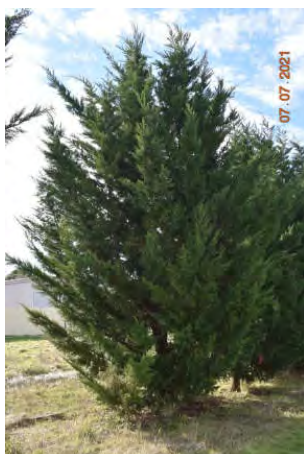
Tree Number: 71

Botanical Name: *Hesperocyparis macrocarpa*
Common Name: Monterey Cypress
Origin: Exotic
Tree Age: Semi mature
H x W: 6m x 3m
Health: Good
Structure: Good
ULE: 20+ years
Retention Value: Low
Defects: None

DBH (cm):	16
TPZ (m):	2
SRZ (m):	1.68

Comments: Group of approximately 24 individuals

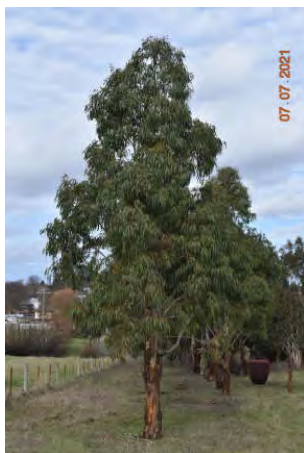
Tree Number: 72

Botanical Name: *Eucalyptus viminalis*
Common Name: Manna Gum
Origin: Indigenous
Tree Age: Semi mature
H x W: 6m x 2m
Health: Good
Structure: Good
ULE: 20+ years
Retention Value: Medium
Defects: None

DBH (cm):	21
TPZ (m):	2.52
SRZ (m):	1.94

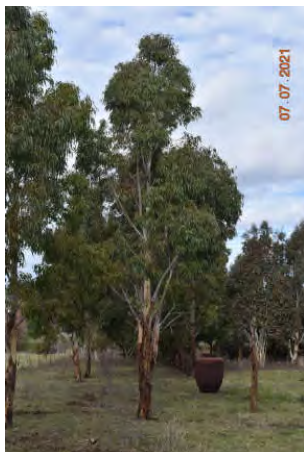
Tree Number: 73

Botanical Name: *Eucalyptus viminalis*
Common Name: Manna Gum
Origin: Indigenous
Tree Age: Semi mature
H x W: 6m x 2m
Health: Good
Structure: Good
ULE: 20+ years
Retention Value: Medium
Defects: None

DBH (cm): 20
TPZ (m): 2.4
SRZ (m): 1.91

Comments: Group of approximately 2 individuals

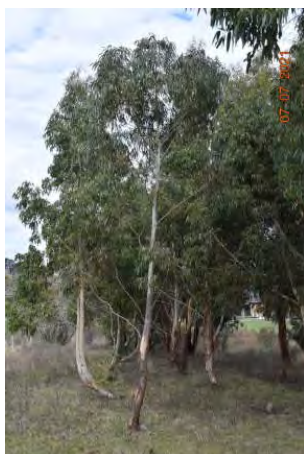
Tree Number: 74

Botanical Name: *Eucalyptus viminalis*
Common Name: Manna Gum
Origin: Indigenous
Tree Age: Semi mature
H x W: 6m x 2m
Health: Good
Structure: Fair
ULE: 20+ years
Retention Value: Medium
Defects: None

DBH (cm): 14
TPZ (m): 2
SRZ (m): 1.65

Comments: Group of approximately 5 individuals

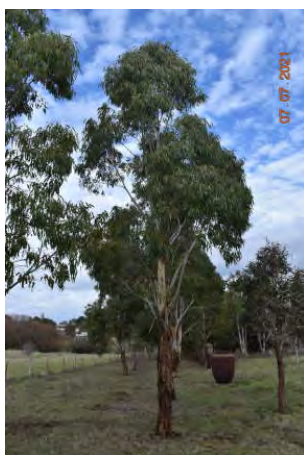
Tree Number: 75

Botanical Name: *Eucalyptus viminalis*
Common Name: Manna Gum
Origin: Indigenous
Tree Age: Semi mature
H x W: 6m x 2m
Health: Good
Structure: Good
ULE: 20+ years
Retention Value: Medium
Defects: None

DBH (cm): 22
TPZ (m): 2.64
SRZ (m): 2.00

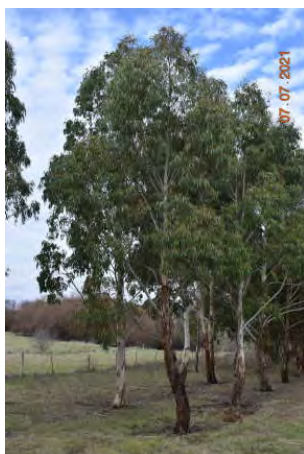
Tree Number: 77

Botanical Name: *Eucalyptus viminalis*
Common Name: Manna Gum
Origin: Indigenous
Tree Age: Semi mature
H x W: 6m x 2m
Health: Good
Structure: Good
ULE: 20+ years
Retention Value: Medium
Defects: None

DBH (cm): 22
TPZ (m): 2.64
SRZ (m): 2.00

Comments: Group of approximately 7 individuals

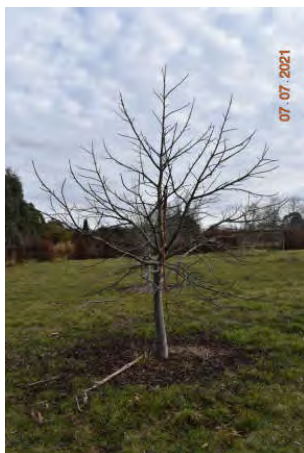
Tree Number: 78

Botanical Name: *Juglans regia*
Common Name: Walnut
Origin: Exotic
Tree Age: Semi mature
H x W: 4m x 2m
Health: Good
Structure: Good
ULE: 20+ years
Retention Value: Low
Defects: None

DBH (cm): 11
TPZ (m): 2
SRZ (m): 1.50

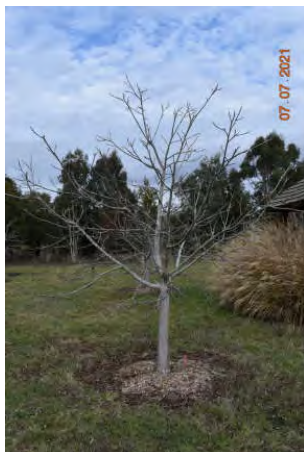
Tree Number: 79

Botanical Name: *Juglans regia*
Common Name: Walnut
Origin: Exotic
Tree Age: Semi mature
H x W: 4m x 2m
Health: Good
Structure: Good
ULE: 20+ years
Retention Value: Low
Defects: None

DBH (cm): 11
TPZ (m): 2
SRZ (m): 1.50
