**Planning Delegated Committee
Meeting
Under Separate Cover**

DEVELOPMENT PLAN

88A-90 Wedge Street, Kyneton

Prepared for ADTS P/L for Jasper Family Trust | July 2022 | Ref: 13263

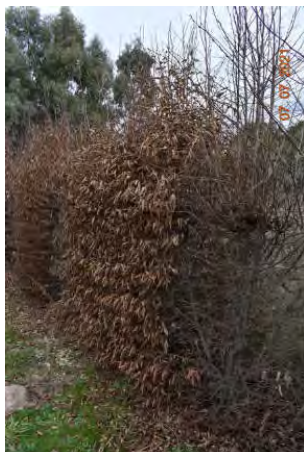
Tree Number: 82

Botanical Name: *Carpinus betulus*
Common Name: Hornbeam
Origin: Exotic
Tree Age: Semi mature
H x W: 2m x 1m
Health: Fair
Structure: Fair
ULE: 20+ years
Retention Value: Low
Defects: None

DBH (cm):	5
TPZ (m):	2
SRZ (m):	1.50

Comments: Group of approximately 30 individuals

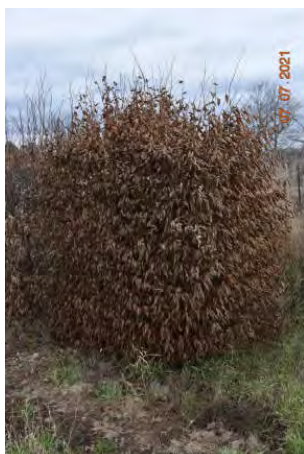
Tree Number: 83

Botanical Name: *Carpinus betulus*
Common Name: Hornbeam
Origin: Exotic
Tree Age: Semi mature
H x W: 2m x 1m
Health: Fair
Structure: Fair
ULE: 20+ years
Retention Value: Low
Defects: None

DBH (cm):	5
TPZ (m):	2
SRZ (m):	1.50

Comments: Group of approximately 30 individuals

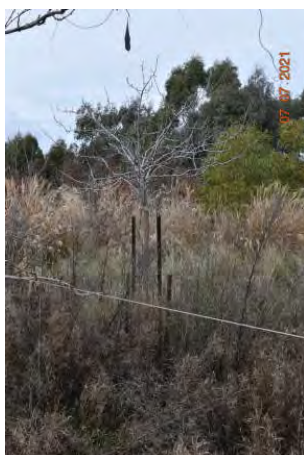
Tree Number: 84

Botanical Name: *Malus domestica*
Common Name: Apple
Origin: Exotic
Tree Age: Young
H x W: 3m x 2m
Health: Good
Structure: Good
ULE: 20+ years
Retention Value: Low
Defects: None

DBH (cm):	6
TPZ (m):	2
SRZ (m):	1.50

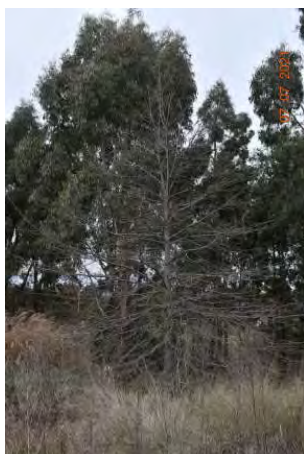
Tree Number: 86

Botanical Name: *Quercus palustris*
Common Name: Pin Oak
Origin: Exotic
Tree Age: Semi mature
H x W: 12m x 6m
Health: Good
Structure: Good
ULE: 20+ years
Retention Value: Medium
Defects: None

DBH (cm):	22
TPZ (m):	2.64
SRZ (m):	1.97

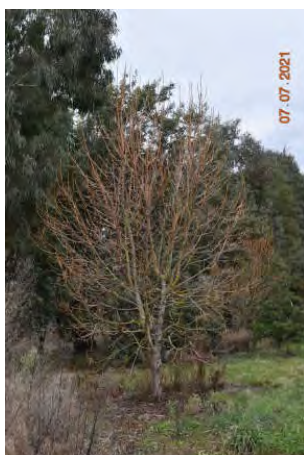
Tree Number: 87

Botanical Name: *Fraxinus excelsior 'Aurea'*
Common Name: Golden Ash
Origin: Exotic
Tree Age: Semi mature
H x W: 5m x 3m
Health: Good
Structure: Good
ULE: 20+ years
Retention Value: Low
Defects: None

DBH (cm):	13
TPZ (m):	2
SRZ (m):	1.53

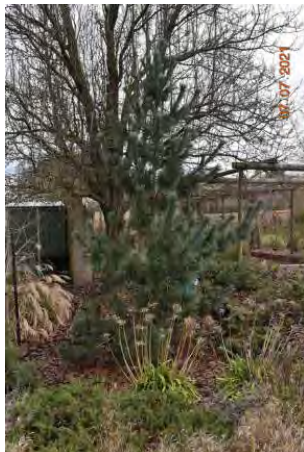
Tree Number: 88

Botanical Name: *Pinus radiata*
Common Name: Monterey Pine
Origin: Exotic
Tree Age: Young
H x W: 3m x 1m
Health: Good
Structure: Good
ULE: 20+ years
Retention Value: Low
Defects: None

DBH (cm): 7
TPZ (m): 2
SRZ (m): 1.50

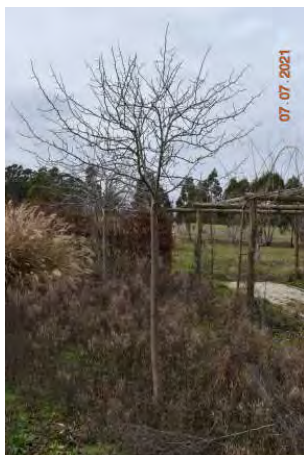
Tree Number: 90

Botanical Name: *Malus domestica*
Common Name: Apple
Origin: Exotic
Tree Age: Young
H x W: 3m x 1m
Health: Good
Structure: Fair
ULE: 20+ years
Retention Value: Low
Defects: None

DBH (cm): 7
TPZ (m): 2
SRZ (m): 1.50

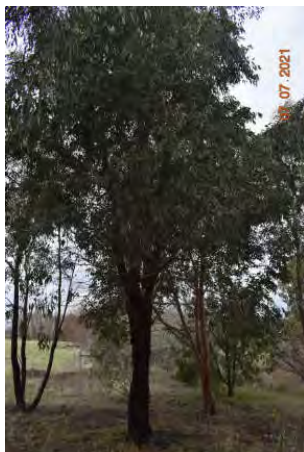
Tree Number: 91

Botanical Name: *Eucalyptus sideroxylon*
Common Name: Red Ironbark
Origin: Native
Tree Age: Semi mature
H x W: 10m x 4m
Health: Good
Structure: Fair
ULE: 20+ years
Retention Value: Medium
Defects: Codominant stems with included union

DBH (cm):	37
TPZ (m):	4.44
SRZ (m):	2.20

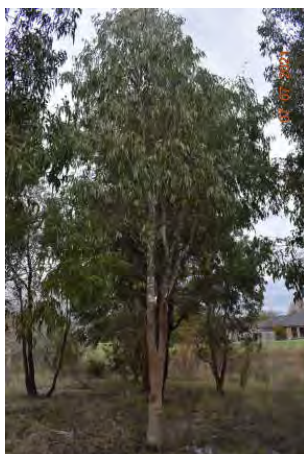
Botanical Name: *Eucalyptus camaldulensis*
Common Name: River Red Gum
Origin: Indigenous
Tree Age: Semi mature
H x W: 10m x 3m
Health: Good
Structure: Fair
ULE: 20+ years
Retention Value: Medium
Defects: Codominant stems with included union

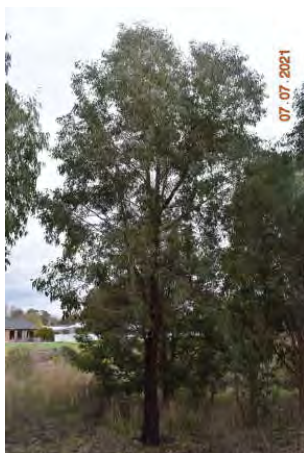
Tree Number: 93

Botanical Name: *Eucalyptus sideroxylon*
Common Name: Red Ironbark
Origin: Native
Tree Age: Semi mature
H x W: 10m x 3m
Health: Good
Structure: Good
ULE: 20+ years
Retention Value: Medium
Defects: Included union

DBH (cm):	25
TPZ (m):	3
SRZ (m):	2.08

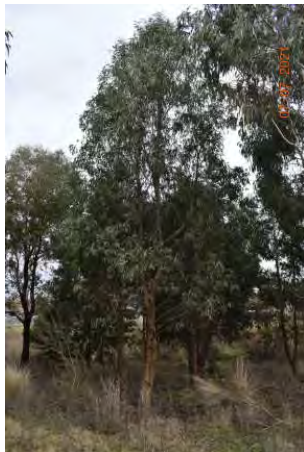
Tree Number: 94

Botanical Name: *Eucalyptus camaldulensis*
Common Name: River Red Gum
Origin: Indigenous
Tree Age: Semi mature
H x W: 10m x 3m
Health: Good
Structure: Good
ULE: 20+ years
Retention Value: Medium
Defects: None

DBH (cm):	25
TPZ (m):	3
SRZ (m):	2.10

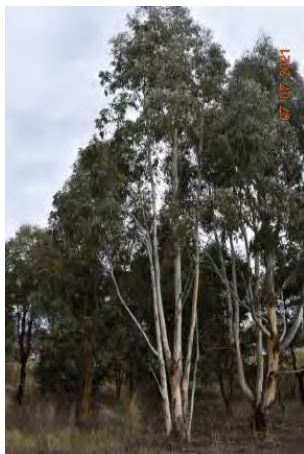
Tree Number: 95

Botanical Name: *Eucalyptus ovata*
Common Name: Swamp Gum
Origin: Indigenous
Tree Age: Semi mature
H x W: 10m x 3m
Health: Fair
Structure: Fair
ULE: 20+ years
Retention Value: Medium
Defects: None

DBH (cm):	35
TPZ (m):	4.2
SRZ (m):	2.30

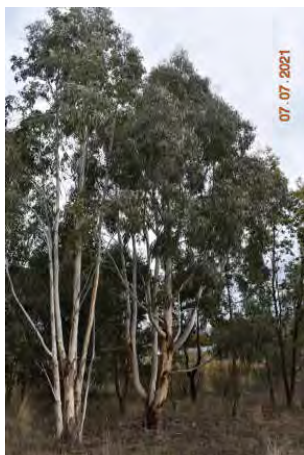
Tree Number: 96

Botanical Name: *Eucalyptus ovata*
Common Name: Swamp Gum
Origin: Indigenous
Tree Age: Semi mature
H x W: 12m x 6m
Health: Good
Structure: Fair
ULE: 20+ years
Retention Value: Medium
Defects: None

DBH (cm):	48
TPZ (m):	5.76
SRZ (m):	2.63

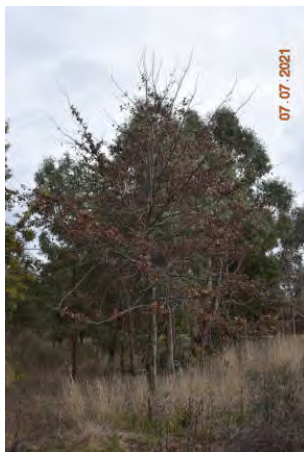
Tree Number: 97

Botanical Name: *Quercus palustris*
Common Name: Pin Oak
Origin: Exotic
Tree Age: Semi mature
H x W: 6m x 3m
Health: Good
Structure: Good
ULE: 20+ years
Retention Value: Medium
Defects: None

DBH (cm): 16
TPZ (m): 2
SRZ (m): 1.82

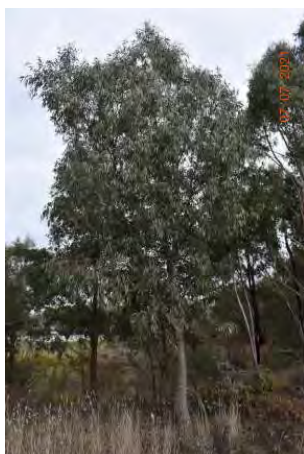
Tree Number: 98

Botanical Name: *Eucalyptus camaldulensis*
Common Name: River Red Gum
Origin: Indigenous
Tree Age: Semi mature
H x W: 10m x 4m
Health: Good
Structure: Good
ULE: 20+ years
Retention Value: Medium
Defects: None

DBH (cm): 26
TPZ (m): 3.12
SRZ (m): 2.13

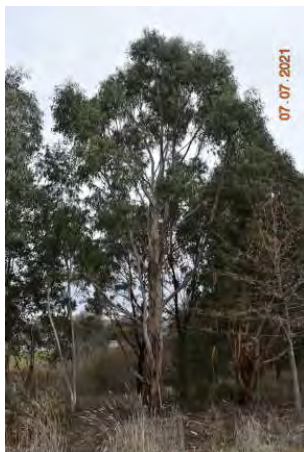
Tree Number: 100

Botanical Name: *Eucalyptus viminalis*
Common Name: Manna Gum
Origin: Indigenous
Tree Age: Semi mature
H x W: 12m x 6m
Health: Good
Structure: Good
ULE: 20+ years
Retention Value: Medium
Defects: None

DBH (cm): 46
TPZ (m): 5.52
SRZ (m): 2.67

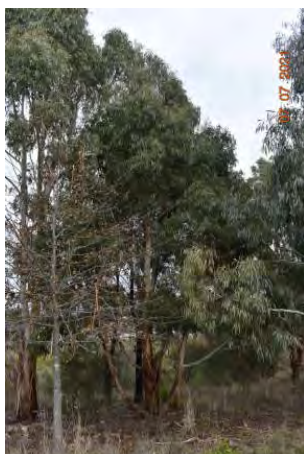
Tree Number: 101

Botanical Name: *Eucalyptus viminalis*
Common Name: Manna Gum
Origin: Indigenous
Tree Age: Semi mature
H x W: 10m x 5m
Health: Good
Structure: Good
ULE: 20+ years
Retention Value: Medium
Defects: None

DBH (cm): 26
TPZ (m): 3.12
SRZ (m): 2.15

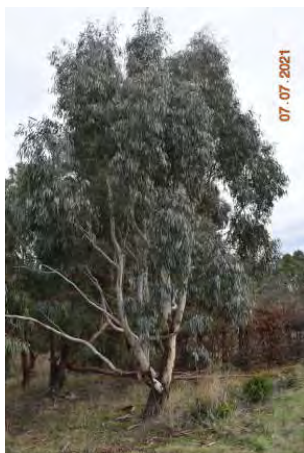
Tree Number: 102

Botanical Name: *Eucalyptus viminalis*
Common Name: Manna Gum
Origin: Indigenous
Tree Age: Semi mature
H x W: 10m x 5m
Health: Good
Structure: Fair
ULE: 20+ years
Retention Value: Medium
Defects: None

DBH (cm): 28
TPZ (m): 3.36
SRZ (m): 2.25

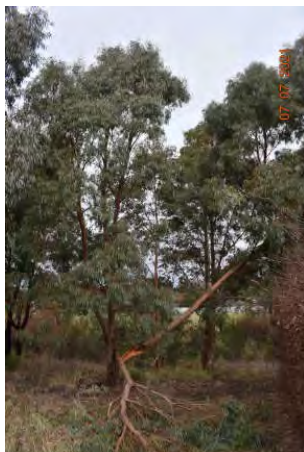
Tree Number: 103

Botanical Name: *Eucalyptus ovata*
Common Name: Swamp Gum
Origin: Indigenous
Tree Age: Semi mature
H x W: 10m x 4m
Health: Good
Structure: Very poor
ULE: 1-5 years
Retention Value: Low
Defects: Codominant included stems with broken branches throughout the canopy
Comments: Evidence of previous branch failure

DBH (cm):	26
TPZ (m):	3.12
SRZ (m):	2.39

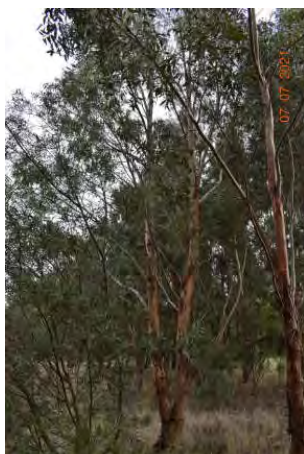
Tree Number: 104

Botanical Name: *Eucalyptus ovata*
Common Name: Swamp Gum
Origin: Indigenous
Tree Age: Semi mature
H x W: 12m x 4m
Health: Good
Structure: Fair
ULE: 20+ years
Retention Value: Medium
Defects: None
Comments:

DBH (cm):	35
TPZ (m):	4.2
SRZ (m):	2.23

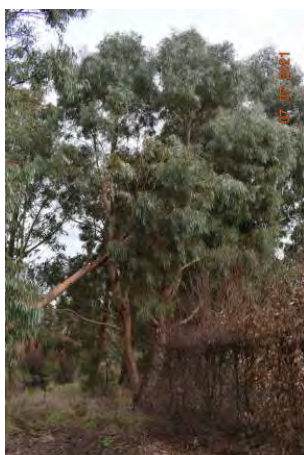
Tree Number: 105

Botanical Name: *Eucalyptus ovata*
Common Name: Swamp Gum
Origin: Indigenous
Tree Age: Semi mature
H x W: 12m x 5m
Health: Good
Structure: Fair
ULE: 20+ years
Retention Value: Medium
Defects: Codominant stems
Comments:

DBH (cm):	44
TPZ (m):	5.28
SRZ (m):	2.28

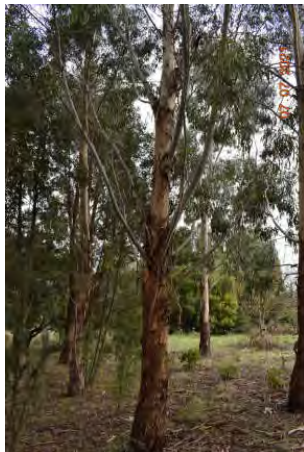
Tree Number: 106

Botanical Name: *Eucalyptus viminalis*
Common Name: Manna Gum
Origin: Indigenous
Tree Age: Semi mature
H x W: 14m x 6m
Health: Good
Structure: Good
ULE: 20+ years
Retention Value: Medium
Defects: None

DBH (cm): 32
TPZ (m): 3.84
SRZ (m): 2.30

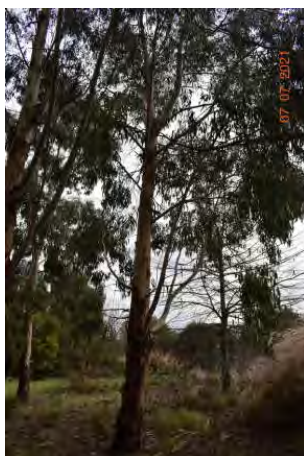
Tree Number: 107

Botanical Name: *Eucalyptus viminalis*
Common Name: Manna Gum
Origin: Indigenous
Tree Age: Semi mature
H x W: 14m x 6m
Health: Good
Structure: Good
ULE: 20+ years
Retention Value: Medium
Defects: None

DBH (cm): 38
TPZ (m): 4.56
SRZ (m): 2.43

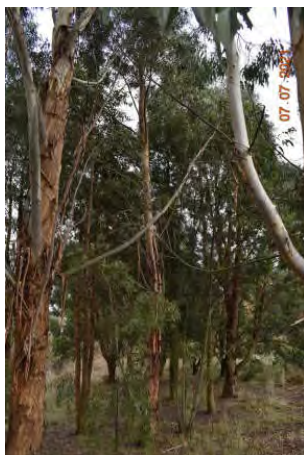
Tree Number: 108

Botanical Name: *Eucalyptus viminalis*
Common Name: Manna Gum
Origin: Indigenous
Tree Age: Semi mature
H x W: 14m x 4m
Health: Good
Structure: Fair
ULE: 20+ years
Retention Value: Medium
Defects: None

DBH (cm): 27
TPZ (m): 3.24
SRZ (m): 2.15

Comments: Evidence of previous branch failure

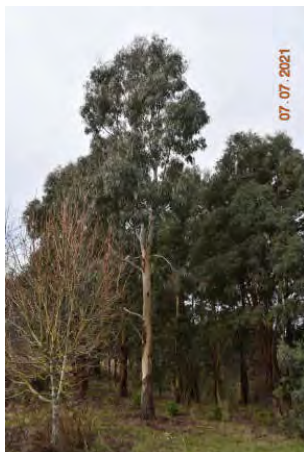
Tree Number: 109

Botanical Name: *Eucalyptus viminalis*
Common Name: Manna Gum
Origin: Indigenous
Tree Age: Semi mature
H x W: 14m x 4m
Health: Good
Structure: Good
ULE: 20+ years
Retention Value: Medium
Defects: None

DBH (cm): 37
TPZ (m): 4.44
SRZ (m): 2.43

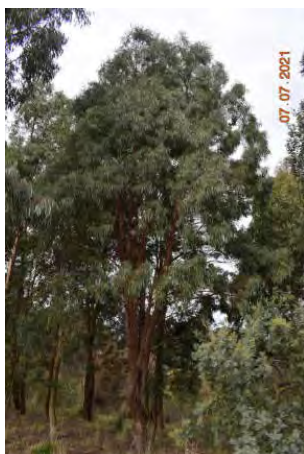
Tree Number: 110

Botanical Name: *Eucalyptus nicholii*
Common Name: Narrow-leaved Black Peppermint
Origin: Native
Tree Age: Semi mature
H x W: 12m x 5m
Health: Good
Structure: Good
ULE: 20+ years
Retention Value: Medium
Defects: None

DBH (cm): 29
TPZ (m): 3.48
SRZ (m): 2.25

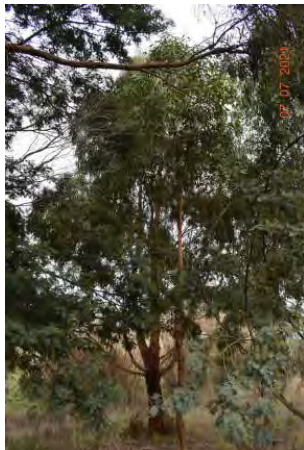
Tree Number: 112

Botanical Name: *Eucalyptus viminalis*
Common Name: Manna Gum
Origin: Indigenous
Tree Age: Semi mature
H x W: 10m x 4m
Health: Good
Structure: Fair
ULE: 20+ years
Retention Value: Medium
Defects: None

DBH (cm): 34
TPZ (m): 4.08
SRZ (m): 2.30

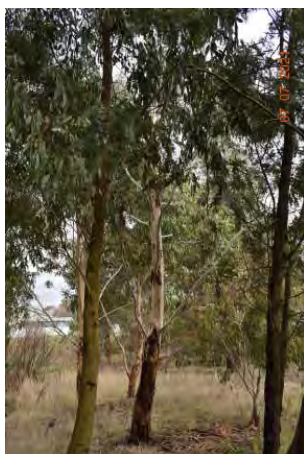
Tree Number: 113

Botanical Name: *Eucalyptus viminalis*
Common Name: Manna Gum
Origin: Indigenous
Tree Age: Semi mature
H x W: 12m x 3m
Health: Good
Structure: Fair
ULE: 20+ years
Retention Value: Medium
Defects: None

DBH (cm): 25
TPZ (m): 3
SRZ (m): 2.10

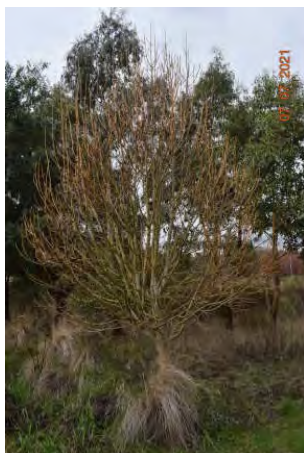
Tree Number: 114

Botanical Name: *Fraxinus excelsior 'Aurea'*
Common Name: Golden Ash
Origin: Exotic
Tree Age: Semi mature
H x W: 5m x 3m
Health: Good
Structure: Good
ULE: 20+ years
Retention Value: Low
Defects: None

DBH (cm): 11
TPZ (m): 2
SRZ (m): 1.53

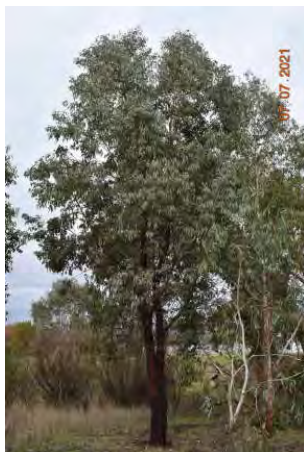
Tree Number: 115

Botanical Name: *Eucalyptus sideroxylon*
Common Name: Red Ironbark
Origin: Native
Tree Age: Semi mature
H x W: 10m x 4m
Health: Good
Structure: Fair
ULE: 20+ years
Retention Value: Medium
Defects: None

DBH (cm):	33
TPZ (m):	3.96
SRZ (m):	2.28

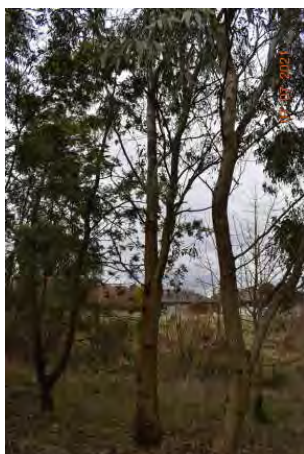
Tree Number: 116

Botanical Name: *Eucalyptus camaldulensis*
Common Name: River Red Gum
Origin: Indigenous
Tree Age: Semi mature
H x W: 10m x 4m
Health: Good
Structure: Good
ULE: 20+ years
Retention Value: Medium
Defects: None

DBH (cm):	25
TPZ (m):	3
SRZ (m):	2.10

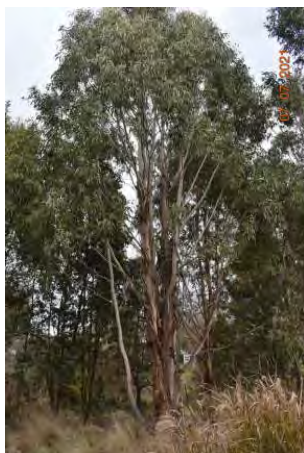
Tree Number: 117

Botanical Name: *Eucalyptus ovata*
Common Name: Swamp Gum
Origin: Indigenous
Tree Age: Semi mature
H x W: 12m x 5m
Health: Good
Structure: Good
ULE: 20+ years
Retention Value: Medium
Defects: None

DBH (cm):	40
TPZ (m):	4.8
SRZ (m):	2.25

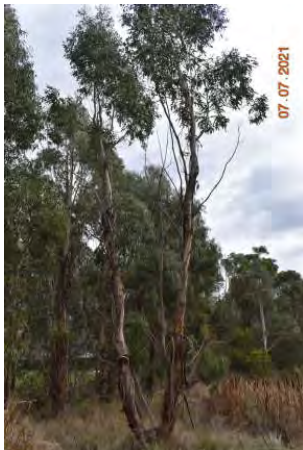
Tree Number: 118

Botanical Name: *Eucalyptus ovata*
Common Name: Swamp Gum
Origin: Indigenous
Tree Age: Semi mature
H x W: 9m x 4m
Health: Fair
Structure: Fair
ULE: 10-20 years
Retention Value: Low
Defects: Decay in main stem

DBH (cm):	25
TPZ (m):	3
SRZ (m):	2.23

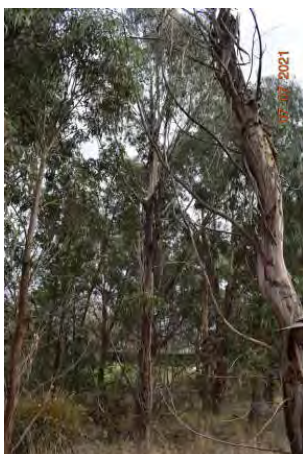
Tree Number: 119

Botanical Name: *Eucalyptus ovata*
Common Name: Swamp Gum
Origin: Indigenous
Tree Age: Semi mature
H x W: 13m x 6m
Health: Good
Structure: Good
ULE: 20+ years
Retention Value: Medium
Defects: None

DBH (cm):	30
TPZ (m):	3.6
SRZ (m):	2.39

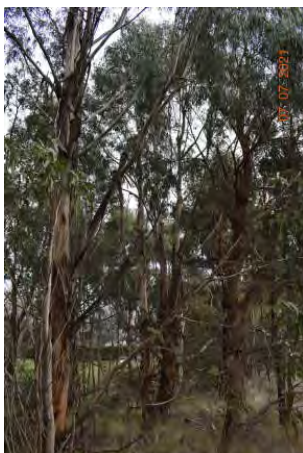
Tree Number: 120

Botanical Name: *Eucalyptus ovata*
Common Name: Swamp Gum
Origin: Indigenous
Tree Age: Semi mature
H x W: 13m x 6m
Health: Good
Structure: Good
ULE: 20+ years
Retention Value: Medium
Defects: None

DBH (cm):	33
TPZ (m):	3.96
SRZ (m):	2.47

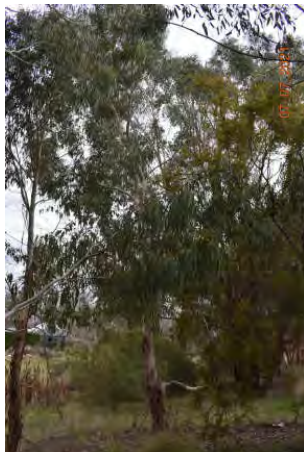
Tree Number: 121

Botanical Name: *Eucalyptus viminalis*
Common Name: Manna Gum
Origin: Indigenous
Tree Age: Semi mature
H x W: 11m x 4m
Health: Good
Structure: Good
ULE: 20+ years
Retention Value: Medium
Defects: None

DBH (cm): 26
TPZ (m): 3.12
SRZ (m): 2.10

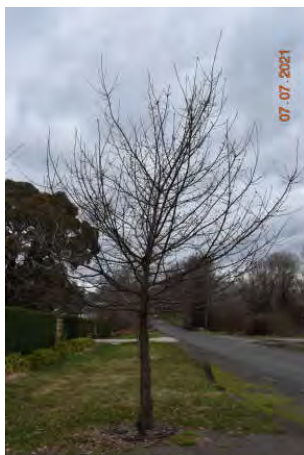
Tree Number: 123

Botanical Name: *Quercus canariensis*
Common Name: Algerian Oak
Origin: Exotic
Tree Age: Young
H x W: 6m x 4m
Health: Good
Structure: Good
ULE: 20+ years
Retention Value: Third party
Defects: None

DBH (cm): 15
TPZ (m): 2
SRZ (m): 1.72

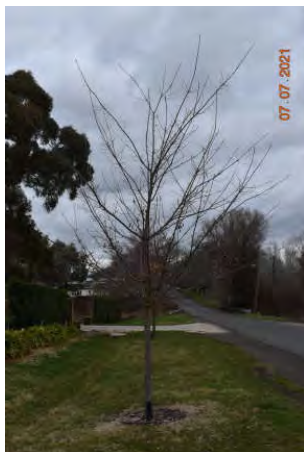
Tree Number: 124

Botanical Name: *Quercus canariensis*
Common Name: Algerian Oak
Origin: Exotic
Tree Age: Young
H x W: 6m x 4m
Health: Good
Structure: Good
ULE: 20+ years
Retention Value: Third party
Defects: None

DBH (cm): 9
TPZ (m): 2
SRZ (m): 1.50

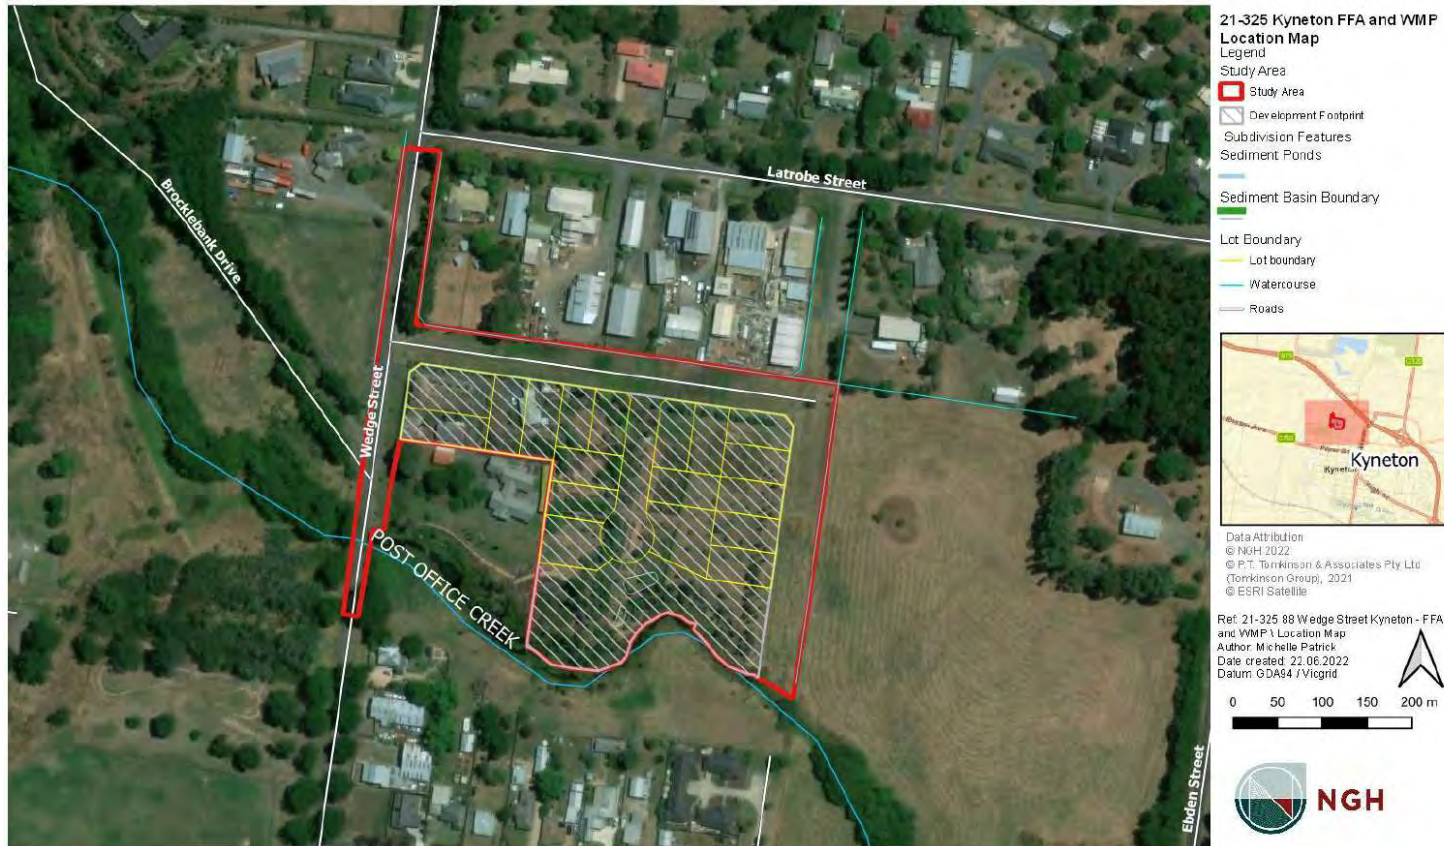
Figure 1-1 Location Map

One waterway flows through the Study Area, known as Post Office Creek. It is located to the south of the study area and flows north (see Figure 1-1). Post Office Creek joins Campaspe River to the northwest of the site. The site is located in the North Central Catchment Management Area.

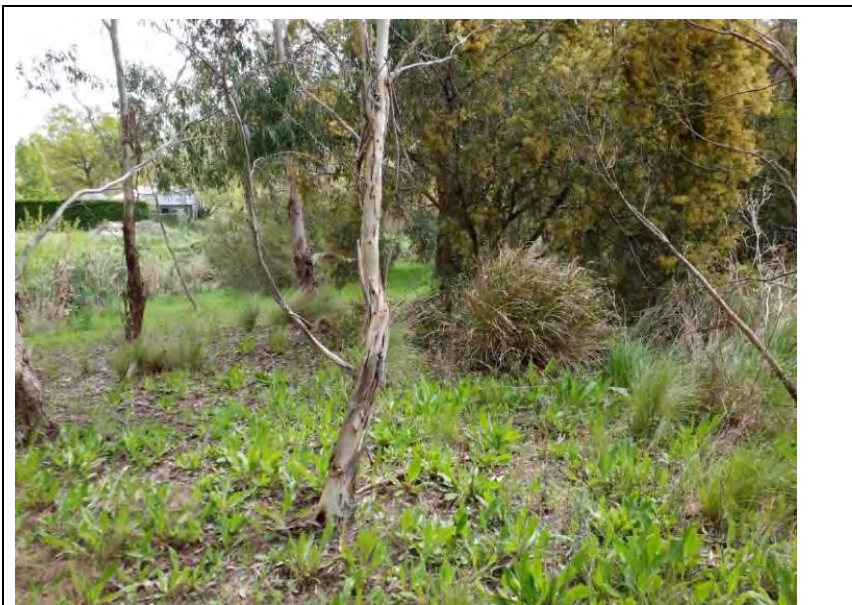
Figure 4-1. Planted Native Vegetation

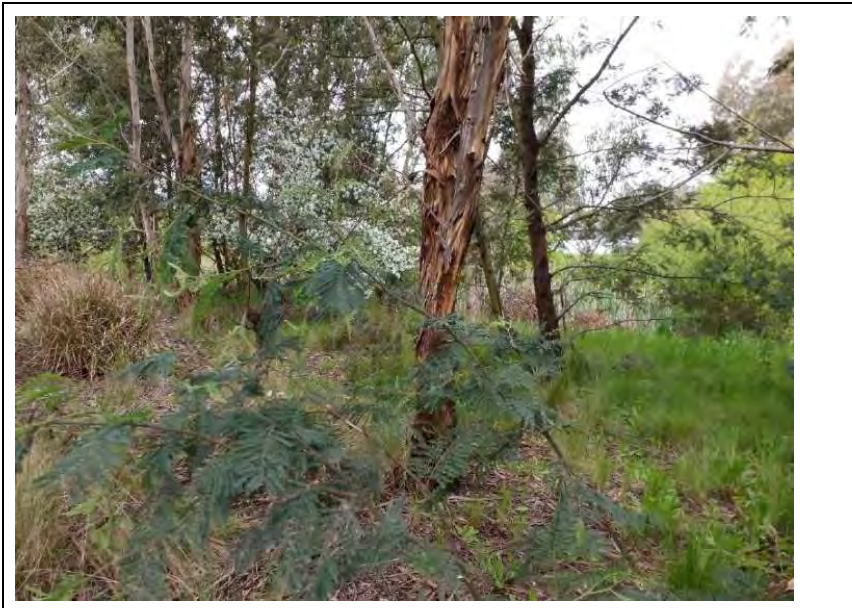
Figure 4-2. Planted Native Vegetation

Examples of Planted Native Vegetation can be found in Figure 4-1 to .

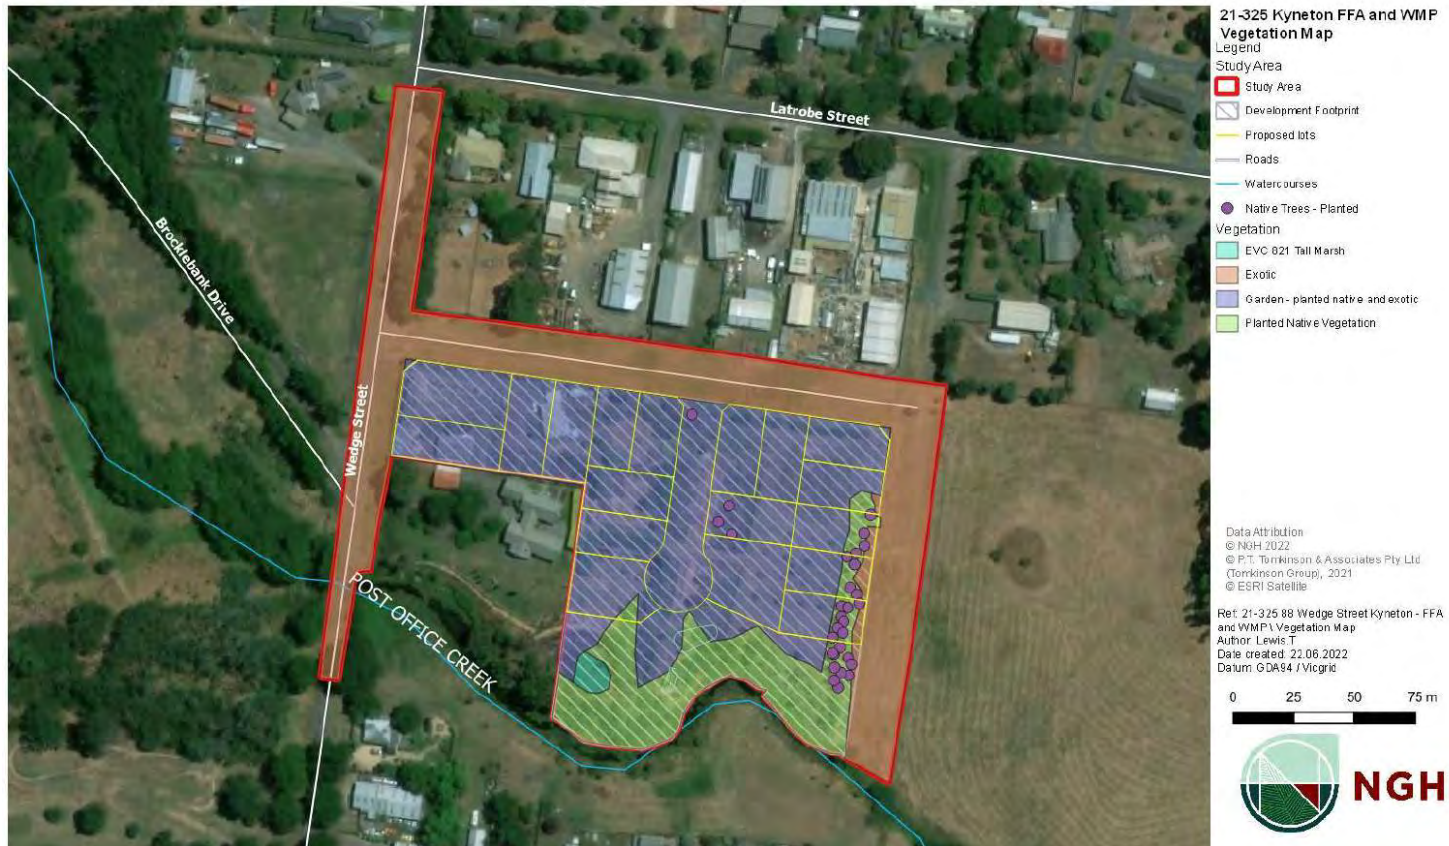
Figure 4-9 Vegetation in the Study Area

The vegetation map is shown in Figure 4-9.

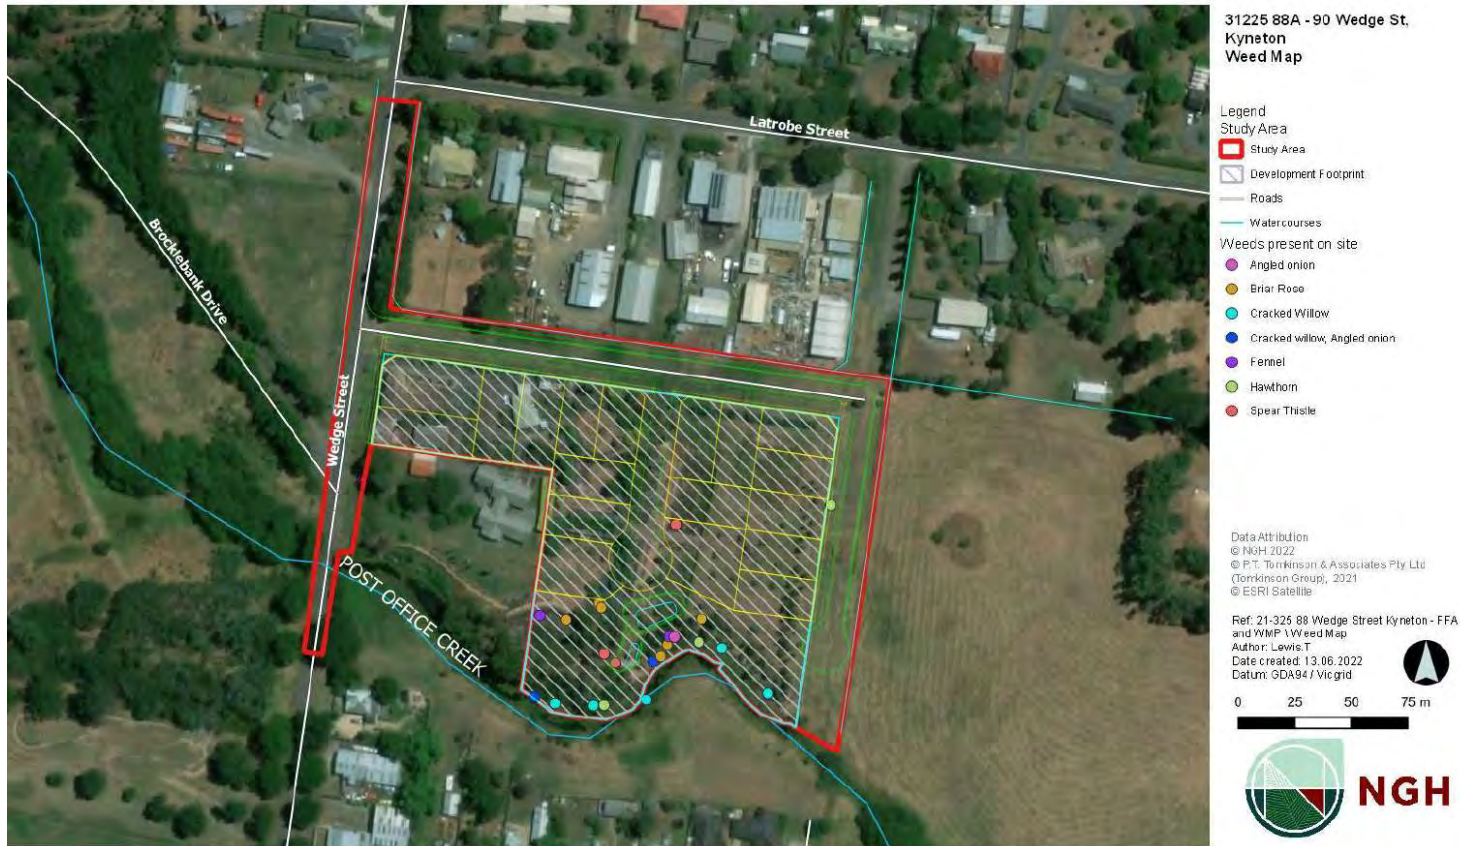
Figure 6-1 High Threat Weeds at 88A-90 Wedge St, Kyneton

There are some high threat weeds in this area that will require management as part of the Weed Management Plan. The noxious weeds include Cracked Willow, Hawthorn, Blackberry, Briar Rose, Spear Thistle and Fennel.

88A-90 Wedge Street, Kyneton is located in Maceon Ranges Local Government Area. The property is approximately 1.6 kms from the centre of Kyneton. 88A-90 Wedge Street covers approximately 1.95 hectares. The property is extensive gardens with exotic trees, planted garden beds and pathways. The native vegetation on site is planted. The creek area has been planted with a mix of local indigenous and regional Australian trees, shrubs and understorey. There are three rows of planted Manna Gums (*Eucalyptus viminalis*). There are some high threat weeds including Willows, Hawthorn, Blackberry, Briar Rose and Fennel (See Figure 6-1).

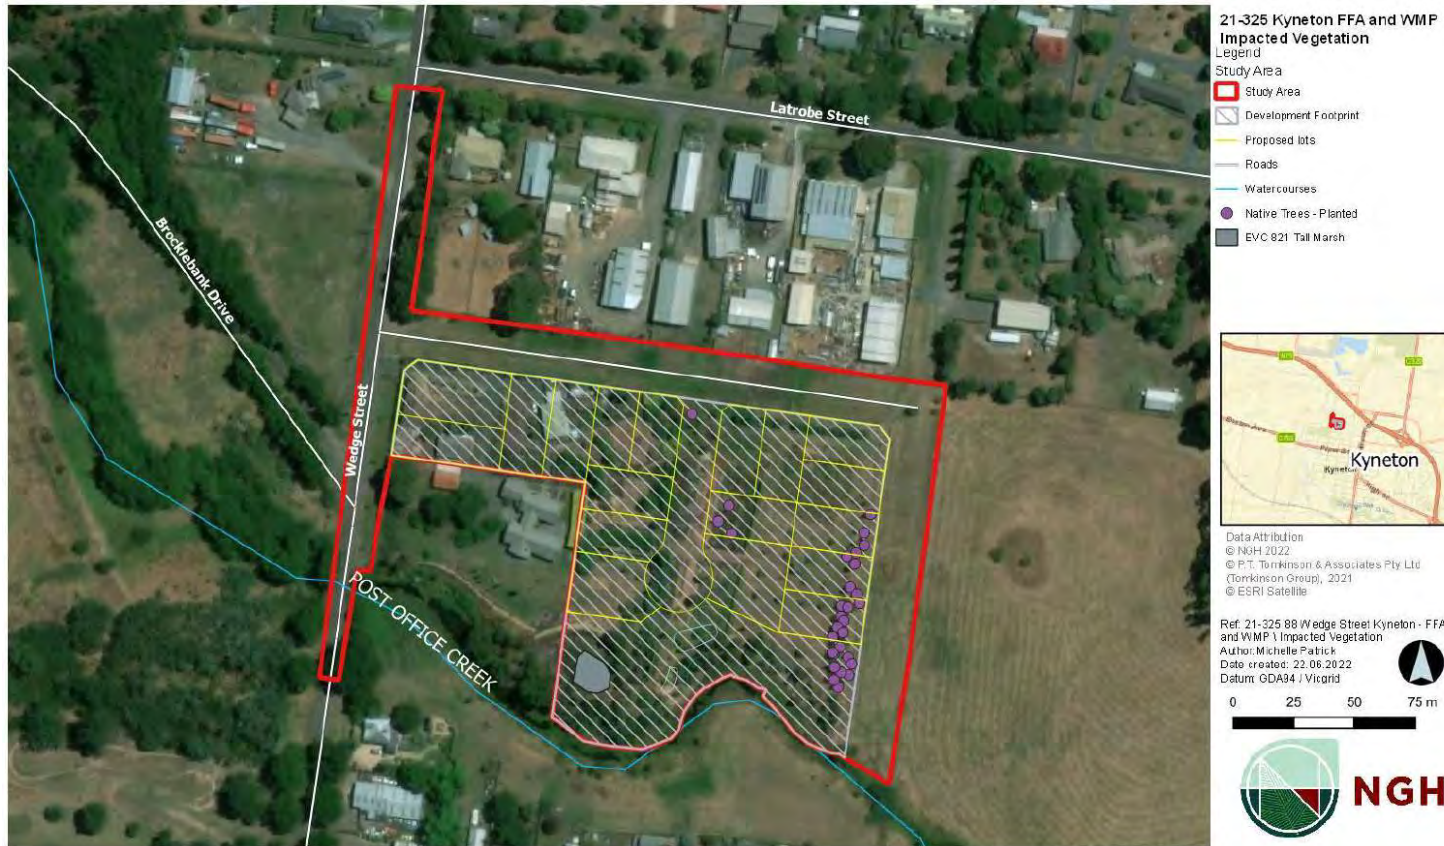
Figure 7-1 Proposed Vegetation Removal

Figure 7-1 shows the native vegetation proposed to be removed.

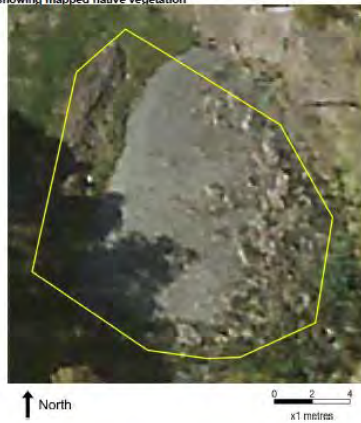
3. Aerial photograph showing mapped native vegetation

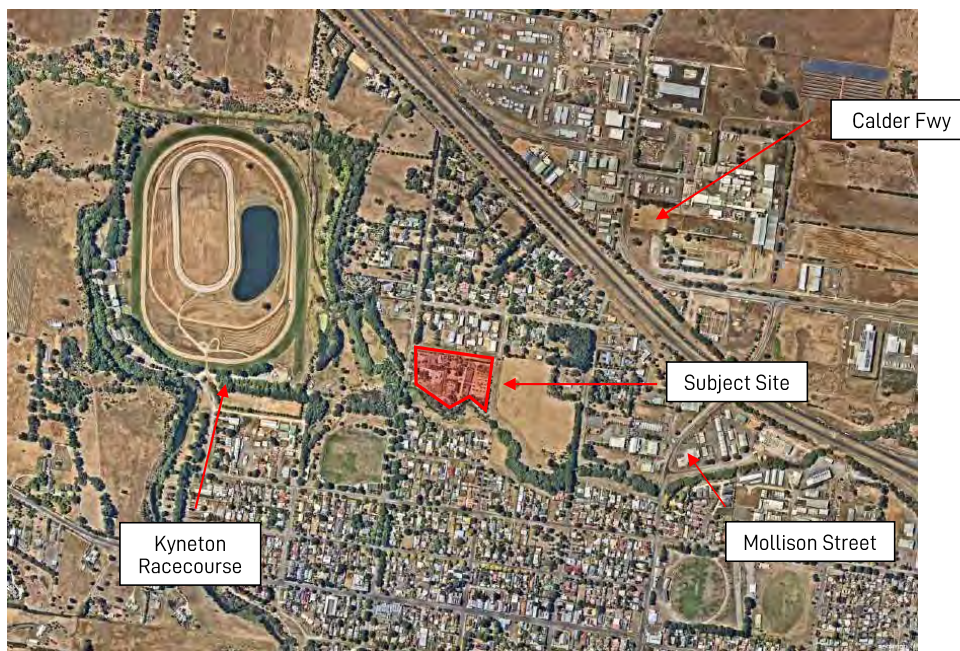
Figure 1: Locality Plan

The Subject Site is located on the southern side of the Calder Freeway and to the west of Mollison Street as shown in Figure 1 below. The subject site comprises of several parcels approximately 2.65 hectares in area and is proposed to be subdivided into 18 lots with a reserve area for stormwater detention and treatment. A services Functional Layout Plan has been prepared to demonstrate the proposed locations of services and infrastructure within the development and surrounds and is located in Appendix A.

The site is typically grassed and contains various tree and vegetation clusters. The topography of the subject site generally falls from north to south towards Post Office Creek.

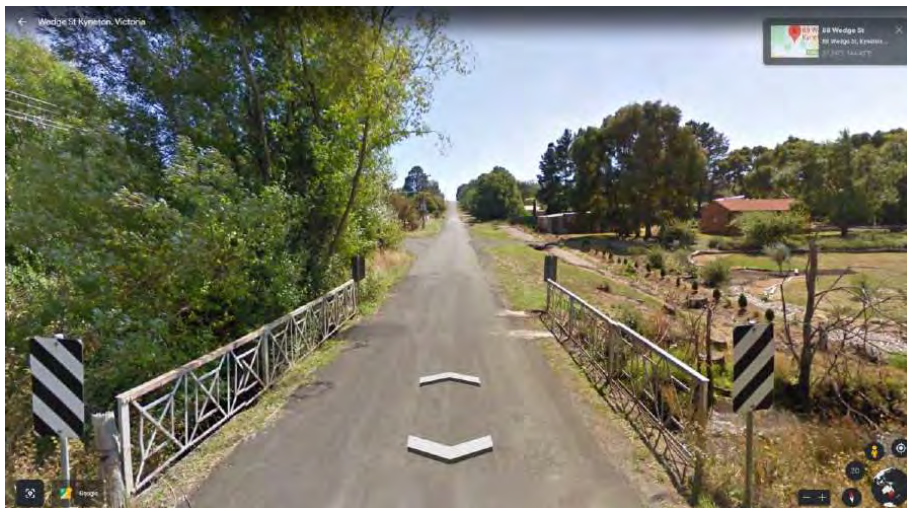
The site will have immediate road access from Wedge Street which is currently a rural profile road consisting of a typical 4.7m seal, 0.5m shoulder and table drains (See Figure 2). Similar to IDM standards, this rural profile has been determined to be a suitable road profile for access to the development and maintain the local rural nature and amenity. Any lots fronting Wedge Street to have sealed driveways for access. A footpath will also be constructed fronting all these lots to provide physical and social pedestrian access to the development.

Figure 2: Wedge Street Google Street View looking North from Post Office Creek

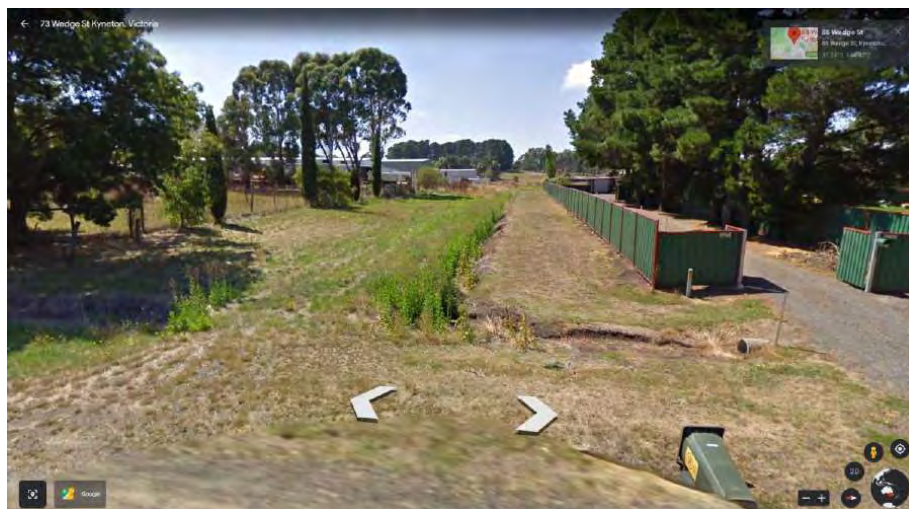
Both the existing unmade government roads (See Figure 3) and Powlett Street road reserves will be upgraded to provide access from Wedge Street into the subdivision. This upgrade will include a modified rural profile adopting similar style to existing local road reserves with an addition of a footpath on one side with table drains and underground drainage as required.

Figure 3: Government Road Reserve Google Street View looking East from Wedge Street
