Re: **Amendment to the Fersfield Development Plan**
110 – 112 Willowbank Road, Gisborne

We act on behalf of the owner of the land in requesting an amendment to the Fersfield Road Development Plan to facilitate the development of 110 – 112 Willowbank Road, Gisborne (**subject site**) for the purpose of a Residential Aged Care Facility.

Transport Impact Assessment – DPO Amendment

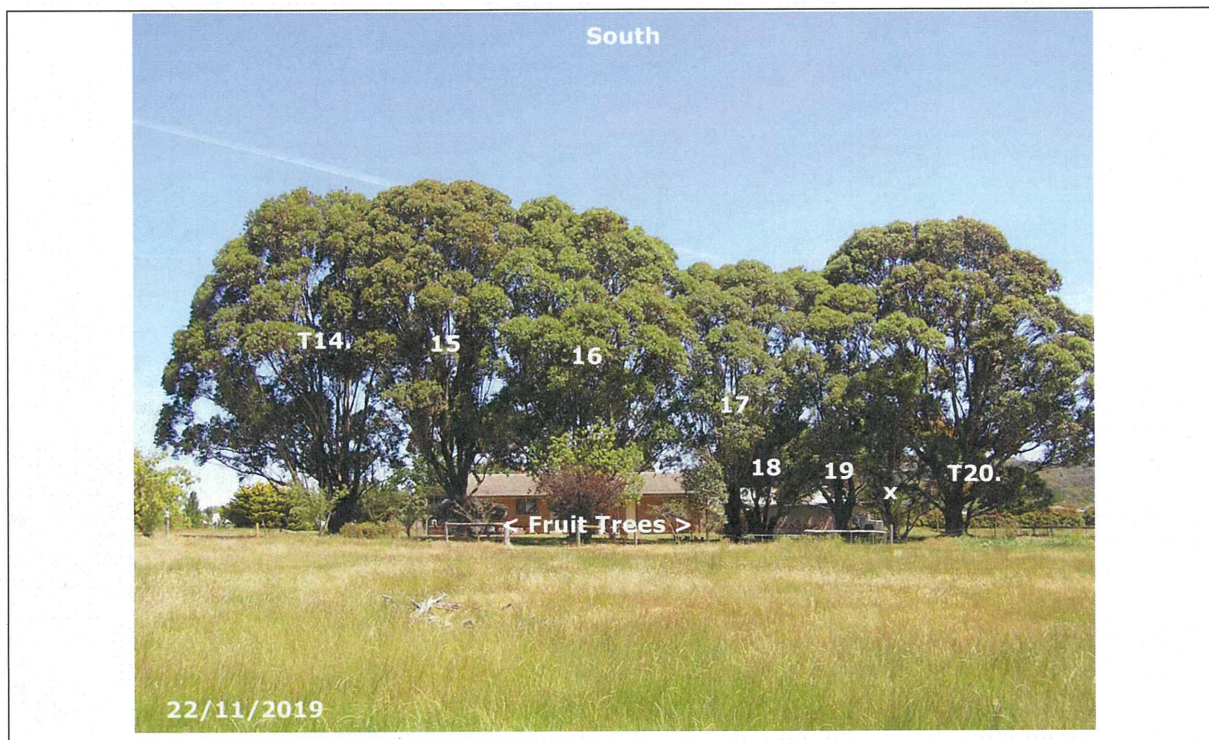
T14 – T20: Lopped Southern Mahoganies. Asymmetrical Grove. All with Poor Structure & Form.

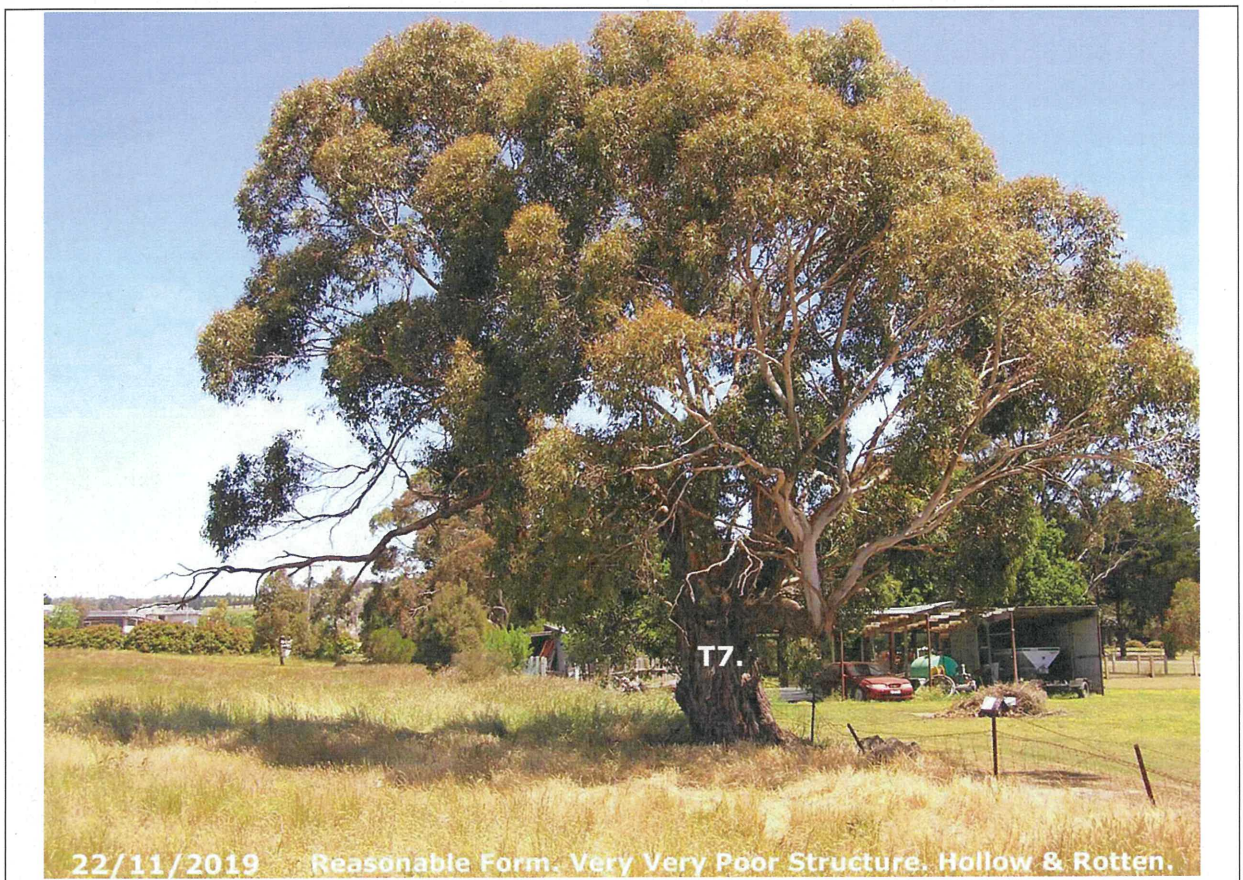
T7: Reasonable Form. Very Very Poor Structure. Hollow & Rotten. On Boundary.

- Some trees are actually Hazardous T7 & T8 or Very Poor and require immediate consideration for safety; they are not viable and some require urgent attention in due course. They cannot possibly be retained.

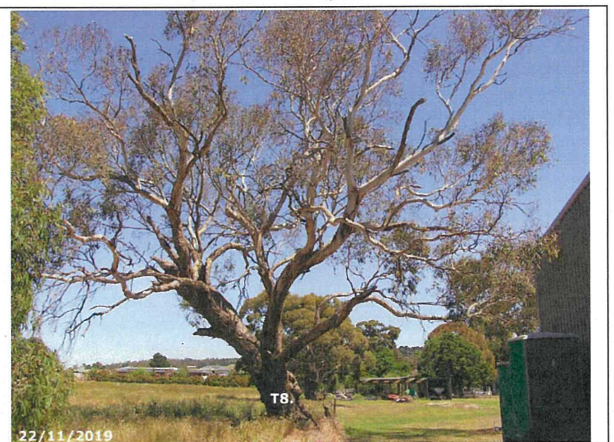
T8: Dead.

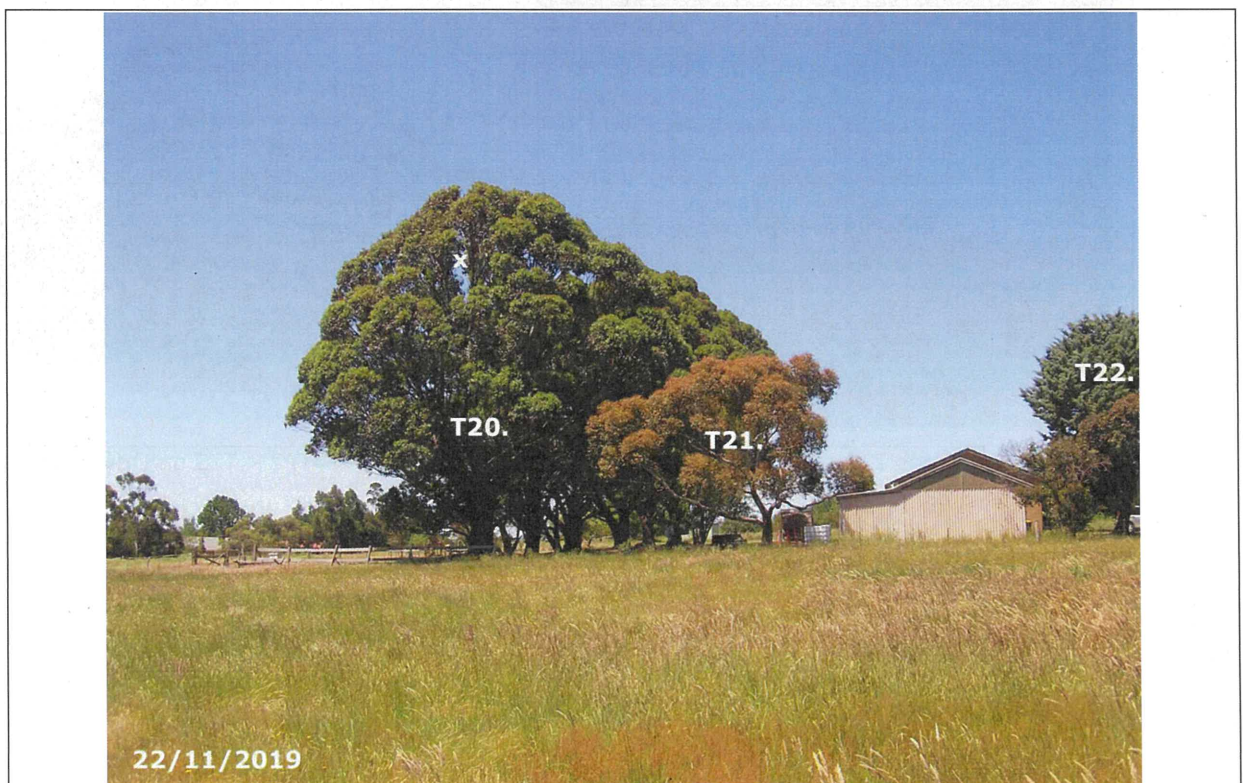
T20 (Canopy Falling apart). T21. T22. Elevation East.

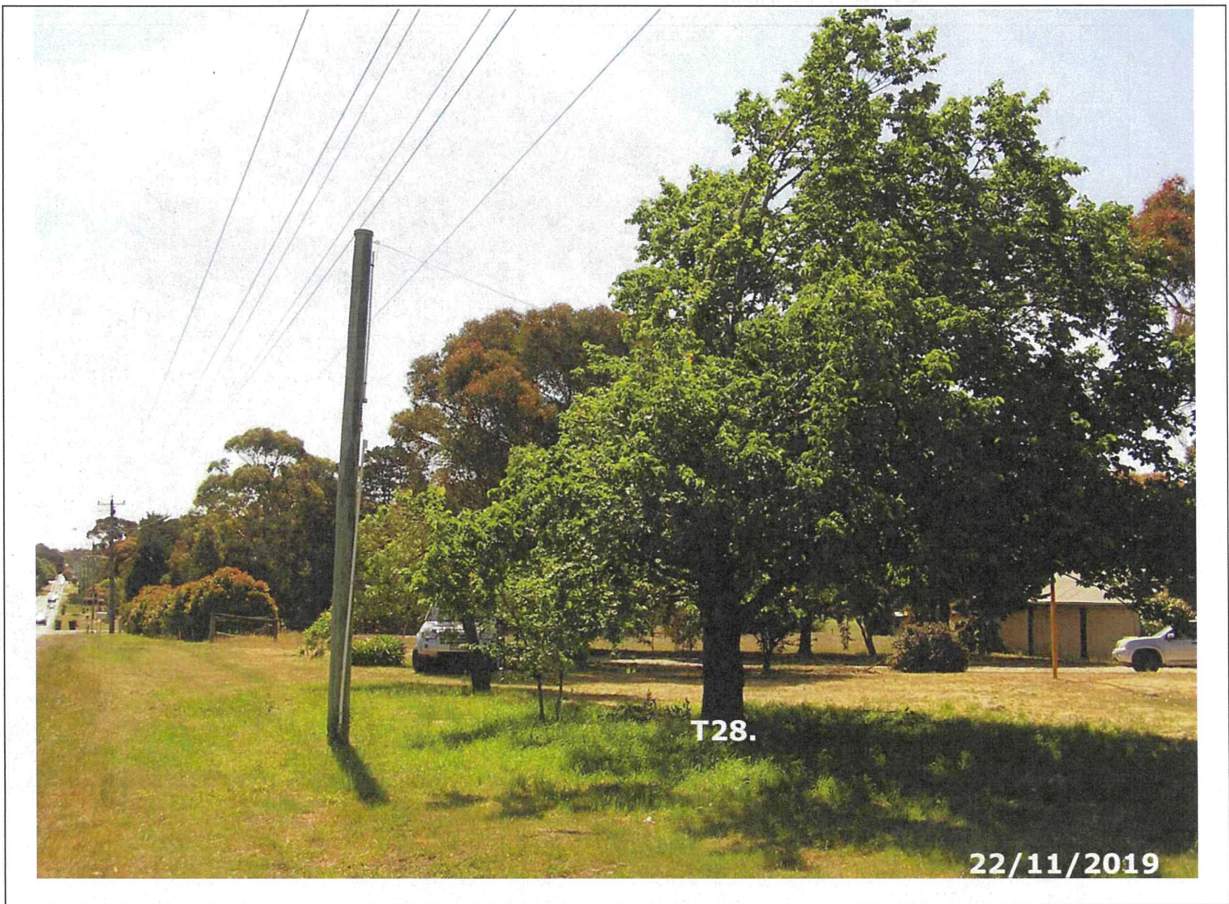
T28: Lopped Elm Tree near HV & LV Mains

- Willowbank Rd frontages are strongly influenced by HV & LV Electricity Mains and various trees have been pruned heavily to abide by statutory clearances and are ongoing maintenance problems; some of these trees have been irrevocably damaged and should be removed; the Pole CAMM Numbers of the relevant poles have been included to assist maintenance interpretation One Pole near Brady Rd has no apparent Pole CAMM Number. But Pole CAMM 741065 has an HV Pole Sub-station; near T29.
