**LOCAL-LEVEL HERITAGE ASSESSMENT:  
BUNJIL CREEK BRIDGE & CHANNEL, GISBORNE**

DATE: 1 April 2020

FILE: 2020-013

## BUNJIL CREEK BRIDGE & CHANNEL, HAMILTON STREET, GISBORNE

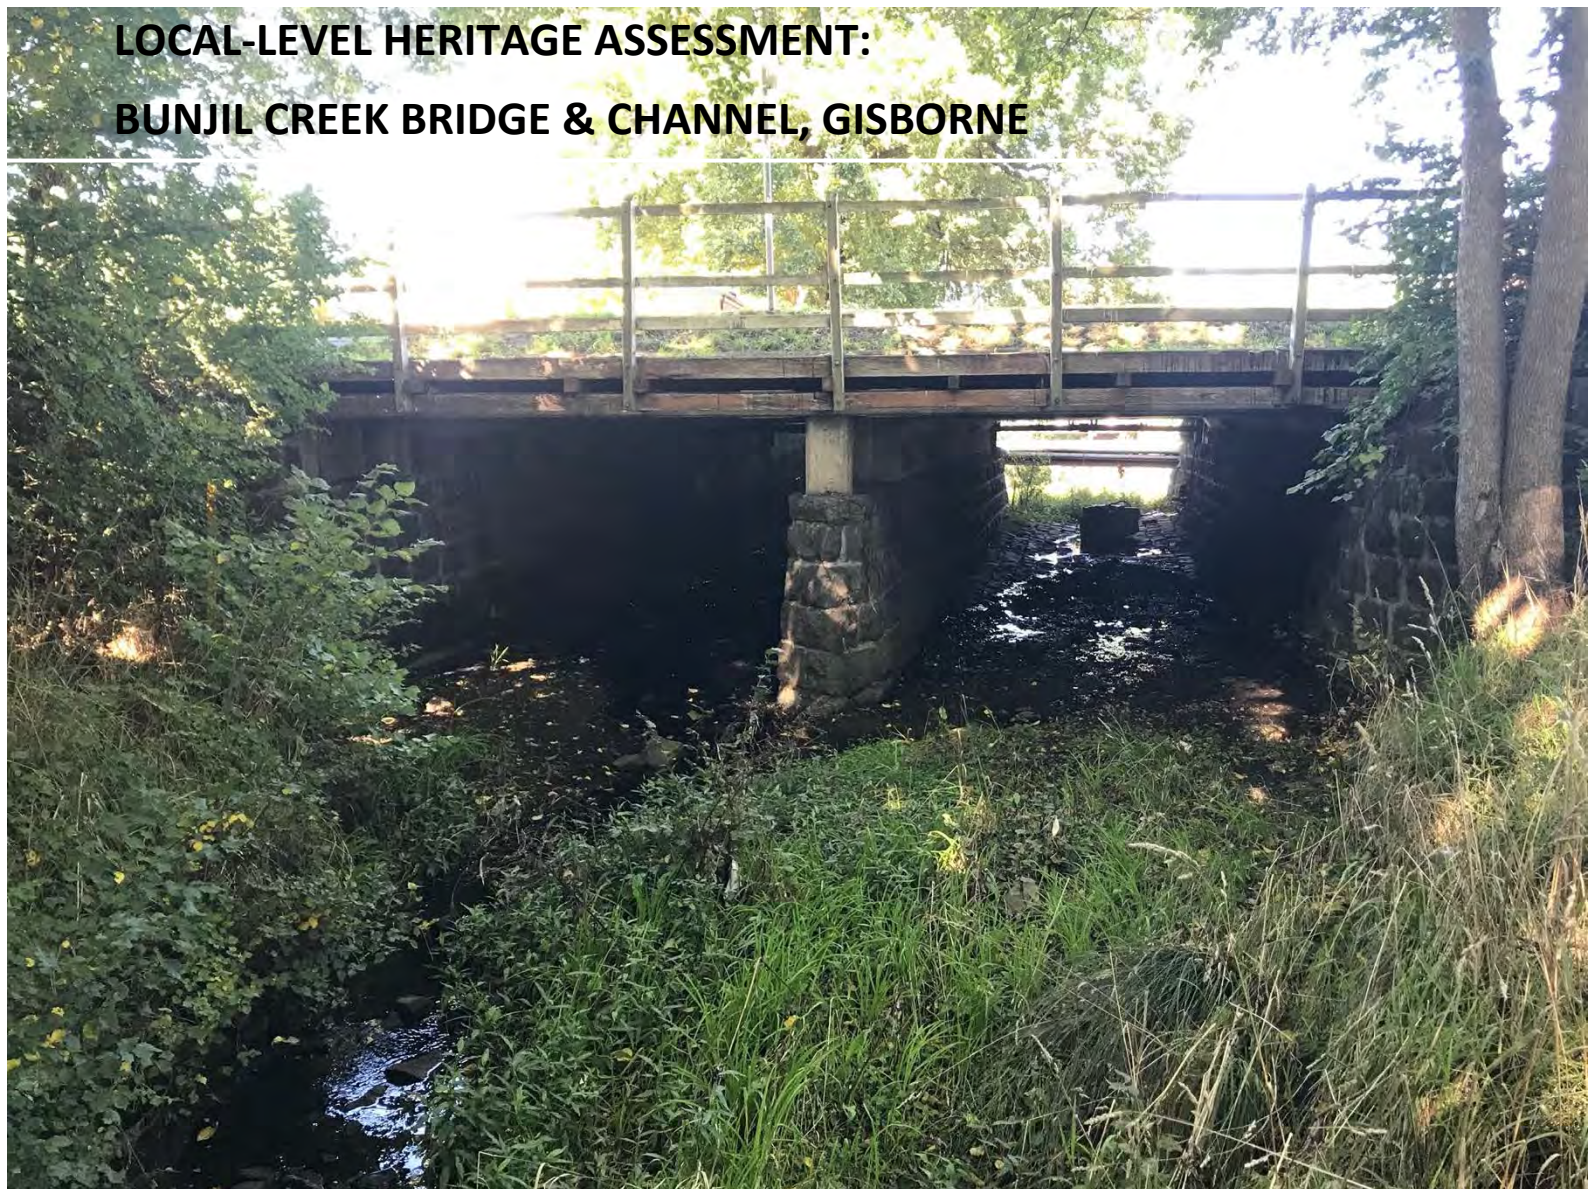
Figure 1: Bunjil Creek Bridge & Channel (GJM Heritage, March 2020)

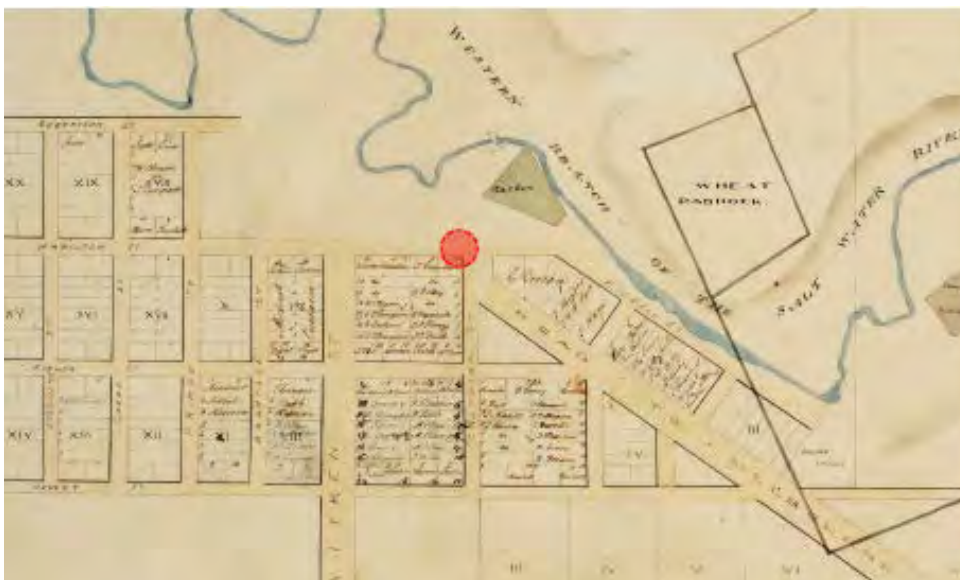
Figure 2. Detail of Town and Suburbs of Gisborne, no. 52, undated, showing original town layout. (Source: SLV, Maps Collection from Uearthed Heritage, *Historical Archaeological Due Diligence Report for the Bunjil Creek Bridge – Melbourne Road and Kilmore Road, Gisborne*, 2019)

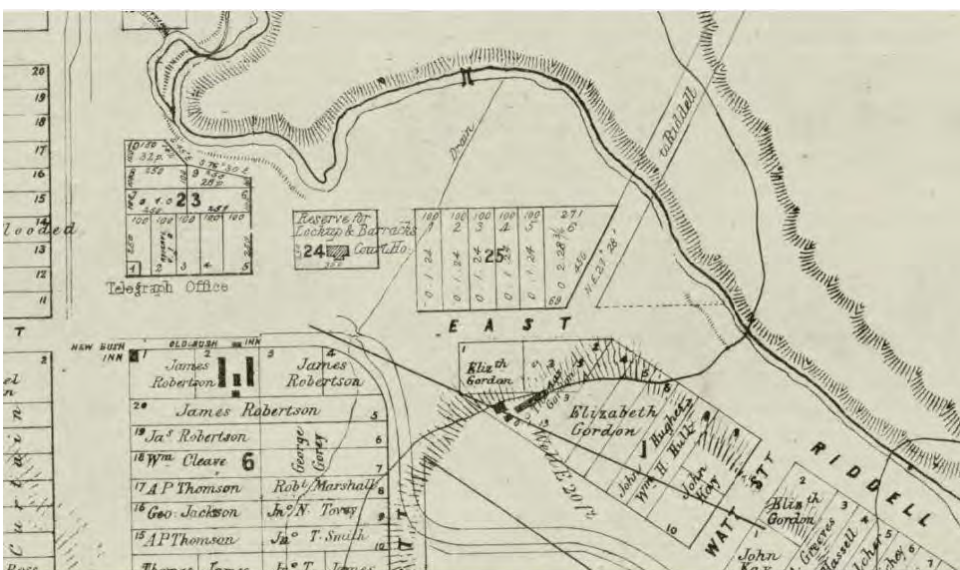
Figure 3. Detail of town and suburban lands at Gisborne, 1856, showing the creek (labelled drain) which ran through the township to Jacksons Creek (Source: SLV).

A small creek ran towards Jacksons Creek in a south-easterly direction across this main traffic route at this intersection. In the early 1850s a crossing was formed across this shallow waterway by placing large stones on the creek bed, in an effort to prevent ‘the wheels of vehicles from sinking in the mud’ (*The Argus*, 16 March 1852:2). This creek, labelled a ‘drain’ on an 1856 plan (Figure 3), is now known as Bunjil Creek.

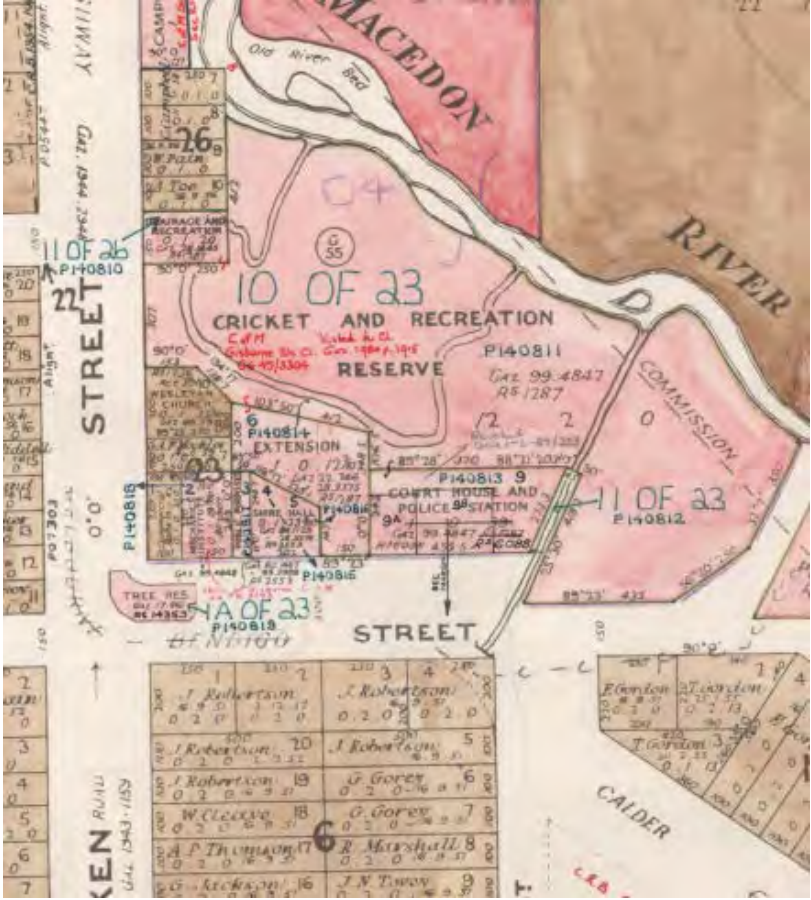
Figure 4. Detail of Township of Gisborne 5320, VPRS 16171, 19 Aug 1929, showing the position of the creek and bridge on the main route through the town (Source: PROV).

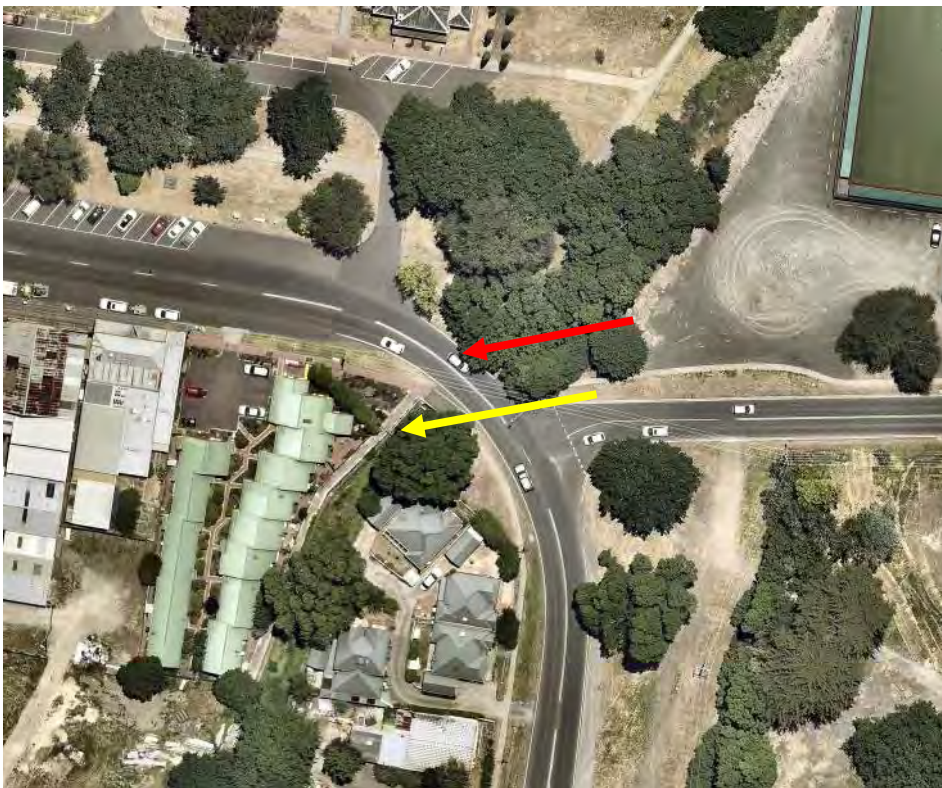
Figure 6. Aerial view showing the location of the Bunjil Creek Bridge (red) and associated channel (yellow) (Source: Nearmaps, December 2019).

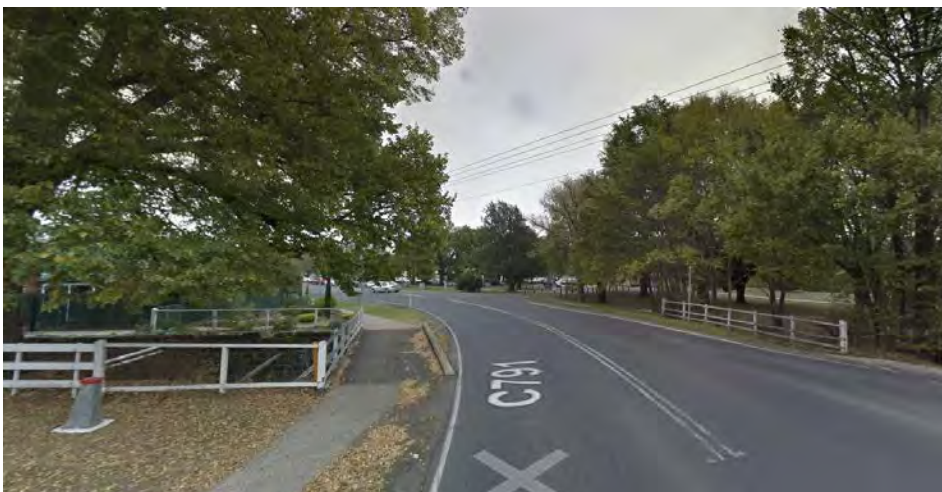
Figure 7. Approach to the Bunjil Creek Bridge from the south. (Source: Google Maps May 2018)

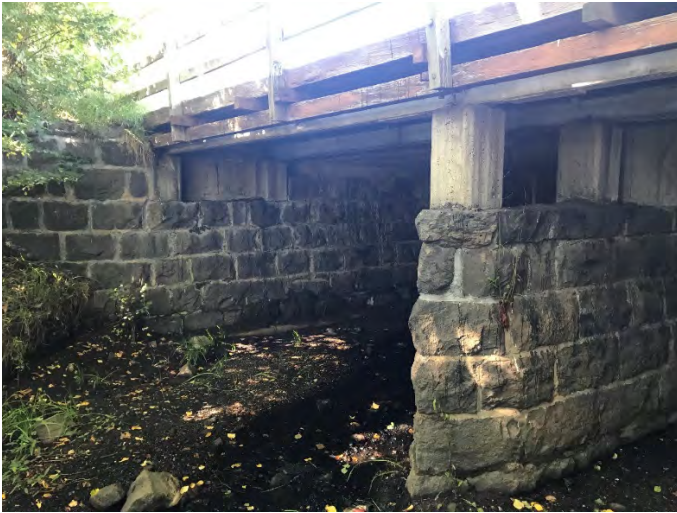
*Figure 8. Detail of the north side of the Bunjil Creek Bridge from the north, showing the 1874 substructure and modifications (Source: GJM Heritage, March 2020)*

The bridge substructure is constructed of coursed bluestone side abutments and central pier. The superstructure comprises a reinforced concrete slab deck and supporting concrete headstock. The footpaths on either side are supported on short precast concrete columns which extend above the bluestone abutments and central pier.

The bluestone substructure of the Bunjil Creek Bridge and the bluestone channel remain highly intact and retain much of the original fabric, form and detail from construction in 1874. This includes bridge abutments and central pier and channel linings under the bridge and extending upstream to the south. The superstructure of the bridge has been extensively modified and replaced with a reinforced concrete deck in 1938. Parts of the

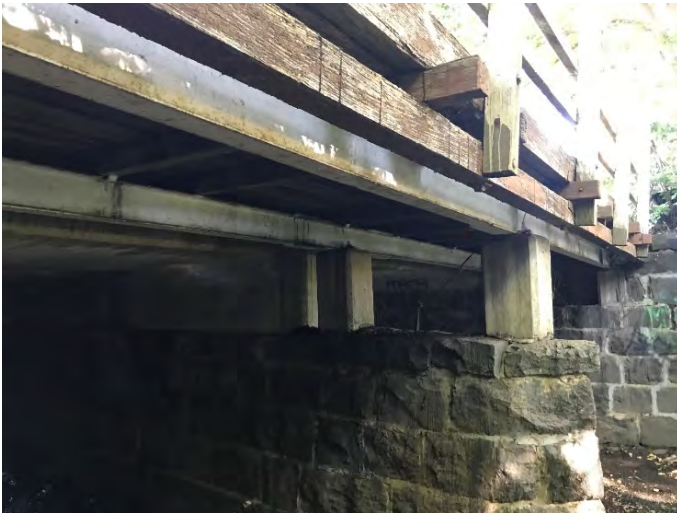
*Figure 9. Detail of the Bunjil Creek Bridge and Channel, showing the extension made to the south side of the bridge in 1938. (Source: GJM Heritage, March 2020)*

In 1938, the Victorian Country Roads Board carried out further alteration works to the Hamilton Street Bridge to support increased motor vehicle traffic requirements. The concrete deck was widened by 6'5" (1.96 metres) on the downstream side and two pedestrian footways were installed; a 6'4" (1.93 m) wide footway along the downstream side of the bridge and a 9'2" (2.8 m) wide footway along the upstream side (Figure 5). These were supported by short precast concrete columns fixed on top of the masonry abutments and piers. The bridge appears to have remained primarily in this structural form since.

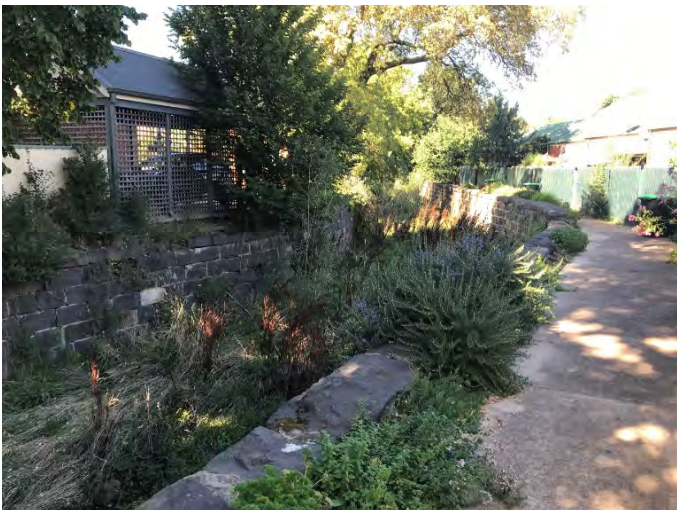
*Figure 10. The extensive bluestone-lined channel which runs south of the Bunjil Creek Bridge (Source: GJM Heritage, March 2020)*

A channel associated with the bridge structure has bluestone retaining walls which line both sides of the creek upstream (south) of the bridge and bluestone pitching along the creek bed, extending from underneath the bridge for a distance to the south.

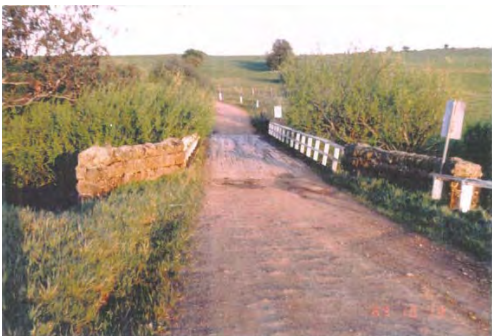
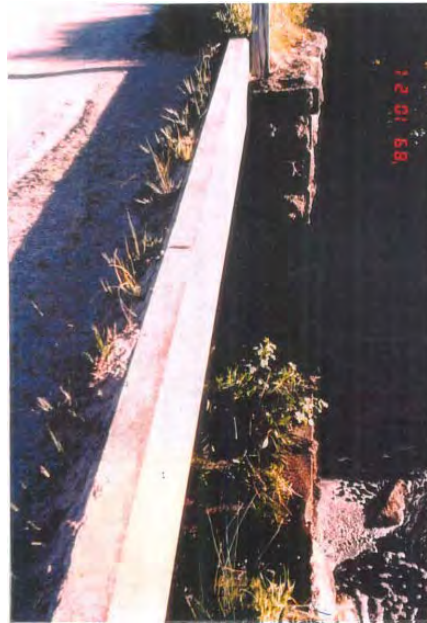
Figures 11 & 12. (L) Stone Bridge Abutments and Piers, Hodges Bridge, Boundary Road, Edgecombe (HO20), Note: 20th century timber deck and balustrade (R) Bluestone Road Bridge Abutments, Central Road, Kyneton South (HO47) (Source: D Bick et al, *Kyneton Conservation Heritage Study*, vol 6, 1990)

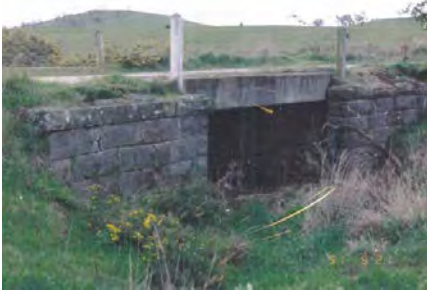
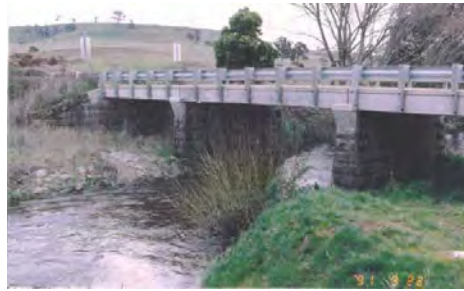
Figures 13 & 14. Bluestone (L) Culvert Abutments over Limbricks Creek, Morris Lane, Pipers Creek (HO183) (R) Manning's Bridge, Springhill Road, Spring Hill, 19th century substructure with later road deck (HO232) (Source: D Bick et al, Kyneton Conservation Heritage Study, vol 7, 1990)

Bunjil Creek Bridge retains sufficient integrity to clearly demonstrate the characteristics of early drainage infrastructure in a rural township. Like the places listed above, the Bunjil Creek Bridge illustrates the early and ongoing need for such infrastructure in rural townships in the Macedon Ranges Shire and is directly comparable to the places listed above. It displays a range of similar characteristics and retains a similar amount of original fabric to examples such as Manning's Bridge, Springhill Road, Spring Hill (HO232).

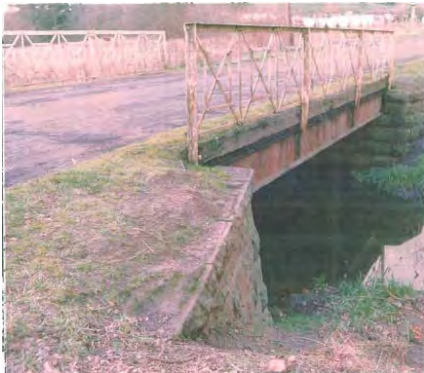
Figure 15. Road Bridge Abutments and Rivetted Railings over Post Office Creek, Wedge Street, Kyneton (HO234) (Source: D Bick et al, Kyneton Conservation Heritage Study, vol 5, 1990)

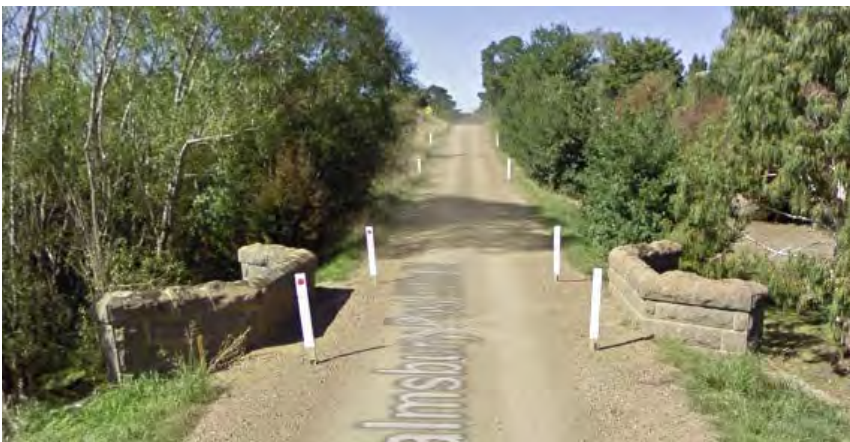
Figure 16. Bluestone Abutments to Road Bridge over Creek, Barker Street, Malmsbury (HO5) (Source: Google Maps, March 2010)

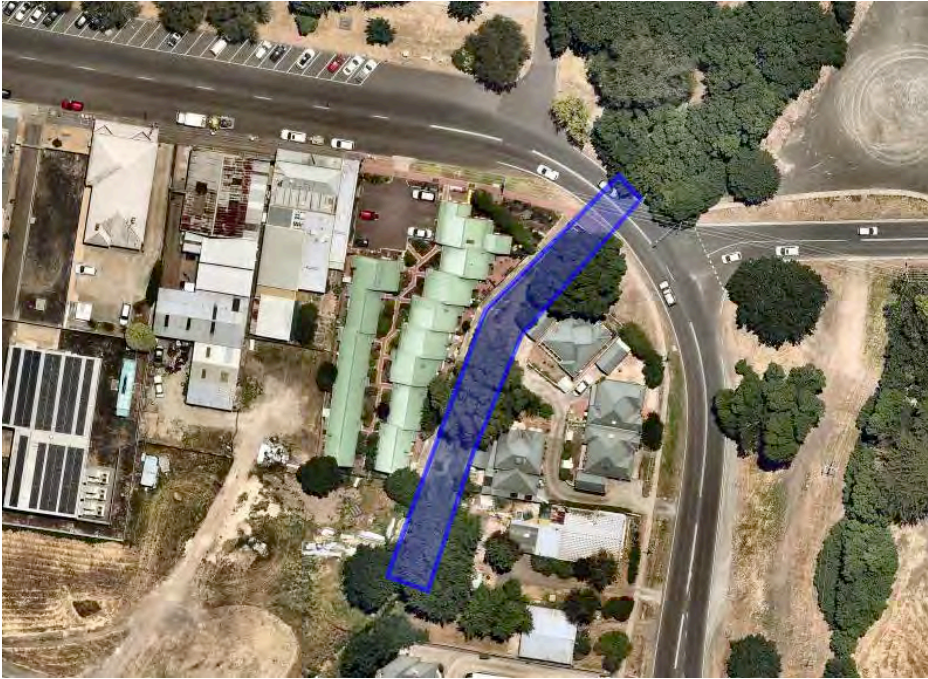
To the extent indicated by the blue polygon on the aerial below. The extent includes the bluestone-lined channel and the Bunjil Creek Bridge (comprising bluestone sub-structure and more recent concrete deck).

*Figure 17. Recommended Extent of Heritage Overlay (Source: Nearmap, December 2019)*
