# Development Impact Report

## Assessment of Trees at 36 Sullivans Lane, Woodend

Friday, 8 May 2020

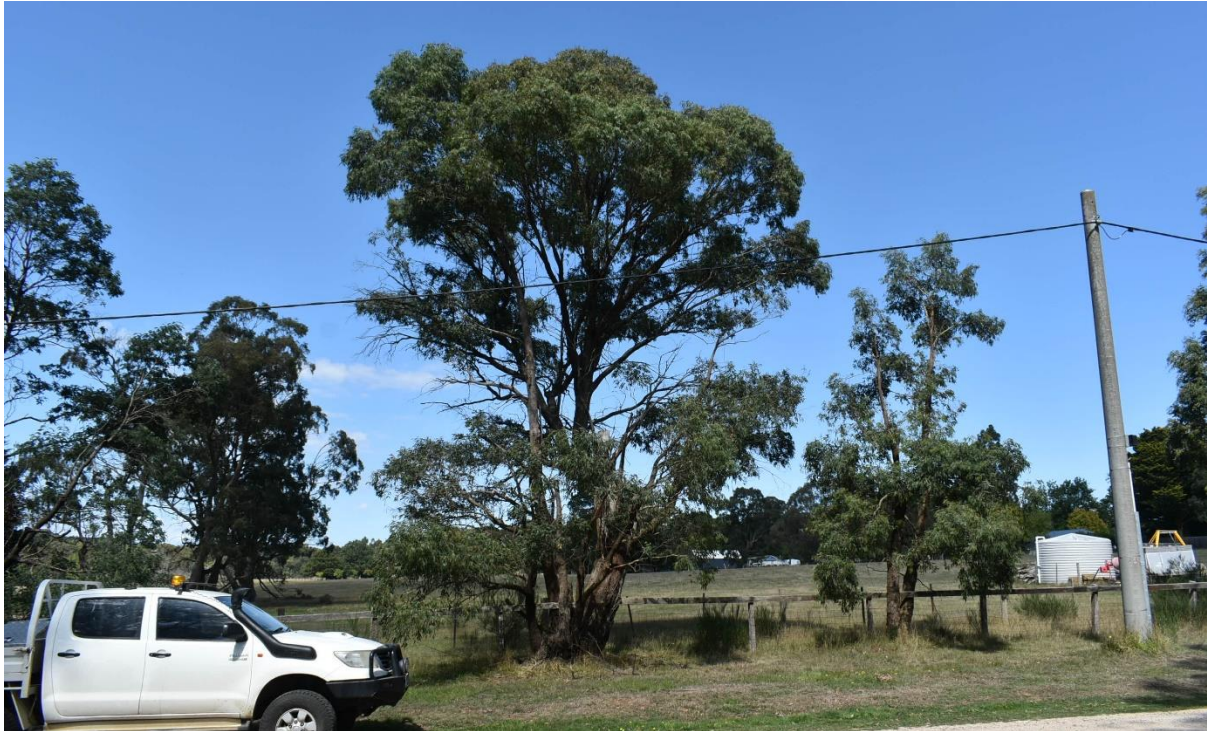
Figure 1 Subject site from Sullivan’s Lane looking from the north looking south

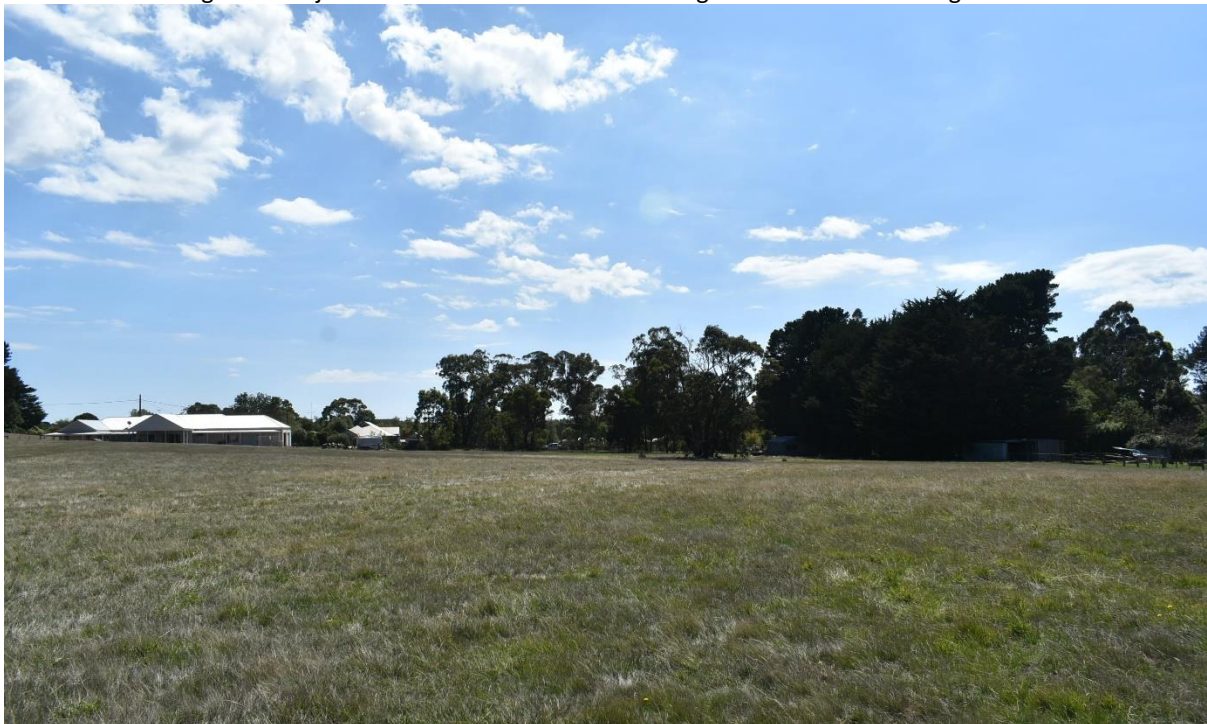
Figure 2 Subject site from the south looking North

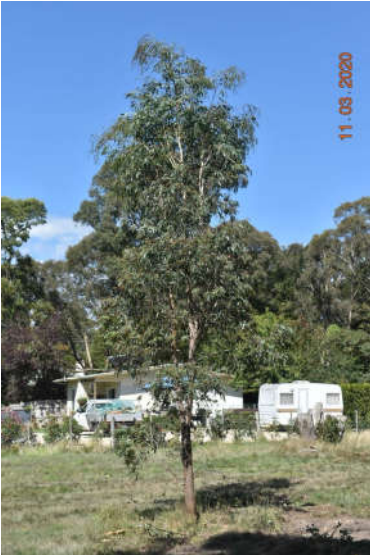
### Tree Number: 16

**Botanical Name:** *Eucalyptus radiata*  
**Common Name:** Narrow-leaved Peppermint  
**Origin:** Indigenous  
**Tree Age:** Young  
**H x W:** 6m x 1m  
**Health:** Good  
**Structure:** Good  
**ULE:** 20+ years  
**Retention Value:** Low

**Comments:** <10 years old

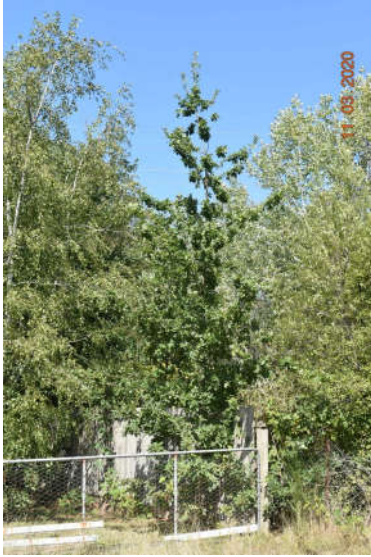
### Tree Number: 17

**Botanical Name:** *Quercus robur*  
**Common Name:** English Oak  
**Origin:** Exotic  
**Tree Age:** Young  
**H x W:** 7m x 1m  
**Health:** Good  
**Structure:** Good  
**ULE:** 20+ years  
**Retention Value:** Low  
**Defects:** None

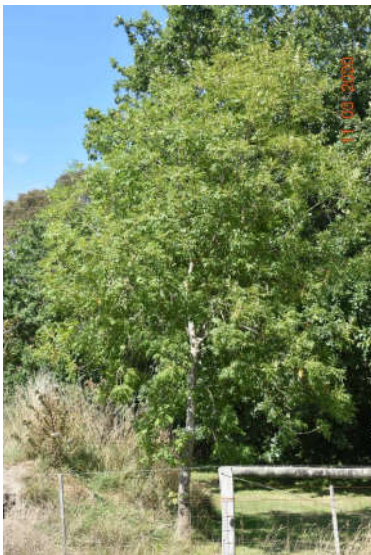
### Tree Number: 19

**Botanical Name:** *Fraxinus excelsior*  
**Common Name:** European Ash  
**Origin:** Exotic  
**Tree Age:** Semi mature  
**H x W:** 7m x 3m  
**Health:** Good  
**Structure:** Good  
**ULE:** 20+ years  
**Retention Value:** Low  
**Defects:** None

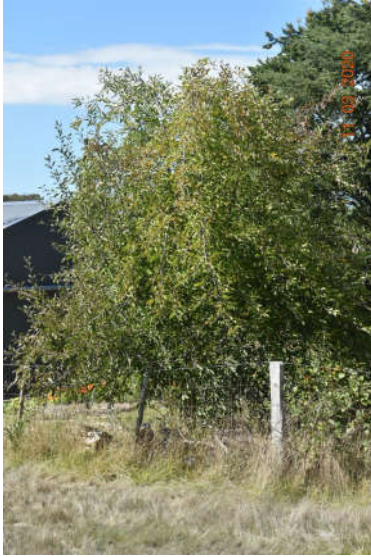
### Tree Number: 20

**Botanical Name:** *Malus domestica*  
**Common Name:** Apple  
**Origin:** Exotic  
**Tree Age:** Semi mature  
**H x W:** 5m x 3m  
**Health:** Good  
**Structure:** Fair  
**ULE:** 10-20 years  
**Retention Value:** Medium  
**Defects:** None

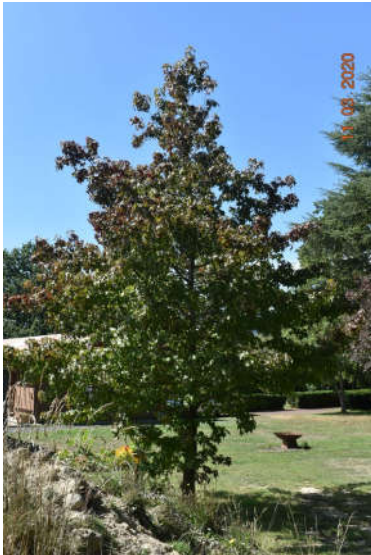
### Tree Number: 21

**Botanical Name:** *Liquidambar styraciflua*  
**Common Name:** Liquidamber  
**Origin:** Exotic  
**Tree Age:** Young  
**H x W:** 6m x 2m  
**Health:** Good  
**Structure:** Good  
**ULE:** 20+ years  
**Retention Value:** Medium  
**Defects:** None

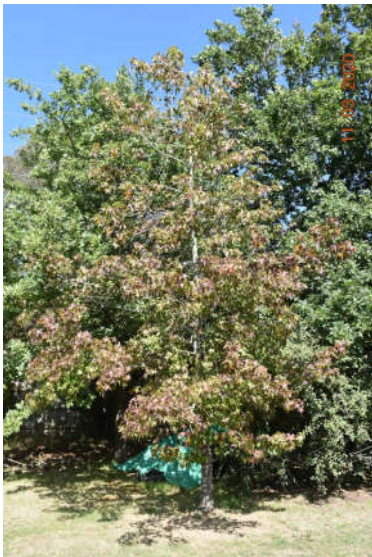
### Tree Number: 24

**Botanical Name:** *Liquidambar styraciflua*  
**Common Name:** Liquidamber  
**Origin:** Exotic  
**Tree Age:** Young  
**H x W:** 8m x 3m  
**Health:** Good  
**Structure:** Good  
**ULE:** 20+ years  
**Retention Value:** Low

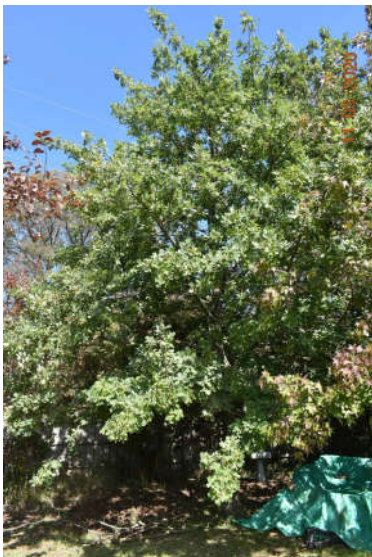
### Tree Number: 25

**Botanical Name:** *Quercus robur*  
**Common Name:** English Oak  
**Origin:** Exotic  
**Tree Age:** Young  
**H x W:** 9m x 4m  
**Health:** Good  
**Structure:** Good  
**ULE:** 20+ years  
**Retention Value:** Medium
